# Evaluation of Riparian Re-Vegetation on Streambank Stability and Erosion

Destiny Russell Texas Water Resources Institute  
Fouad Jaber, PhD, PE Texas A&M AgriLife

# Study Site

## Geronimo Creek

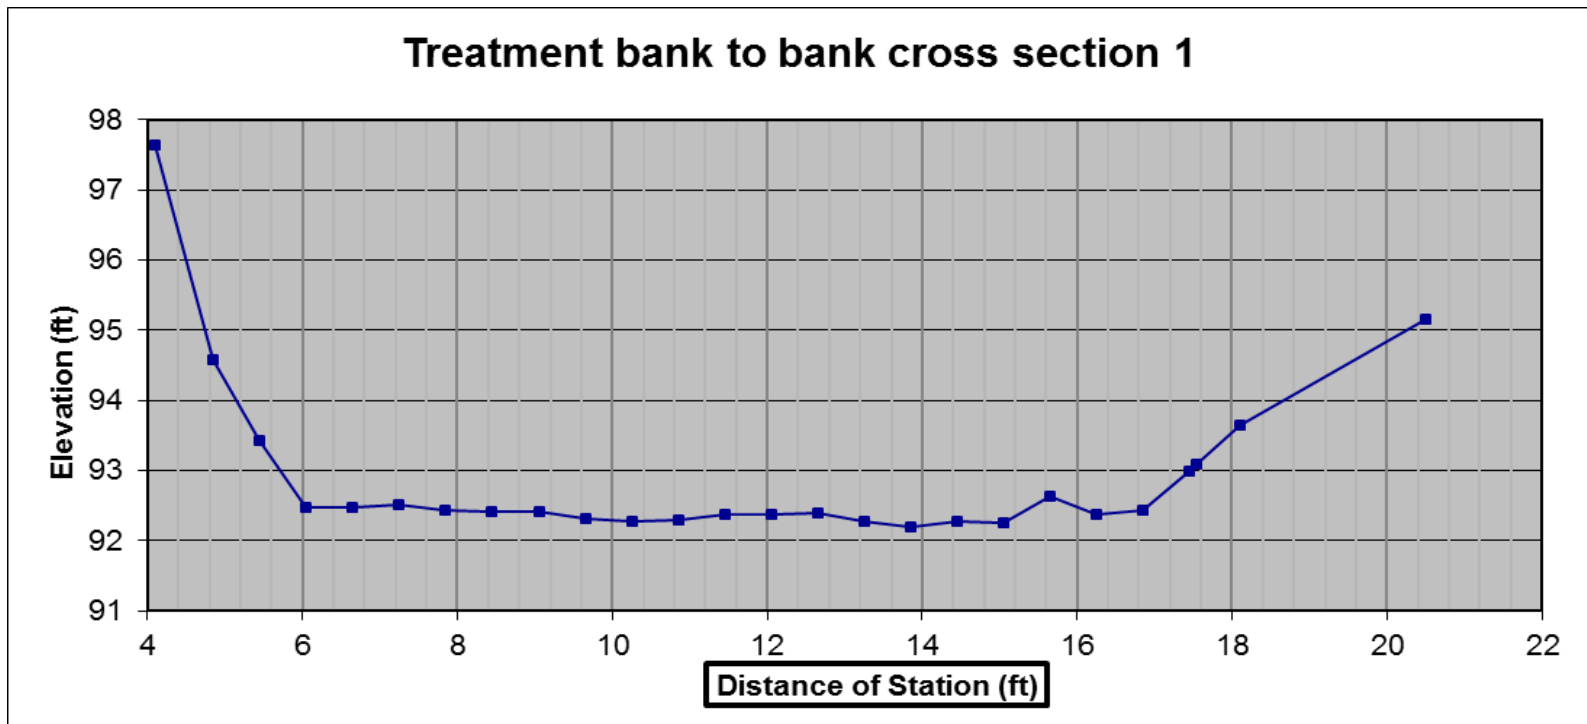
Pebble Count D50 clay

Classification: C6 morphing to a G6c

Left bank: 29.75 (Mod/High)

Right Bank: 20.4 (Moderate)

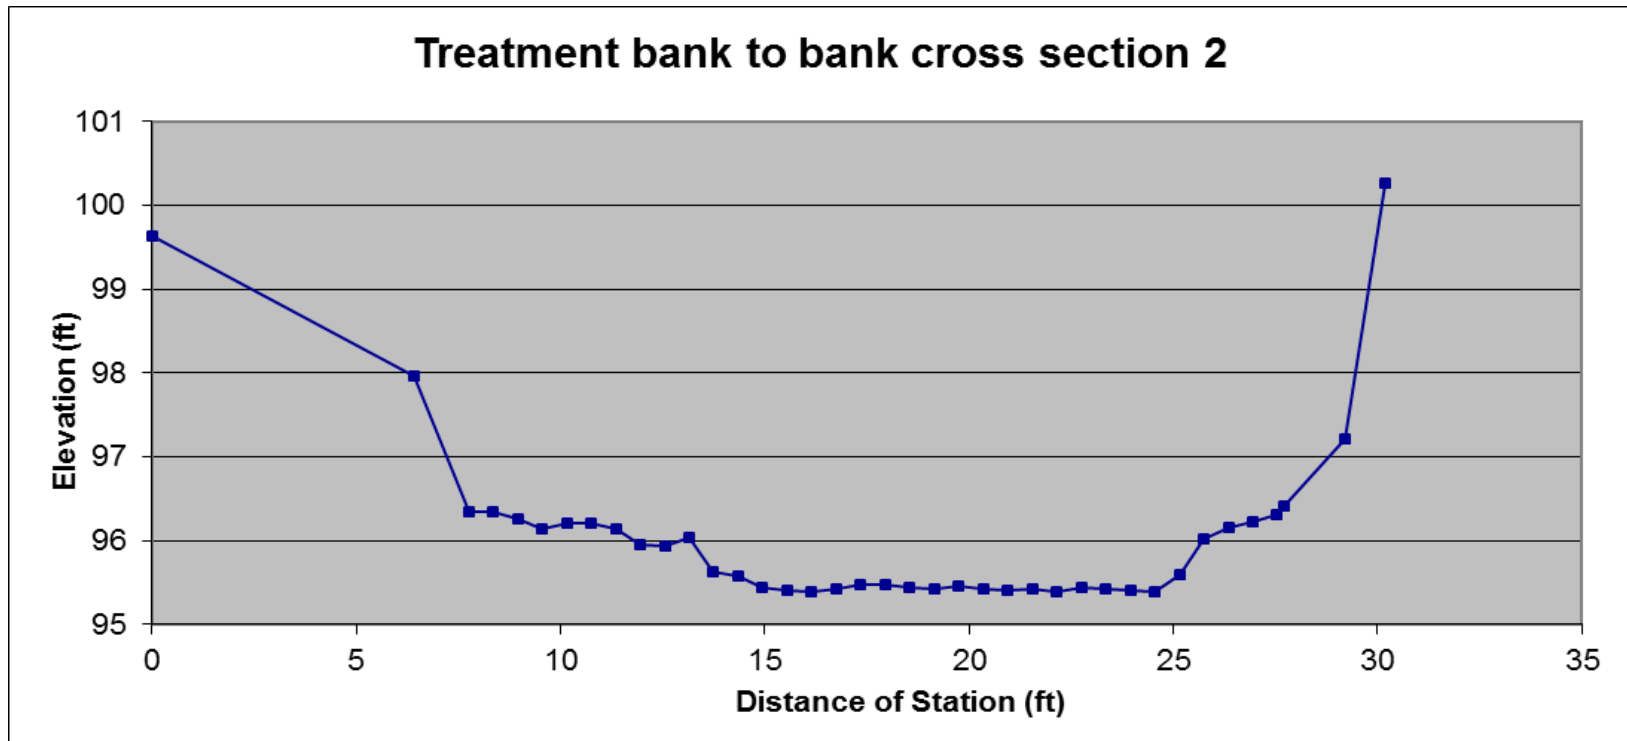
Classification: C6

Left bank: 19.3 (Low/Mod)

Right Bank: 19.1 (Low/Mod)

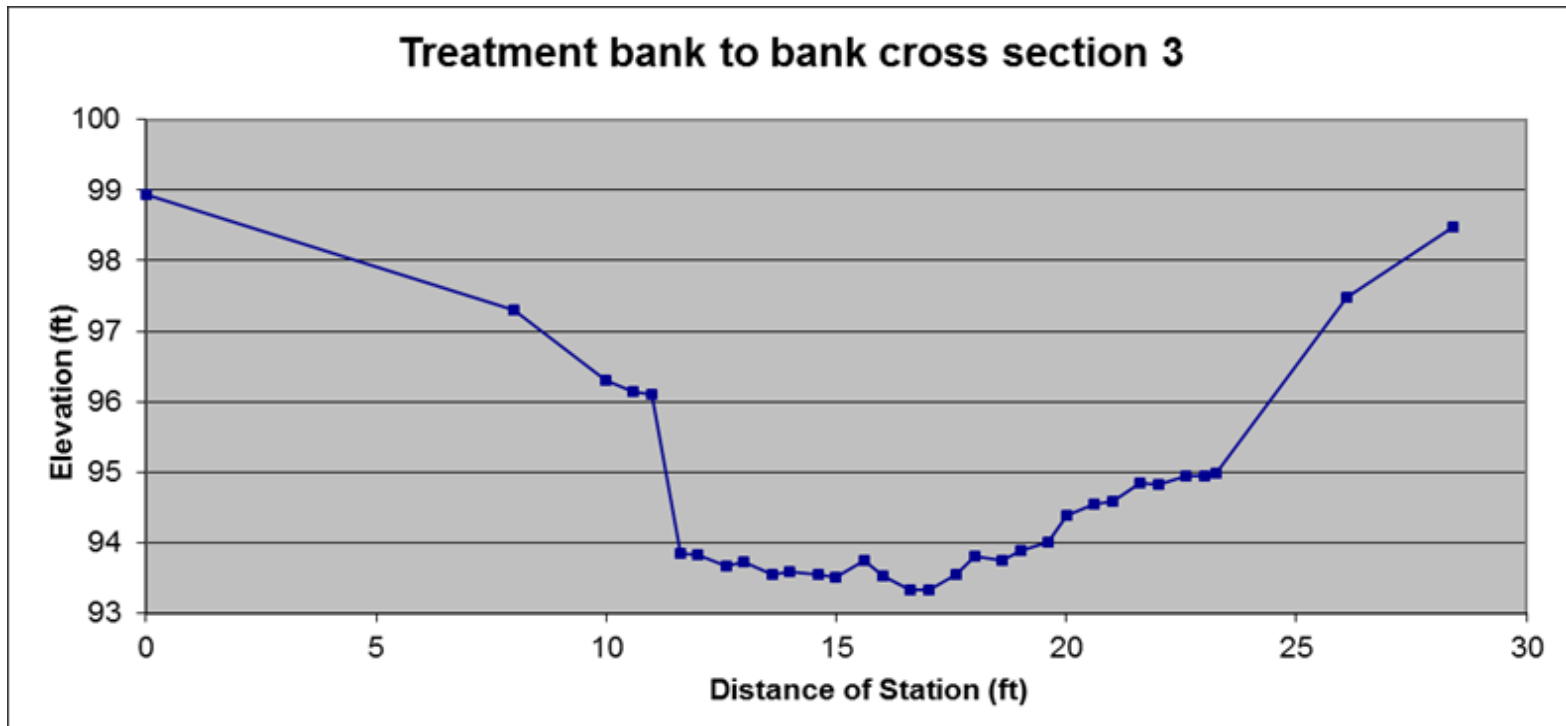
Classification: C6

Left bank: 24.58 (Moderate)

Right Bank: 24.5 (Moderate)

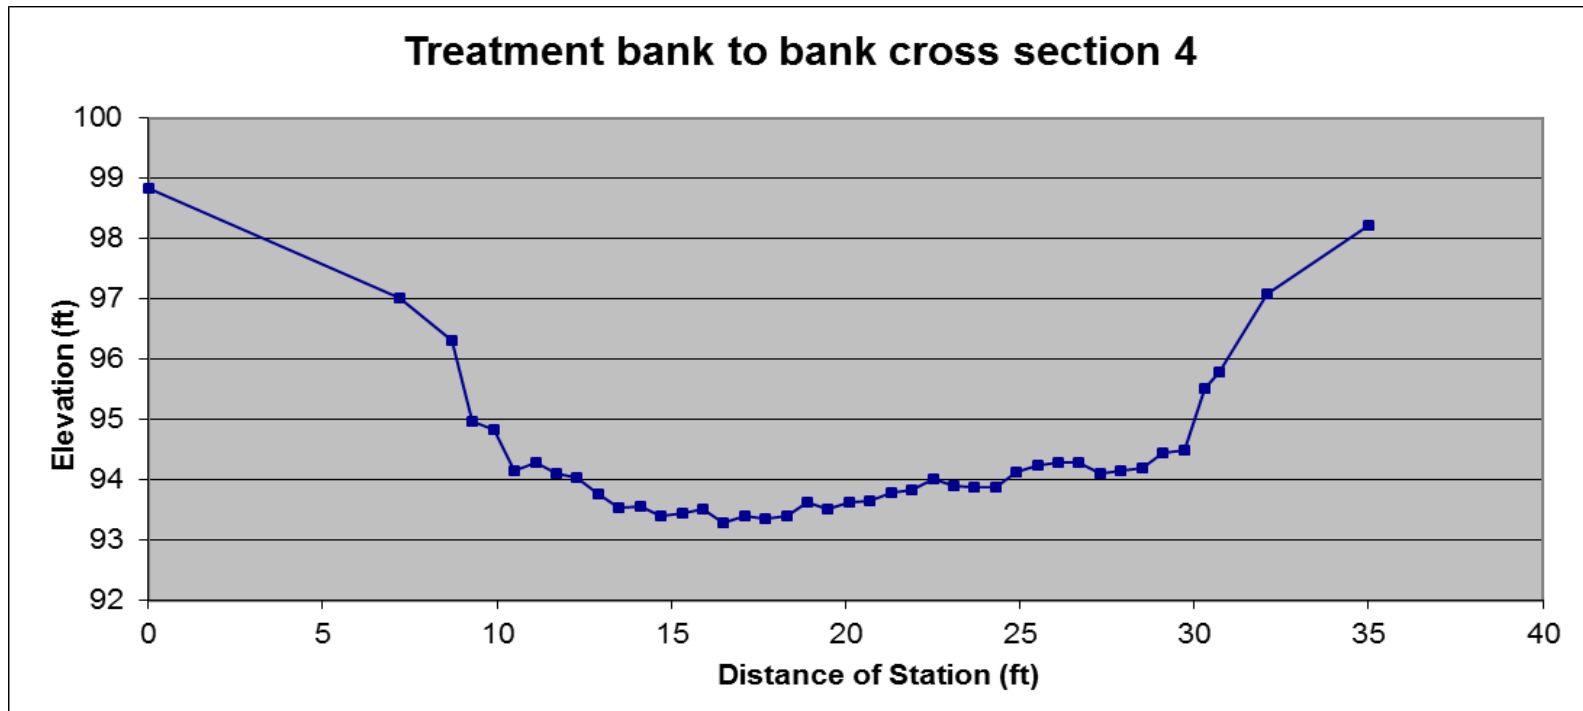
Classification: G6c

Left bank: 21.7 (Moderate)

Right Bank: 22.4 (Moderate)

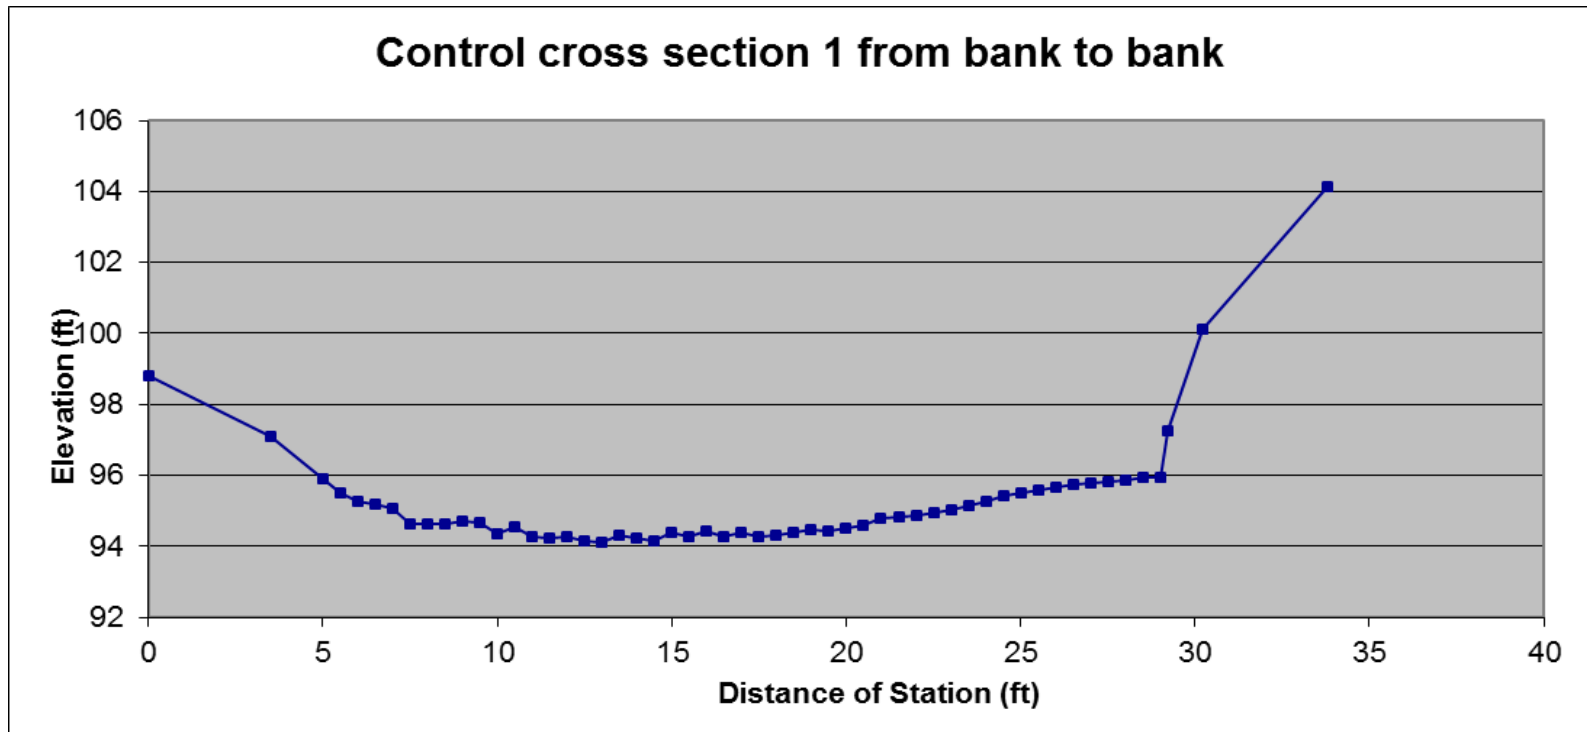
Classification: G6c

Left bank: 34.8 (High)

Right Bank: 28.9 (Moderate)

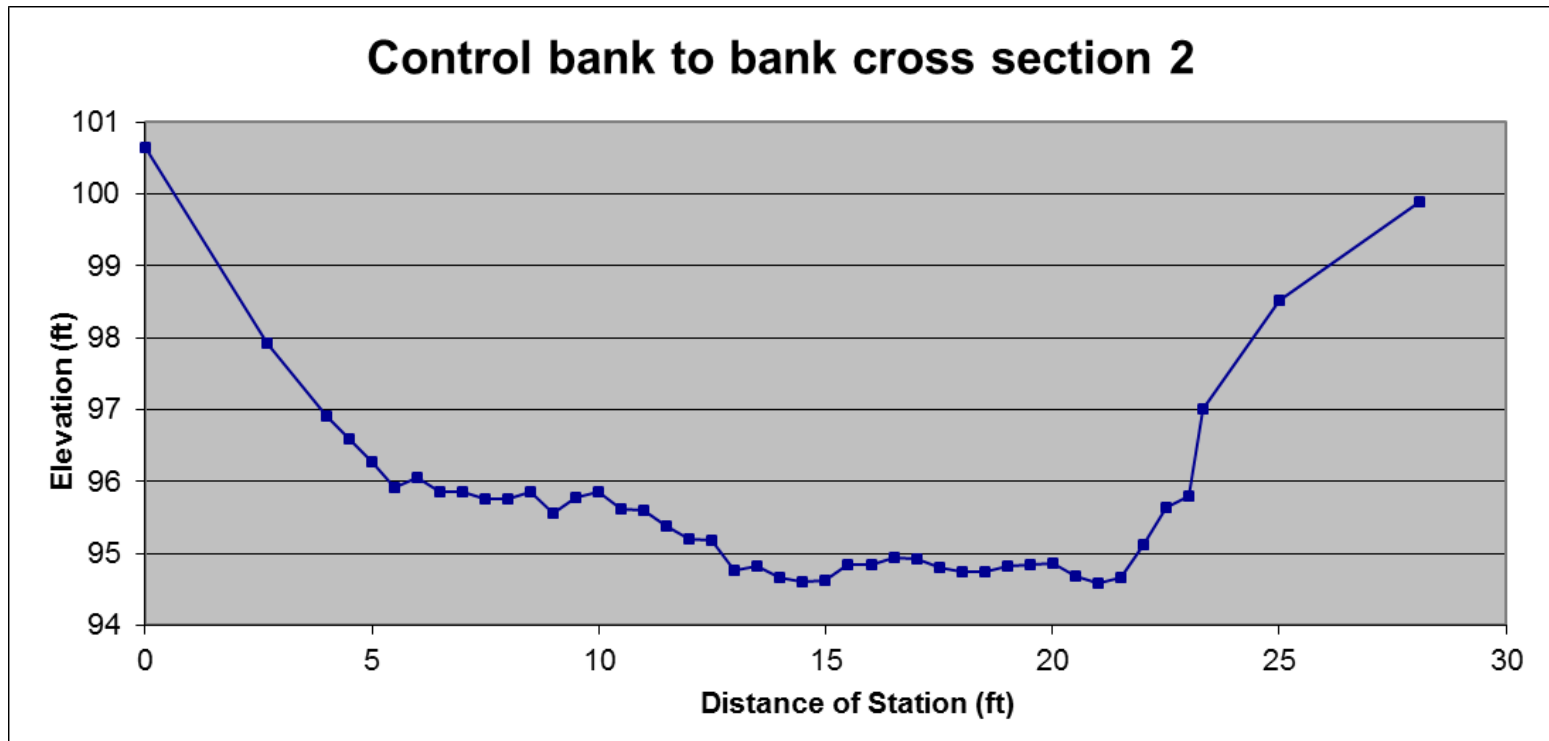
Classification: G6c

Left bank: 34.8 (High)

Right Bank: 23.4 (Moderate)

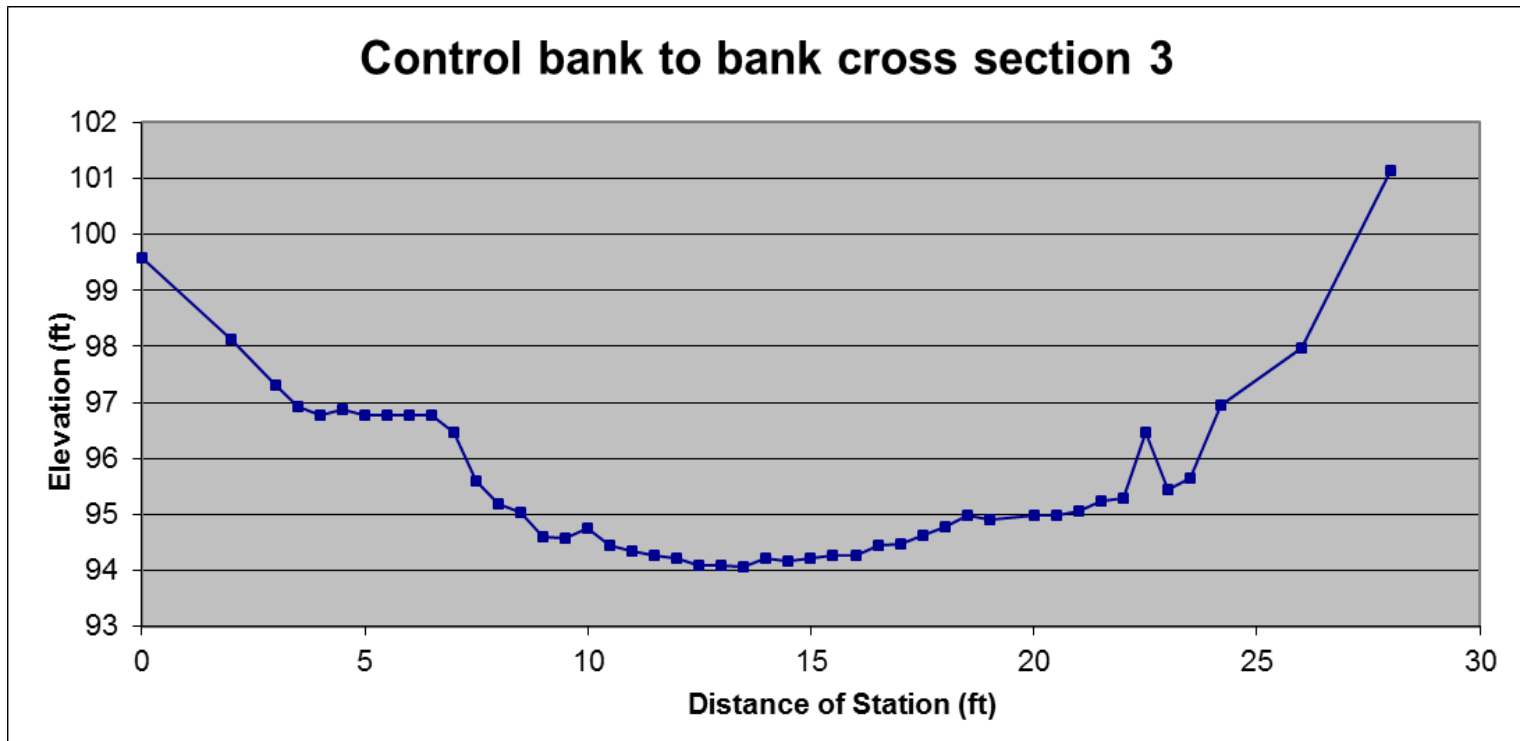
Classification: G6c

Left bank: 34.8 (High)

Right Bank: 28.9 (Moderate)

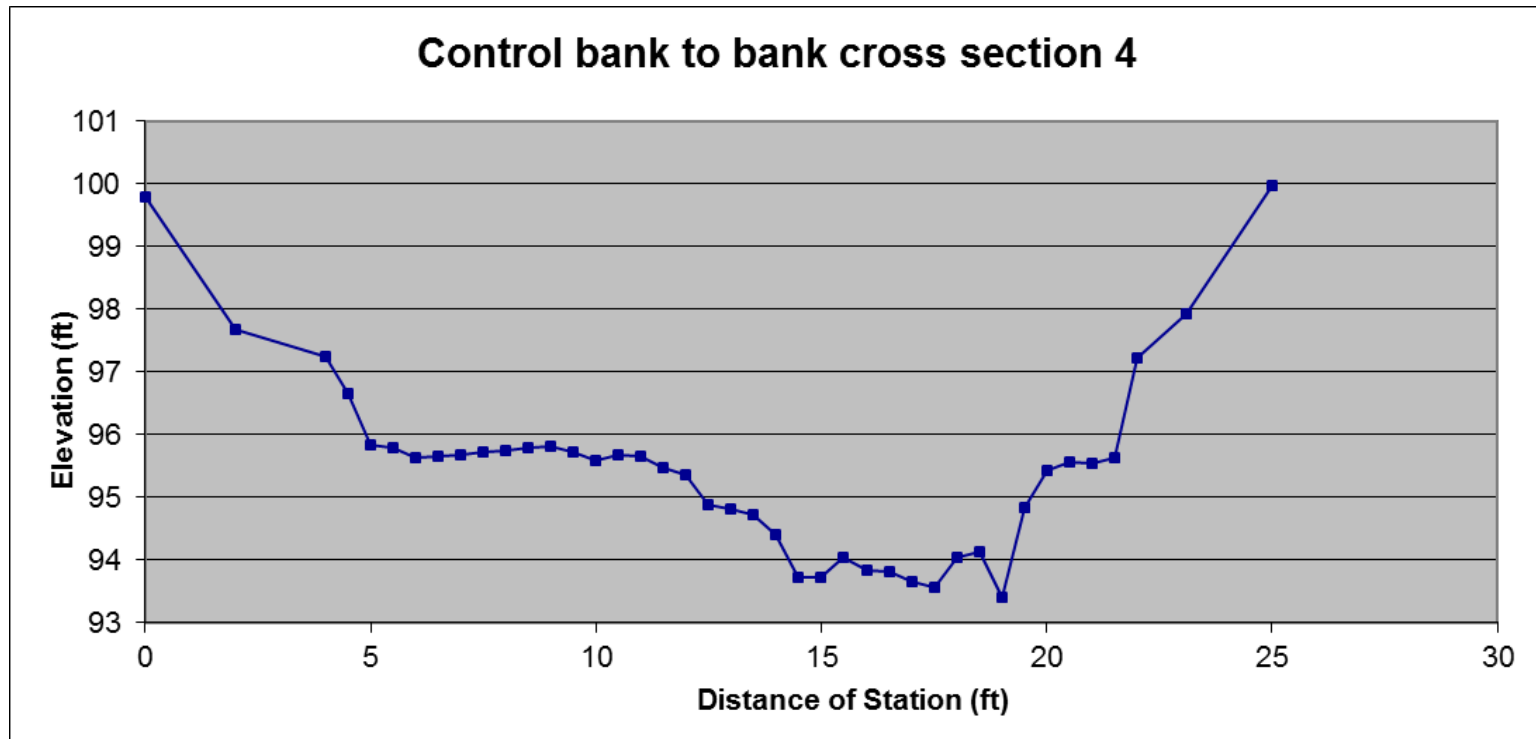
Classification: G6c

Left bank: 30.9 (High)

Right Bank: 30.75 (High)
