Enlargement and Instability of Stream Channels in Austin, Texas: When to Restore?

Michelle Adlong, E.I.T. | City of Austin Watershed Protection Department
Urban Riparian Symposium | February 12, 2015

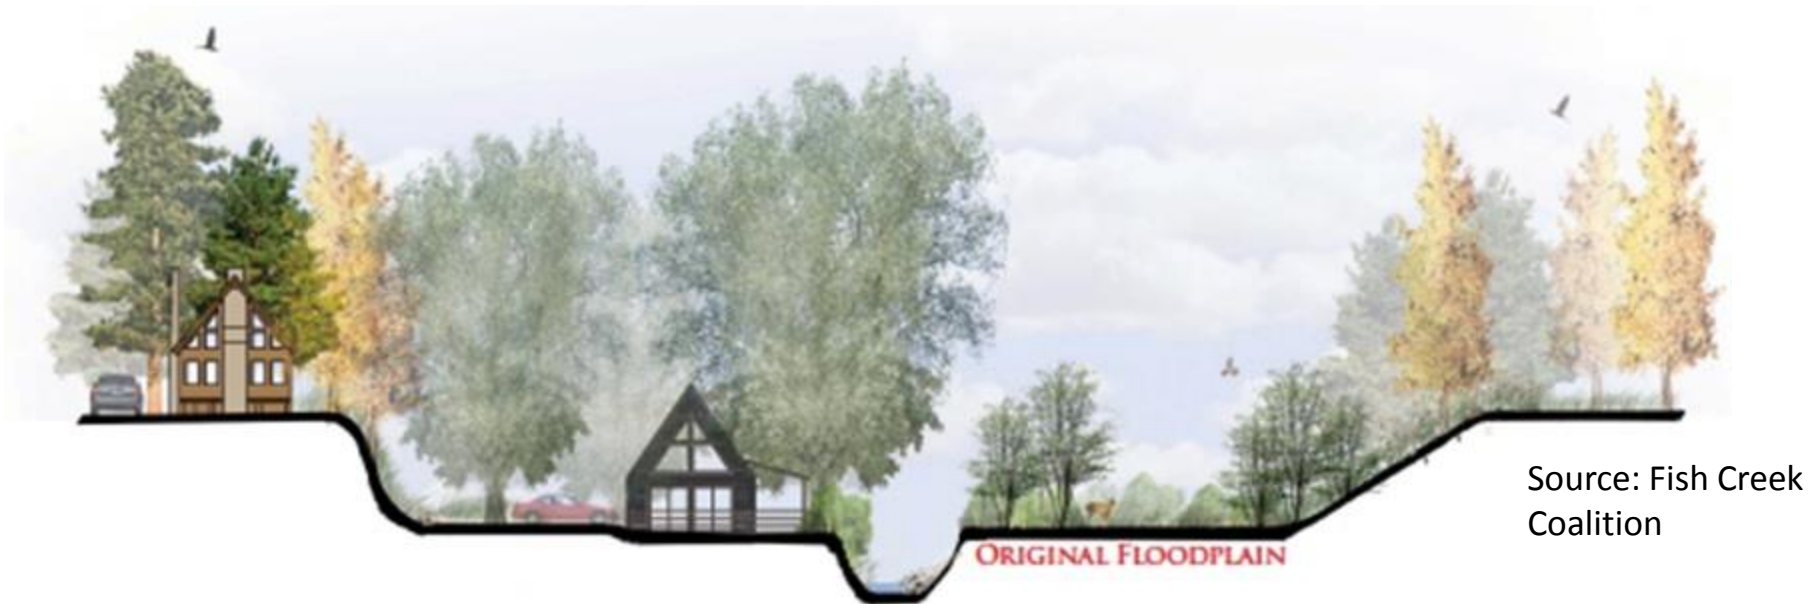
INITIAL STABLE CHANNEL

- Original stable channel: sediment load and stream power are in equilibrium
- Typically channel is vegetated and well-connected to floodplain

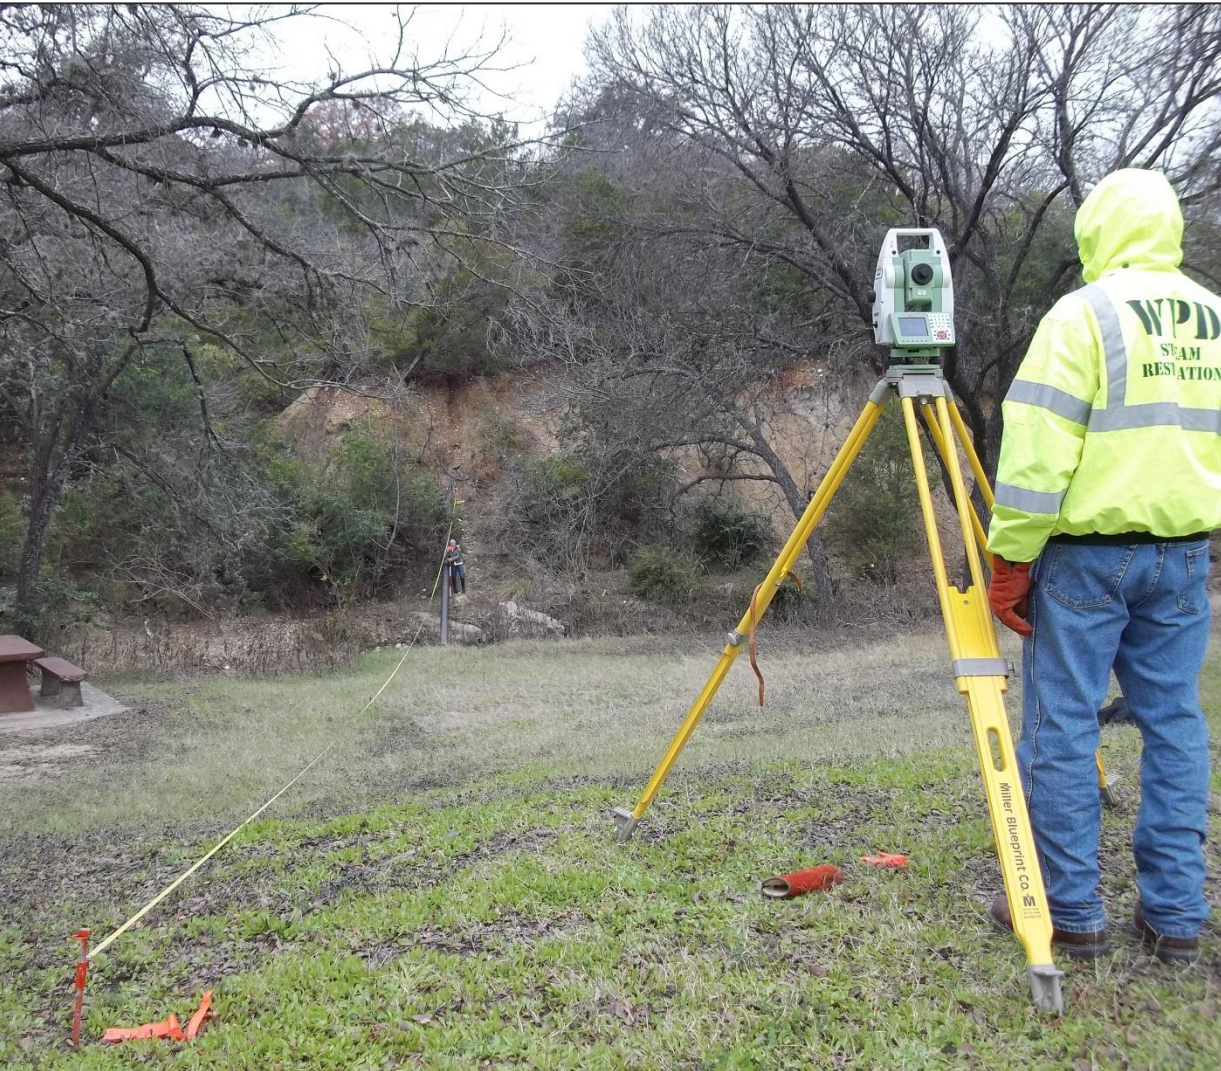
Channel Enlargement Study

- 1 to 3 cross sections at 45 sites in Austin watersheds
- Sites were re-surveyed in 2015 (in progress)

Tannehill Creek at Givens Park in 2015

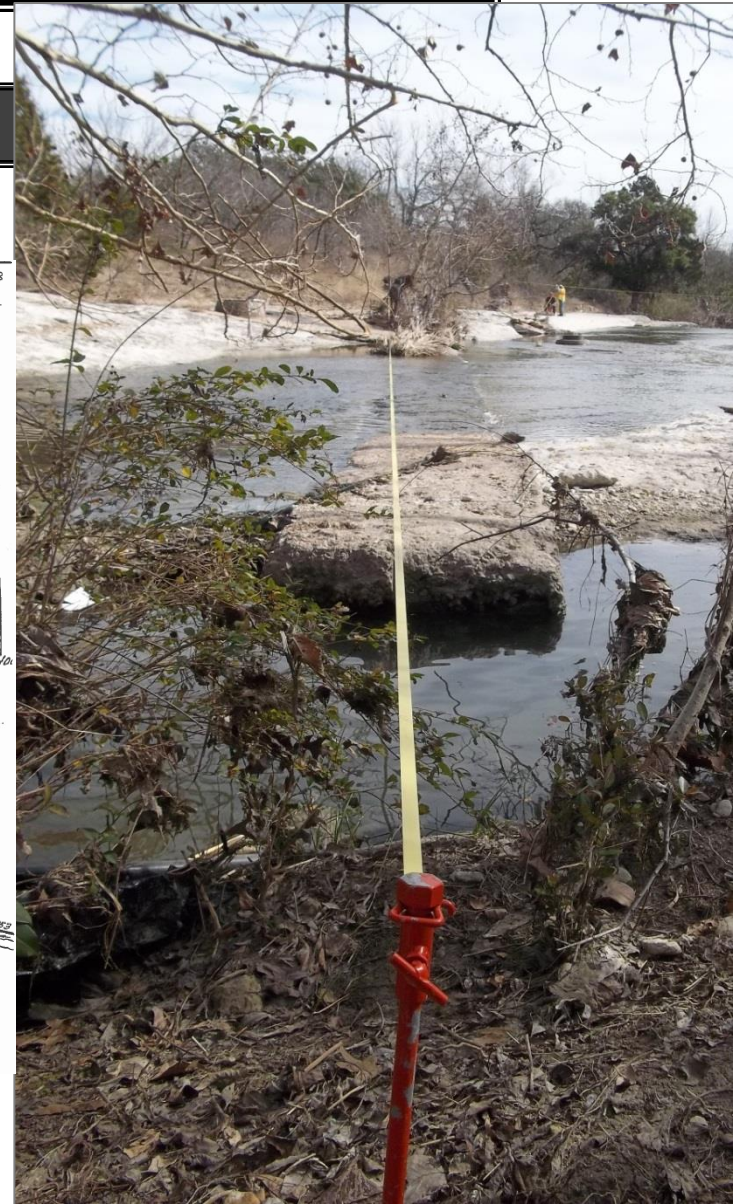
Survey Procedure

- Select cross section location at wastewater lines
- Survey cross sections in 1997 and 2015
 1. Wastewater line alignment
 2. Perpendicular & downstream of wastewater line
- Note locations of flowline, active bankfull channel, top of banks
- Observe channel type, channel features

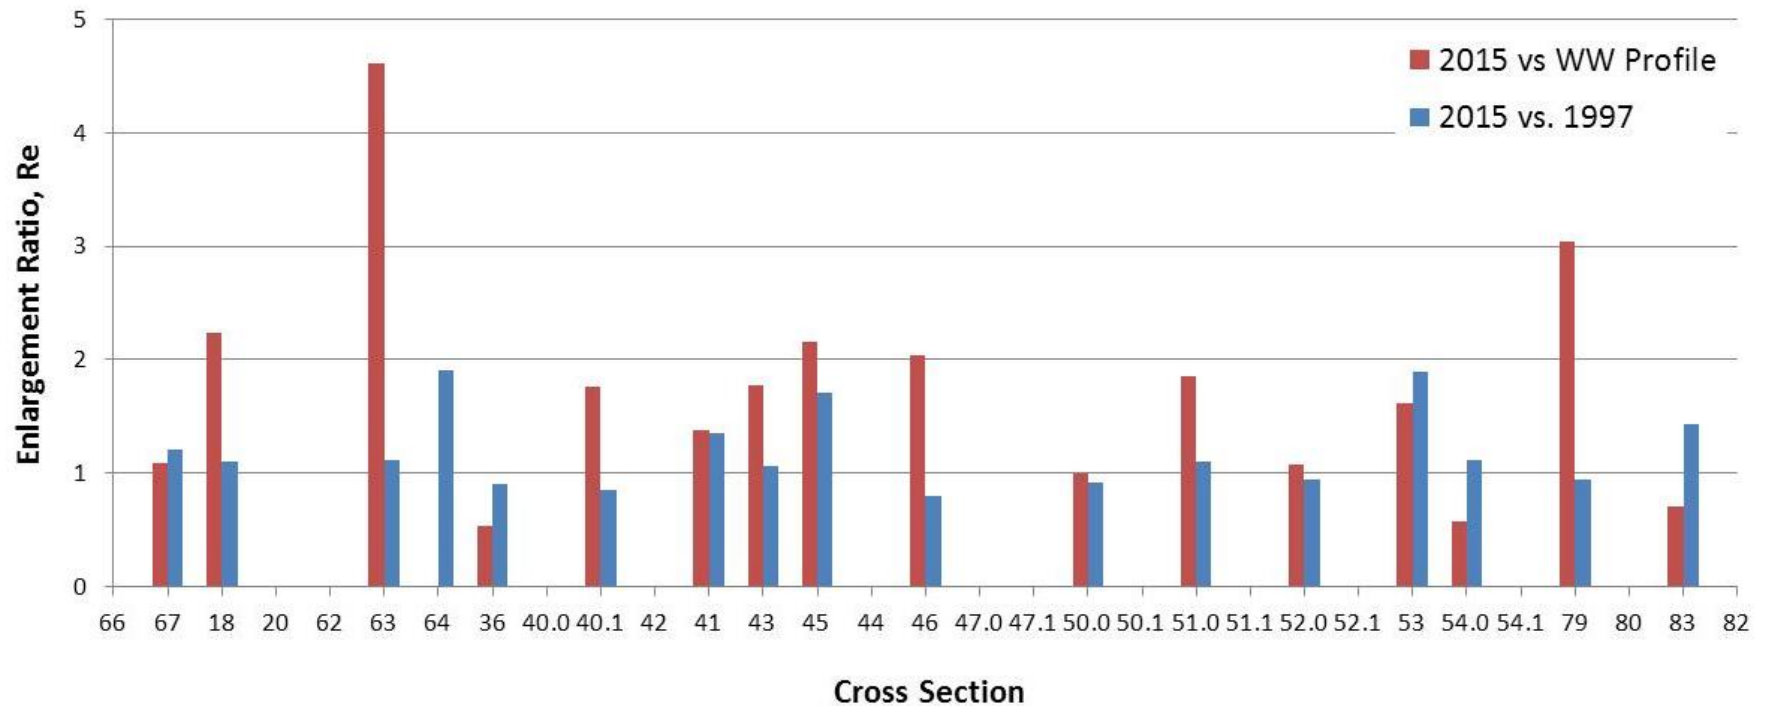
Enlargement Ratio over Time (Reference: Active Bankfull)

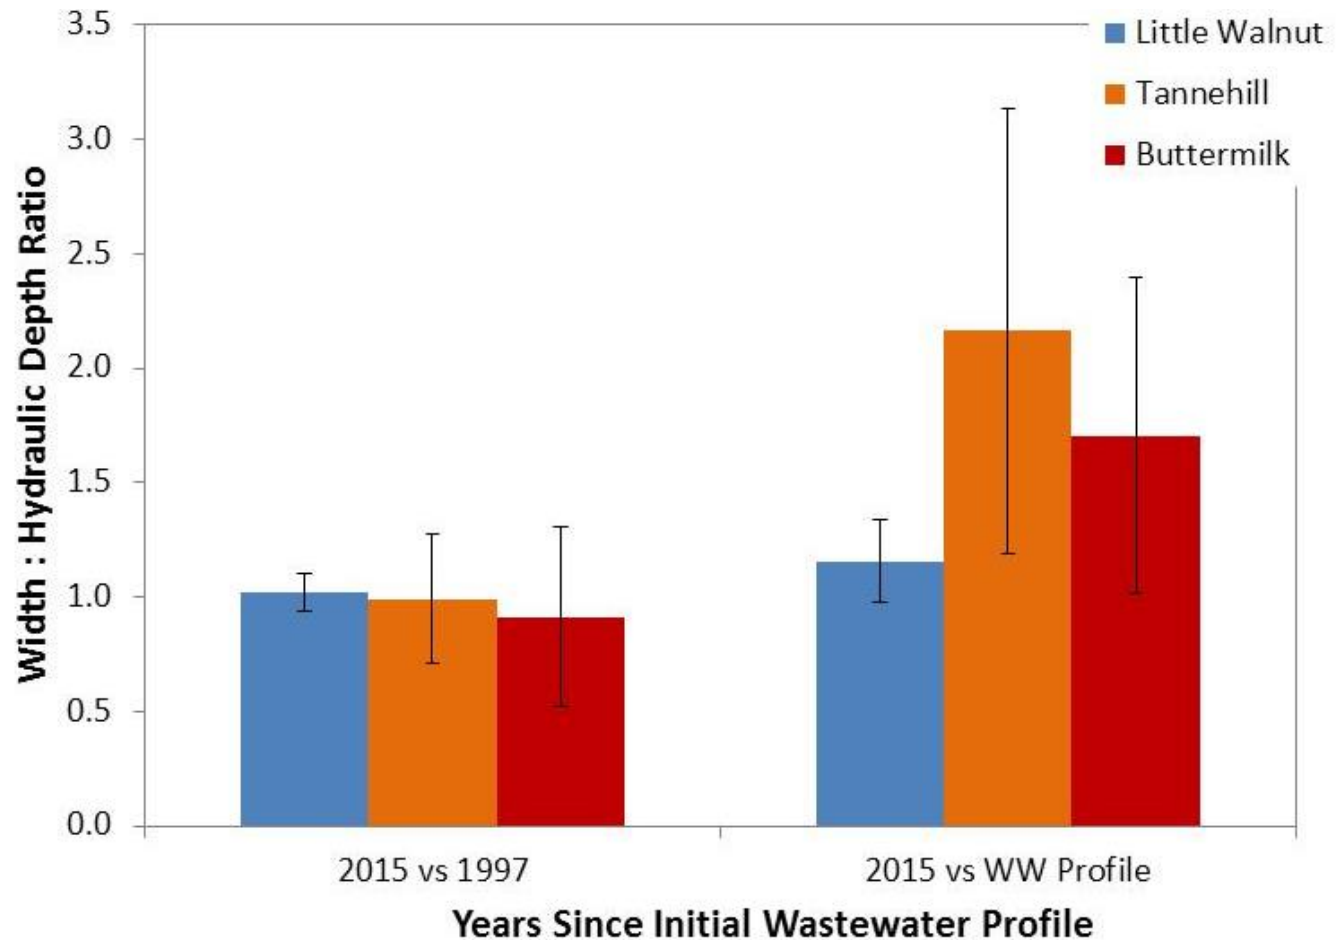
Incision Factor
(Hydraulic
depths taken
from geometric
top of bank)
By Watershed

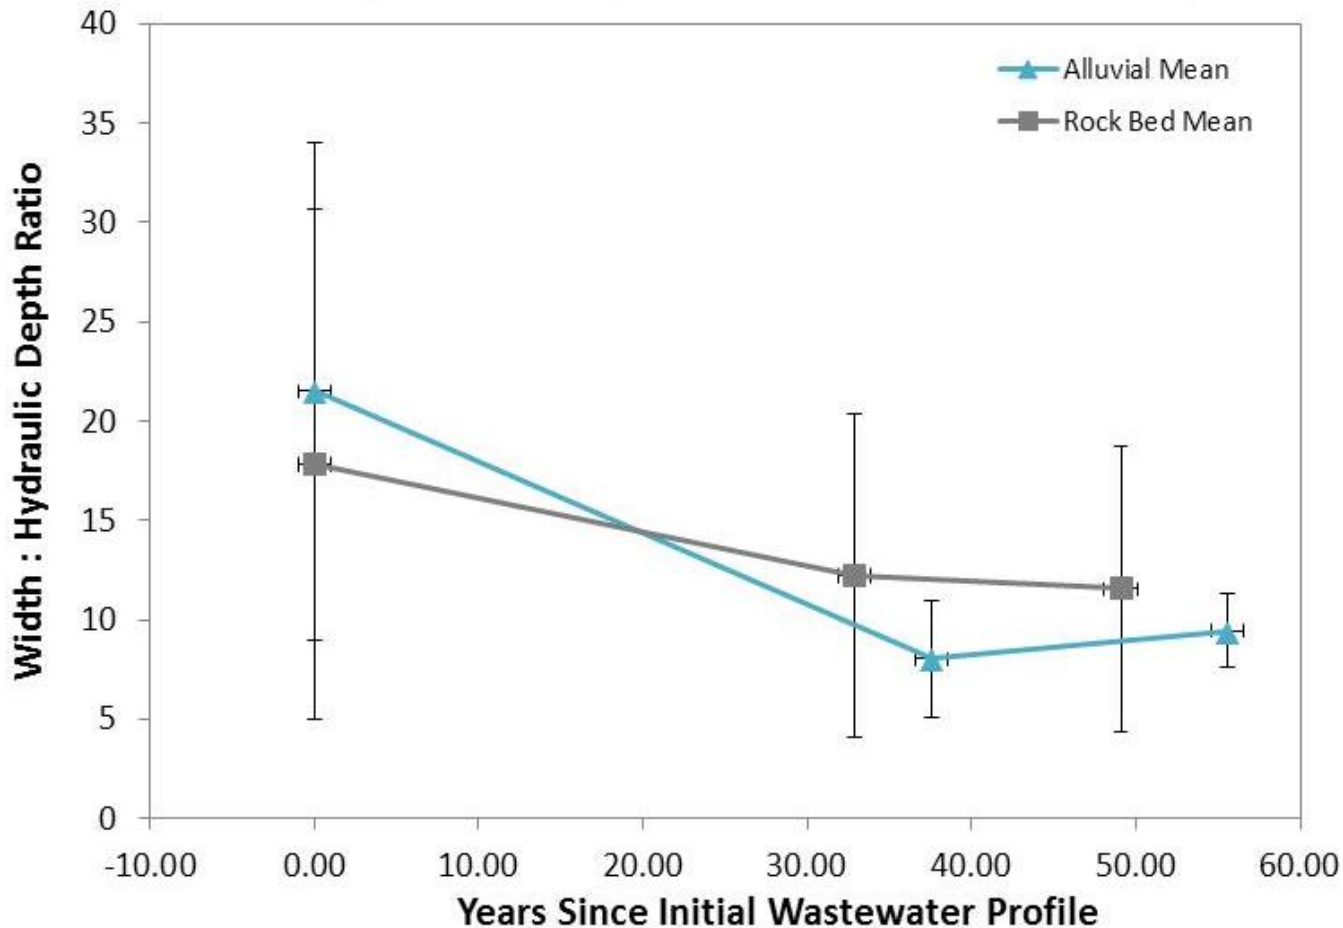
Width :
Hydraulic Depth
Ratio over Time
By Channel Type

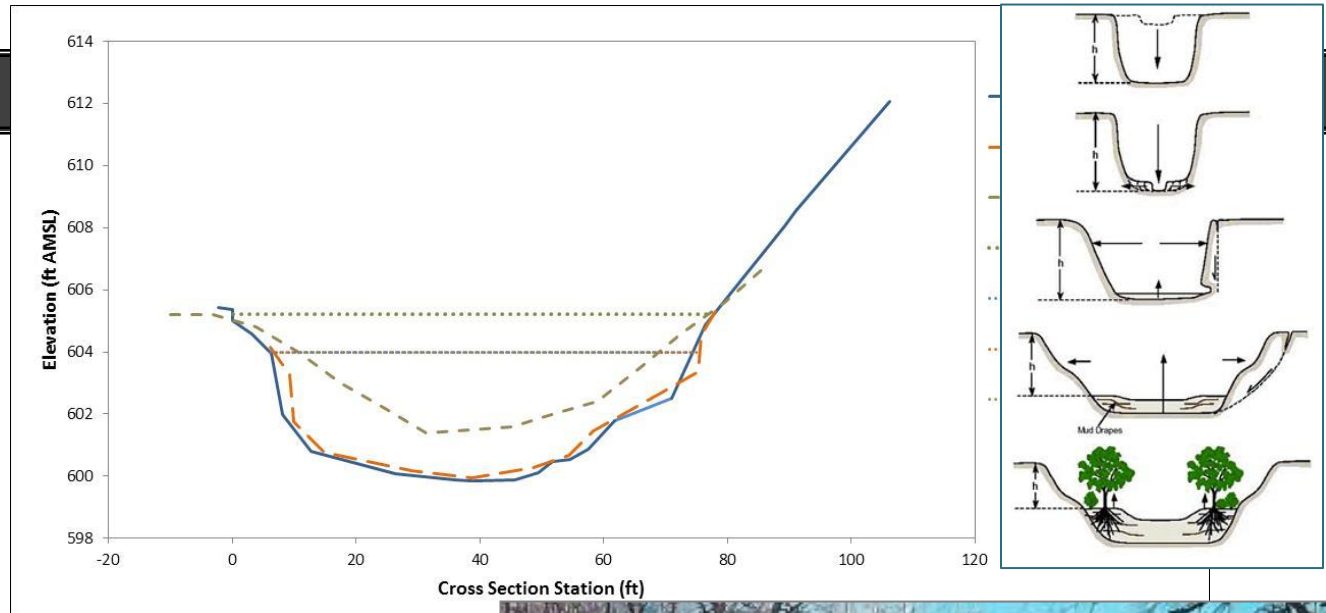
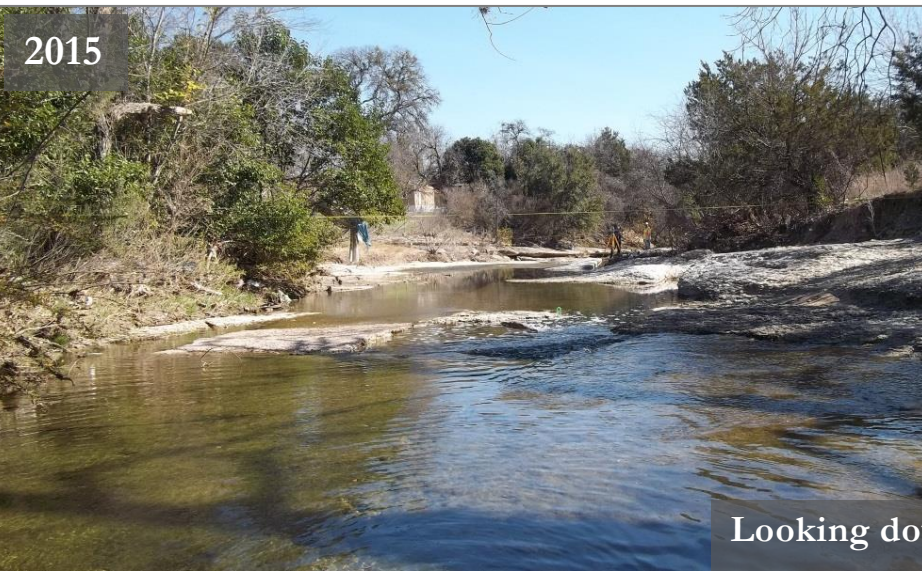
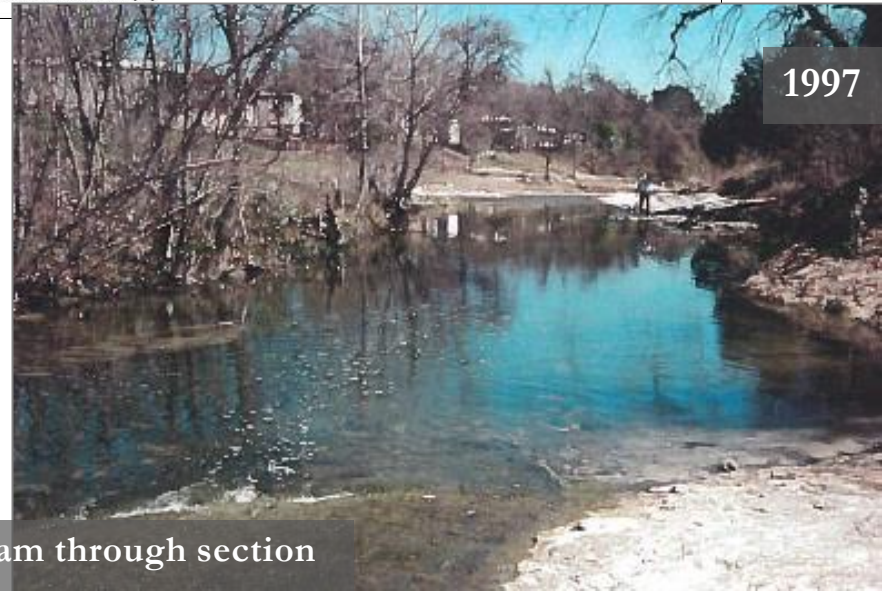
Section 18

- Bedrock bottom channel
- Mowed on left side, natural on right

Looking downstream through section

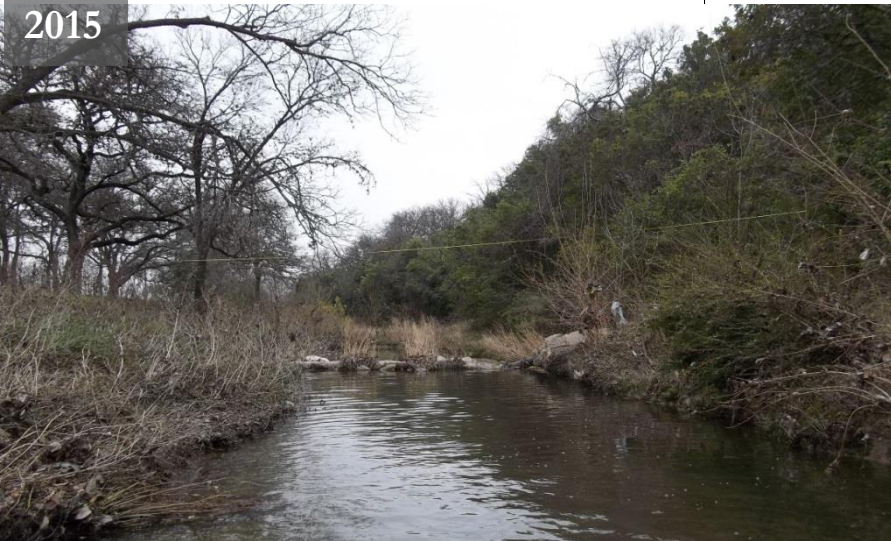
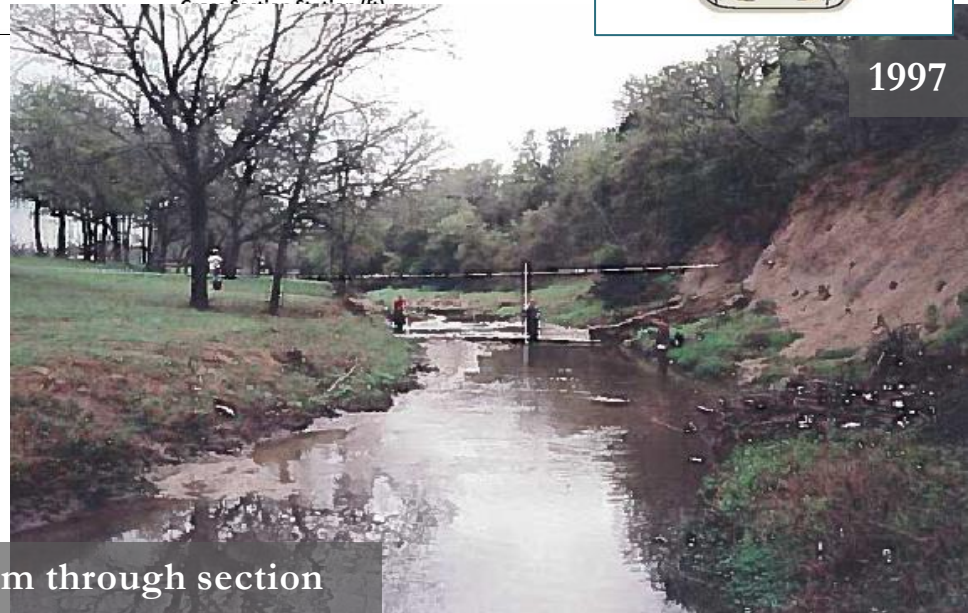
Section 54

- Initial downcutting and widening
- Erosion of steep bluff on right bank
- Reestablishment of inset channel

Looking downstream through section

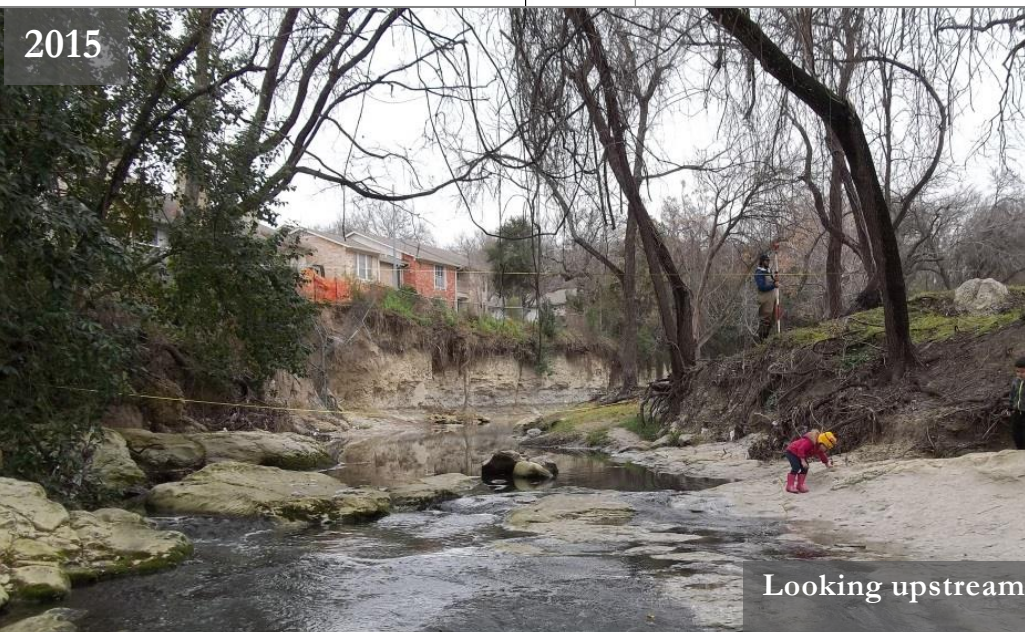
Section 83

- Clearing of banks
- Widening
- Possible meandering of bend
- Stormwater infrastructure

Looking upstream through section

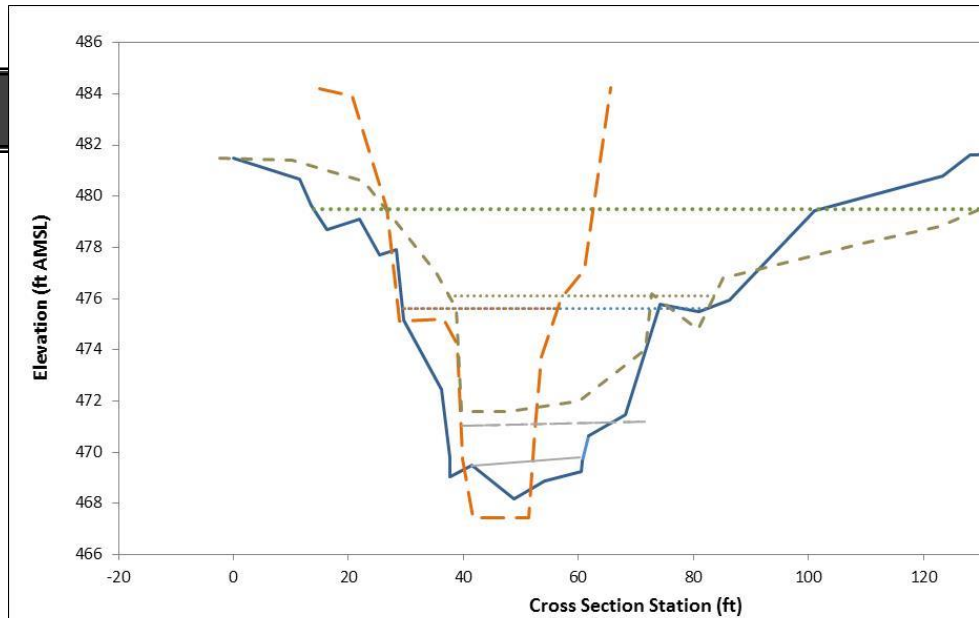
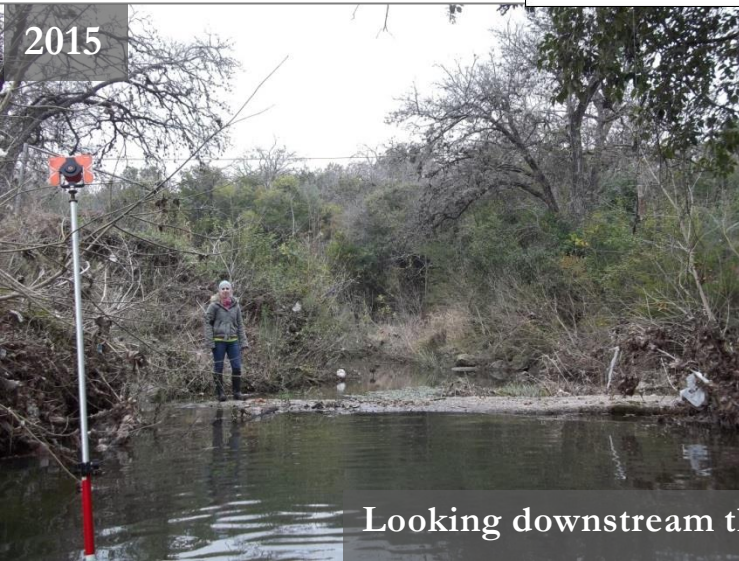
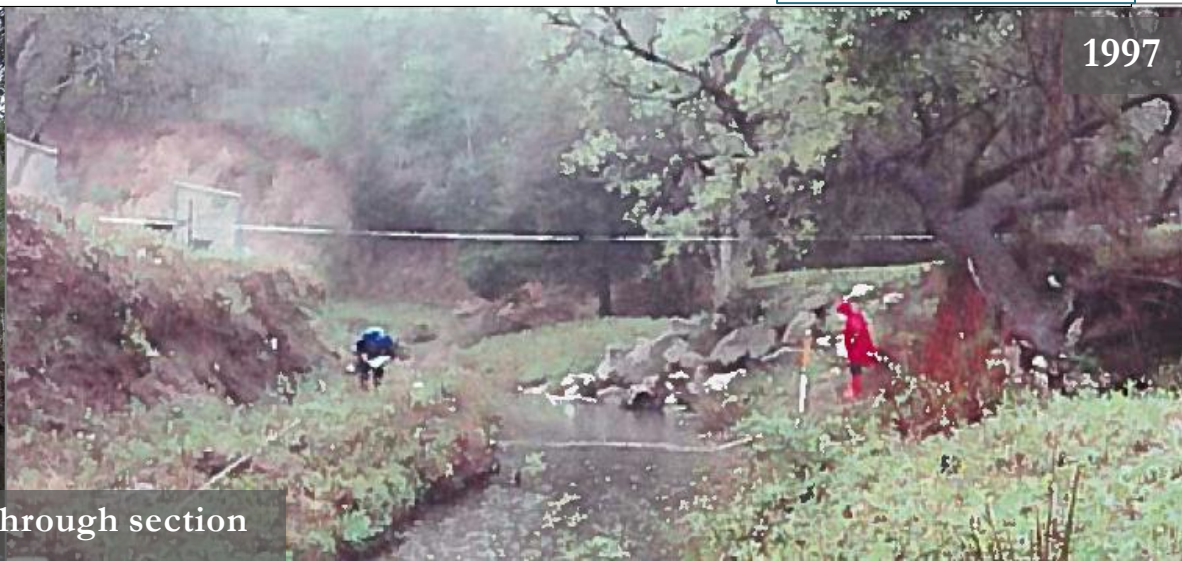
Section 53

- Outside of bend
- Mowed to top of bank
- Informal trail

Looking downstream through section
