COLLABORATIVE URBAN STREAM RIPARIAN STREAM REHABILITATION: THE J.J. SEABROOK PROJECT

Susan Kenzle, RLA
Kristin K. Pipkin, P.E., CPESC
Mateo Scoggins
City of Austin , Watershed Protection
Department

The J.J. Seabrook Stream Restoration, Rain Garden, and Urban Trail Project

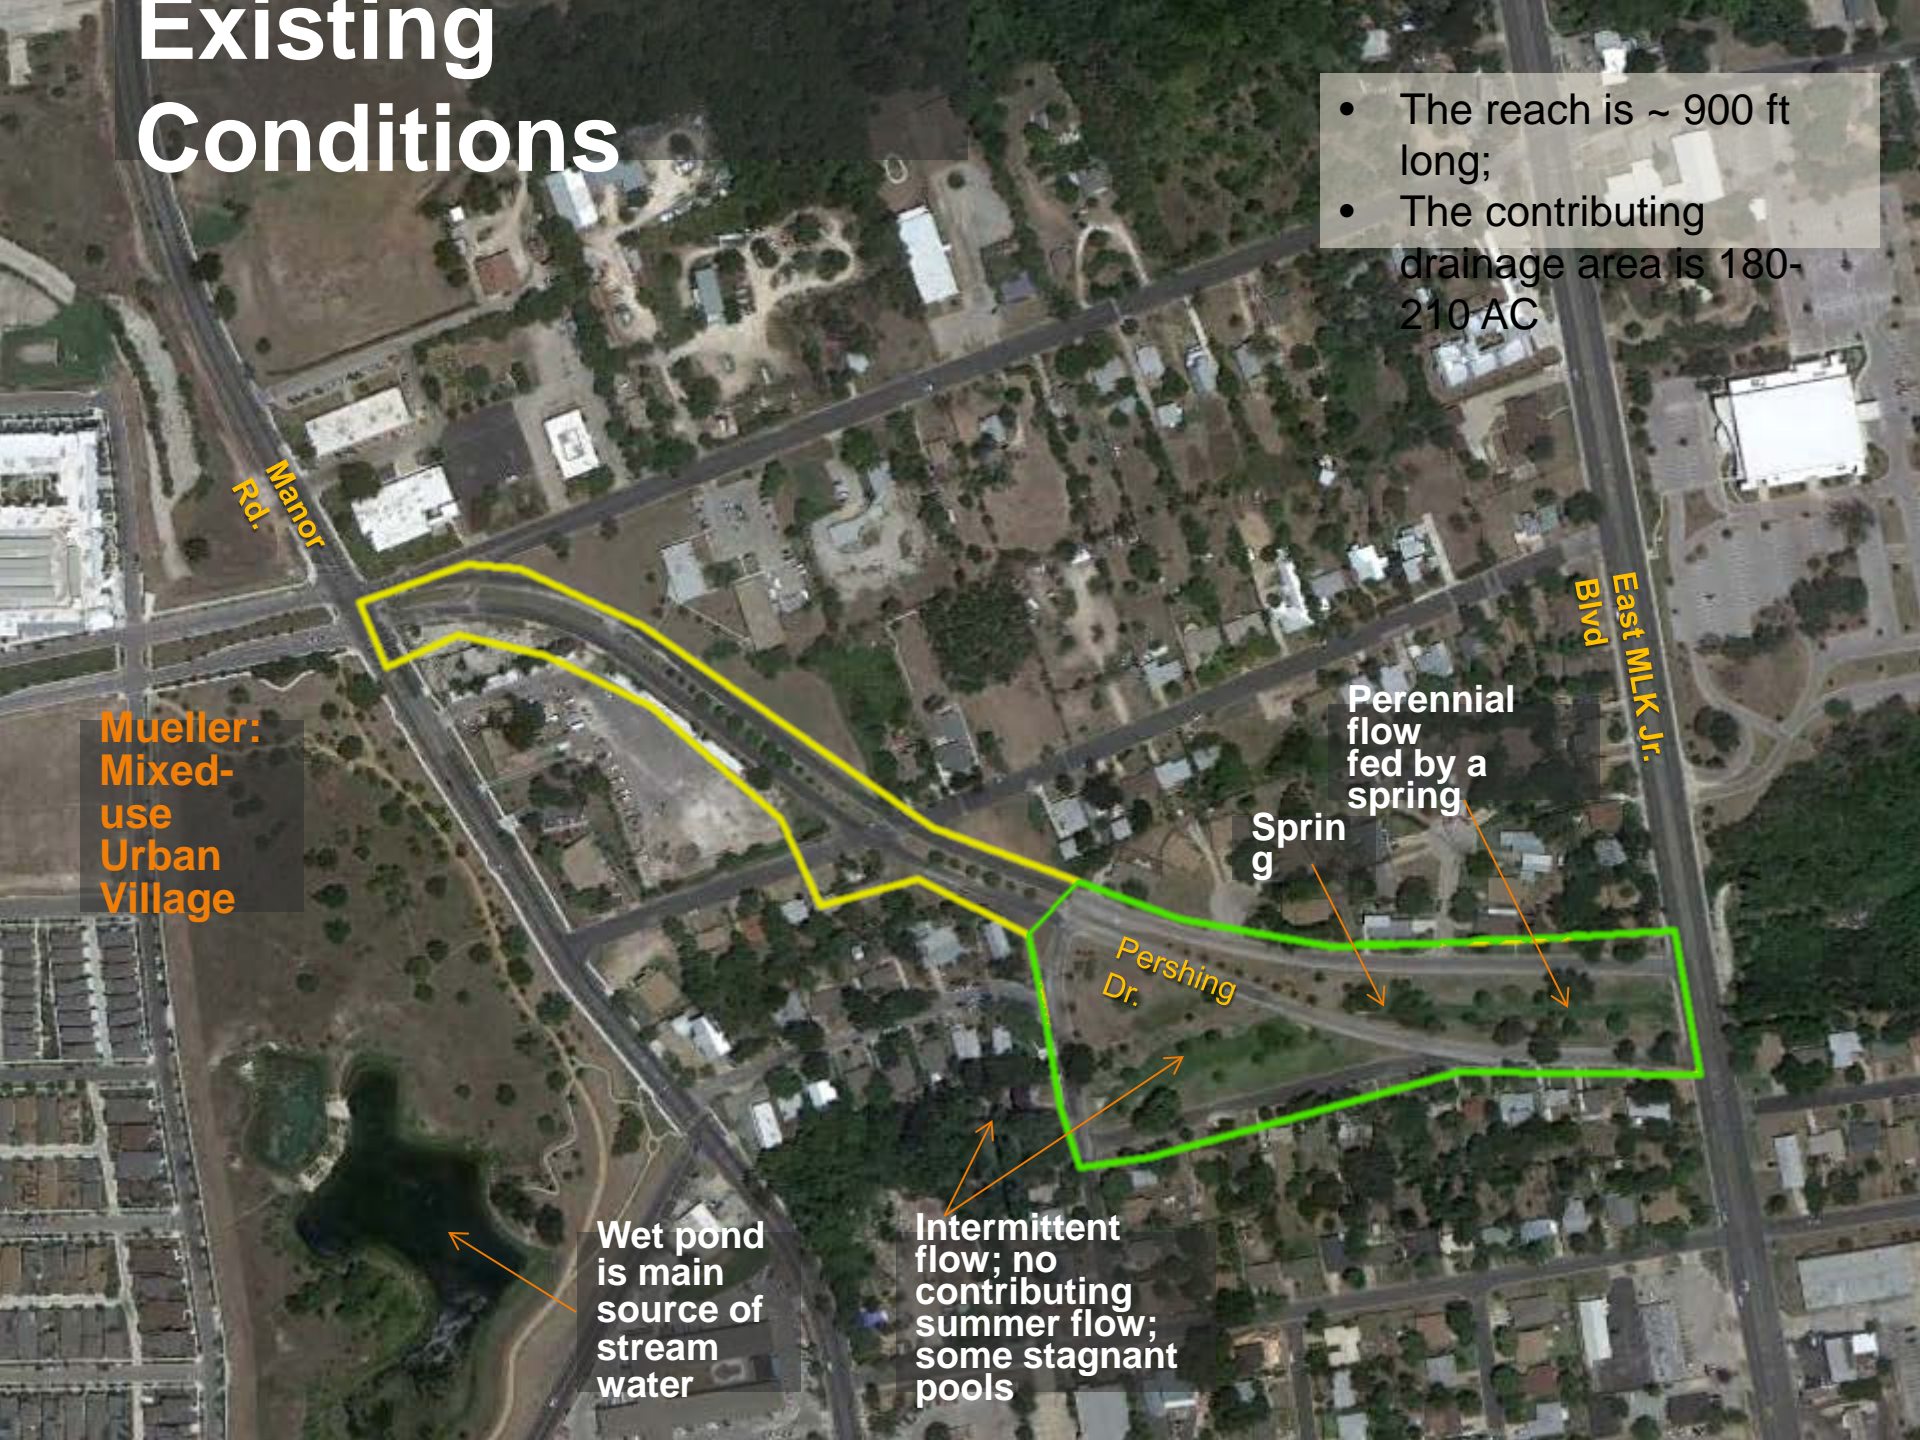
- The reach is ~ 900 ft long;
- The contributing drainage area is 180-210 AC

**Perennial
flow
fed by a
spring**

**Wet pond is main
source of
stream
water**

**Intermittent
flow; no
contributing
summer flow;
some stagnant
pools**

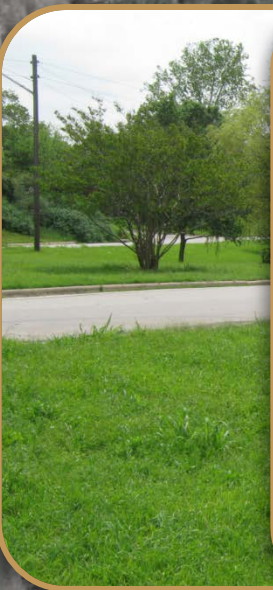
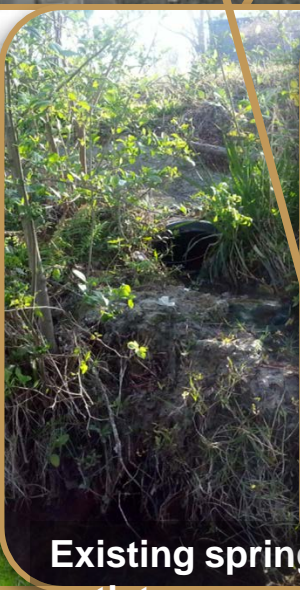
Existing spring outlet

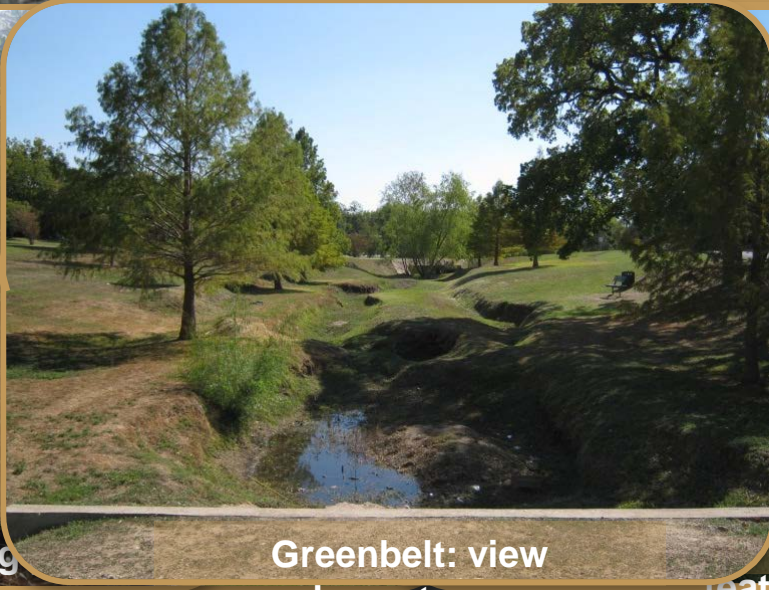
Greenbelt: view downstream

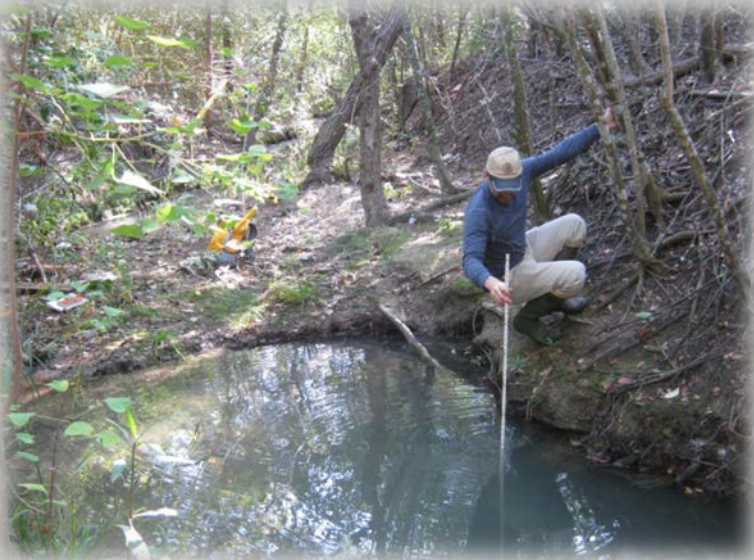
- Measured metrics at reference reach downstream to inform design
 - Bankfull widths & depths
 - Riffle/pool spacing, depths
 - Sediment size distribution

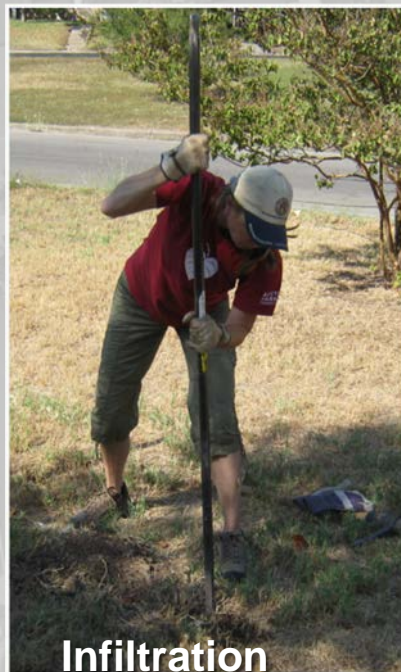
Infiltration

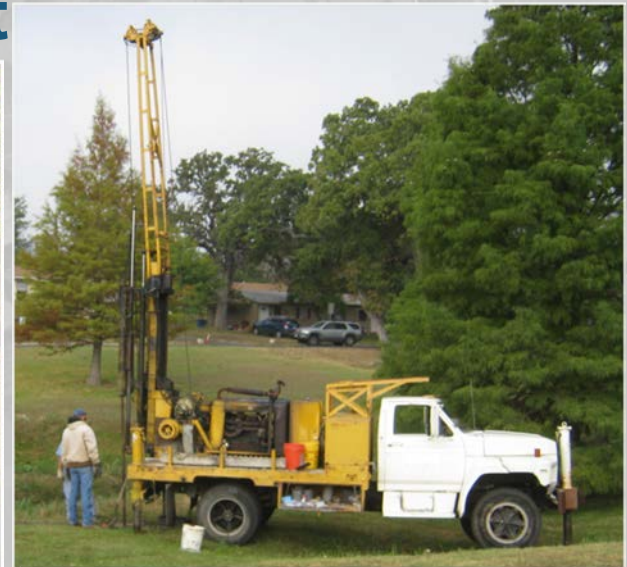
Geotechnical borings

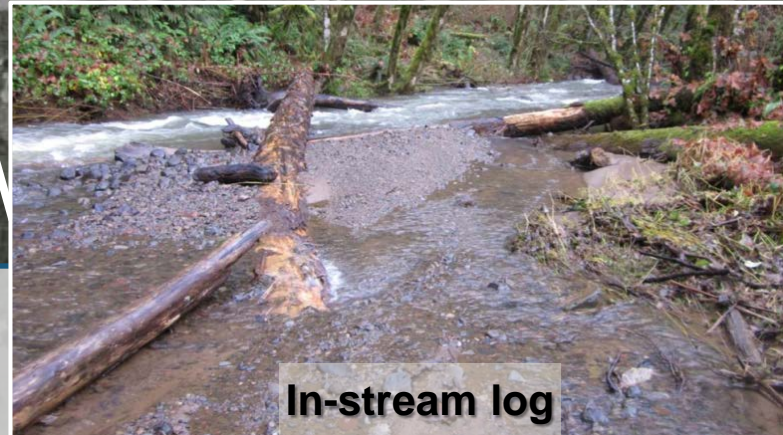
In-stream log

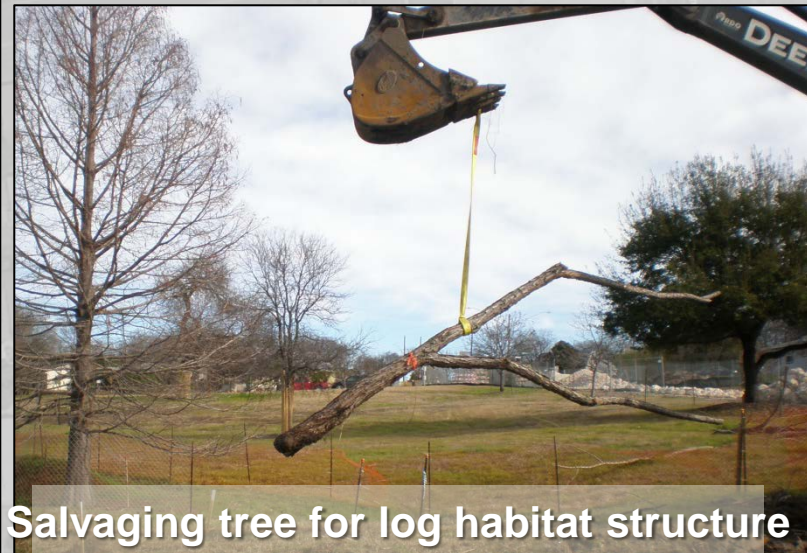
Salvaging tree for log habitat structure

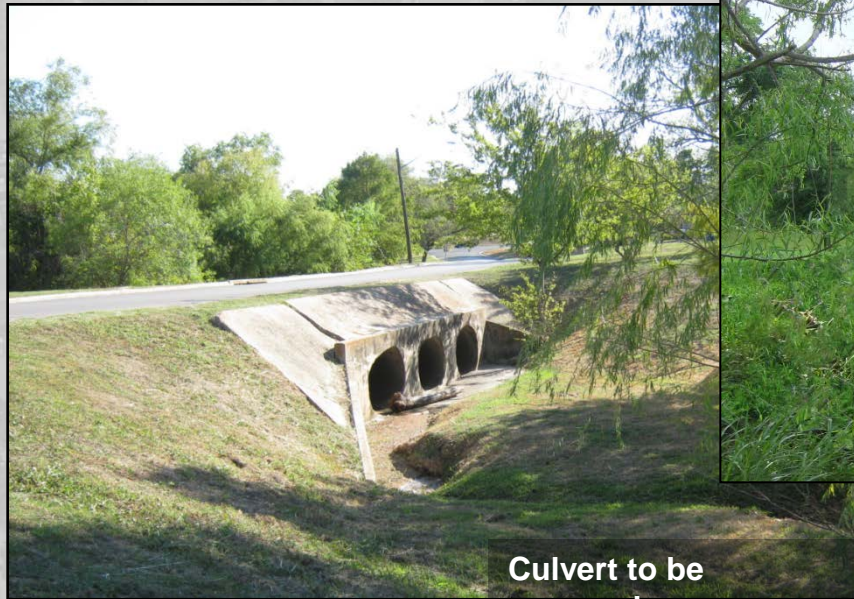
Culvert to be removed

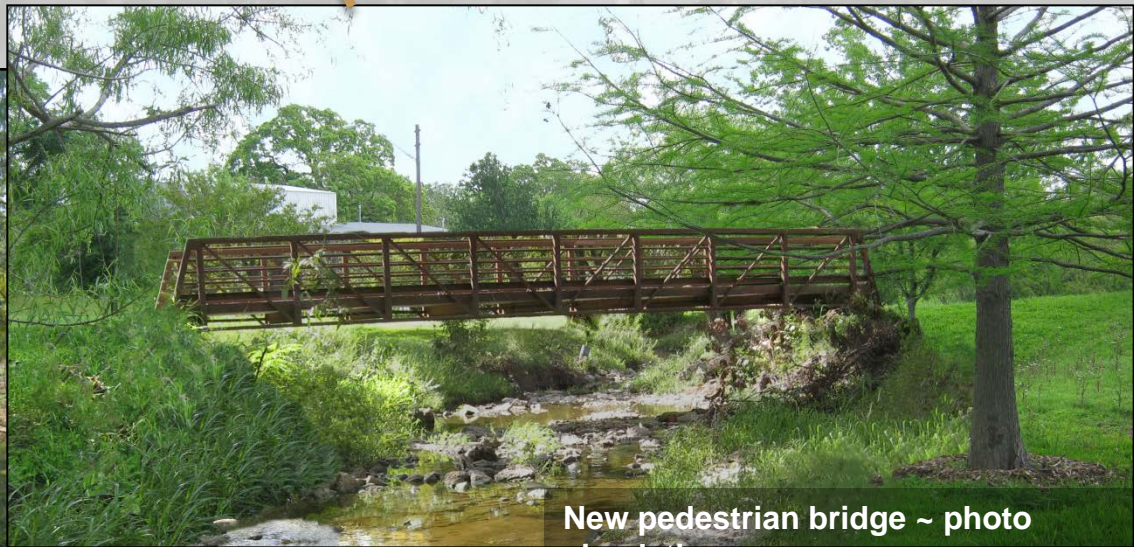
New pedestrian bridge ~ photo simulation

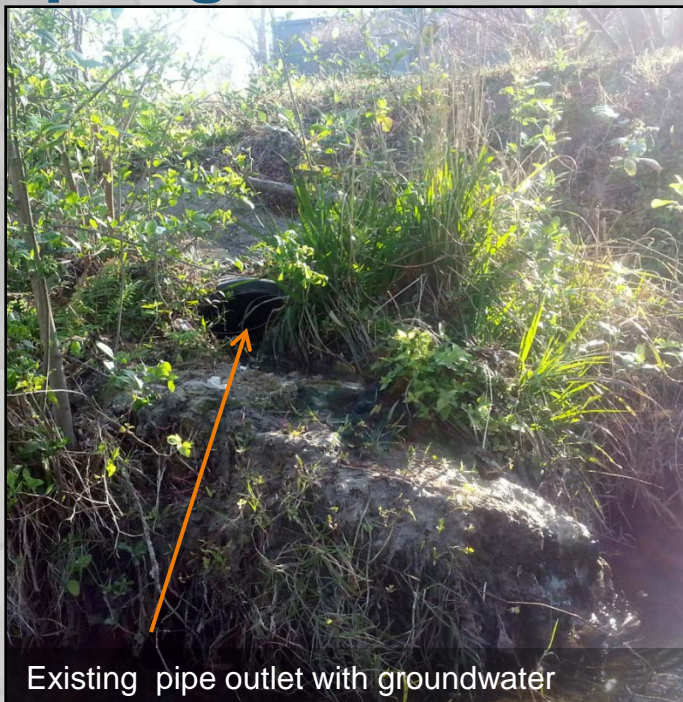
Existing pipe outlet with groundwater discharge

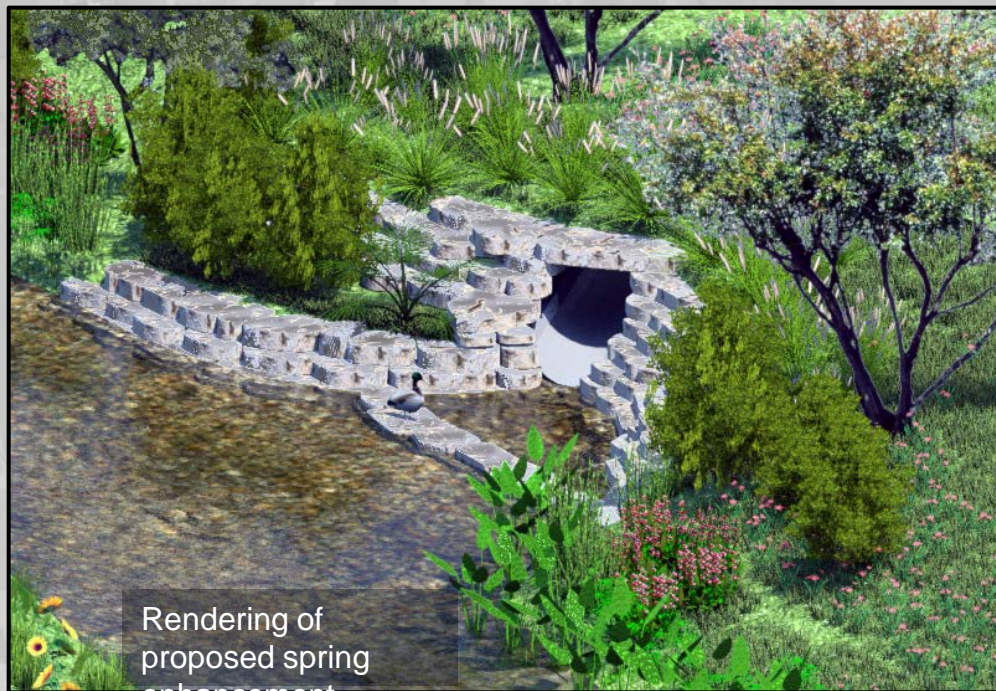
Rendering of proposed spring enhancement

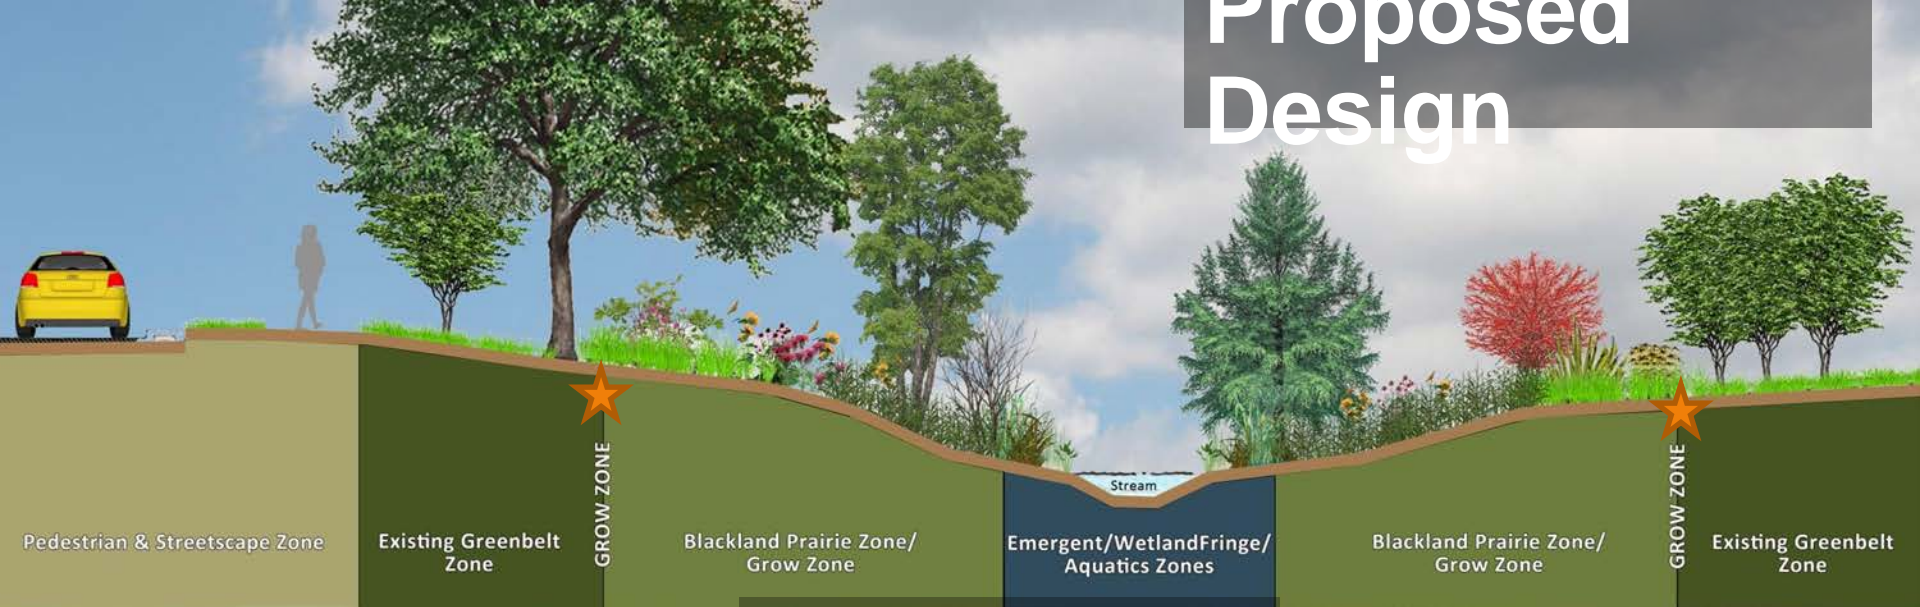
Cross Section showing zones

Hydrologic Zones
(Hoag, et al. 2011)

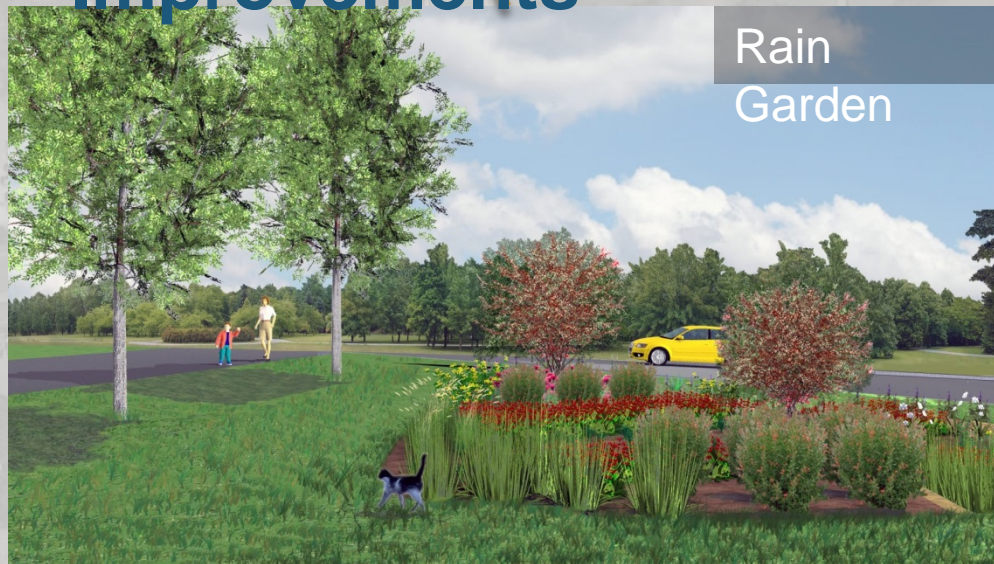
Rain
Garden

Denver Avenue Rain garden rendering

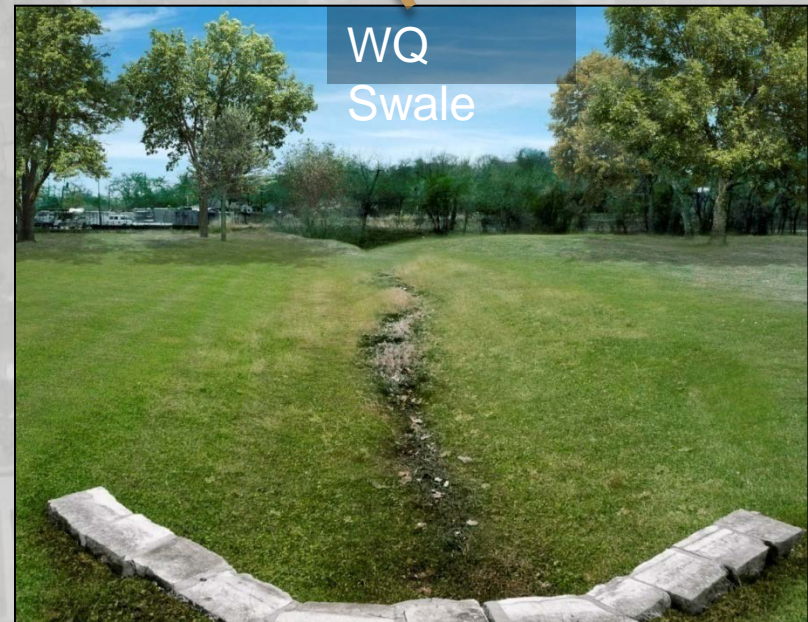
WQ
Swale

Photo simulation of water quality swale

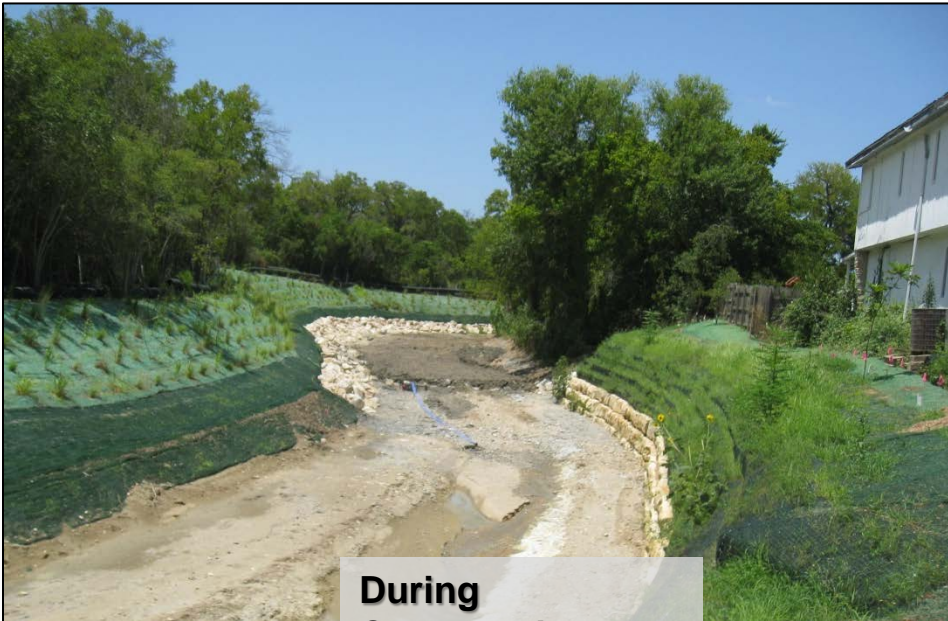
**During
Construction**

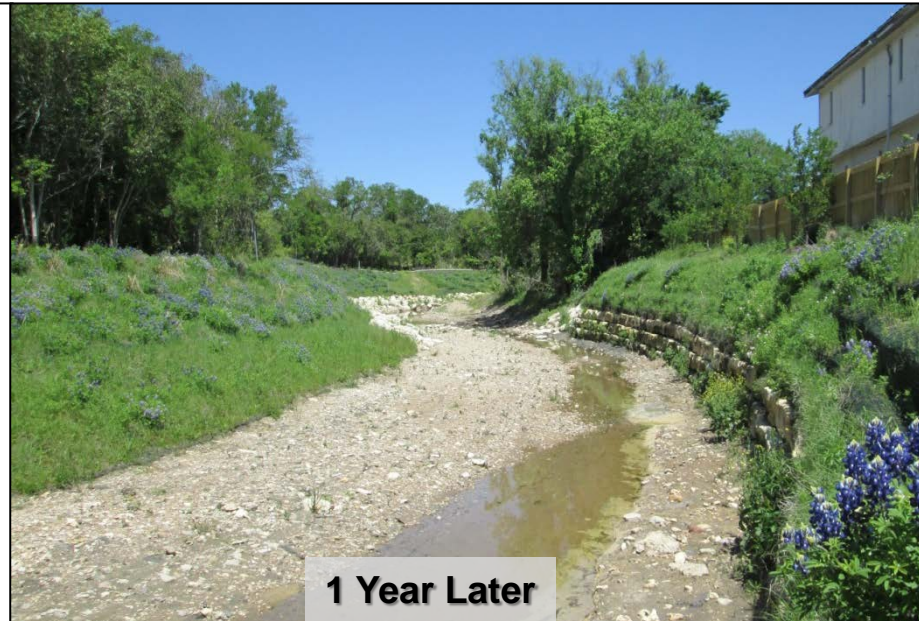
1 Year Later

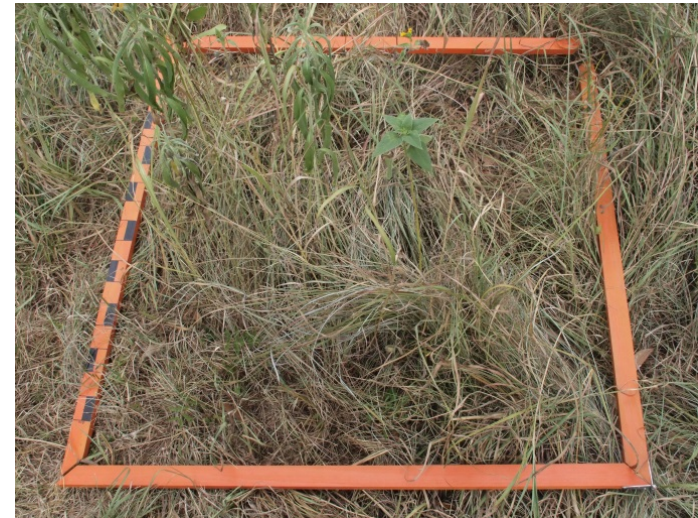
**Quadrat Measuring
Method**

Vegetation Category	Landscape Performance Criteria Target Values		
	Year 1	Year 2	Year 3
Desired Native Plant Coverage	At least 30-50%	At least 60-70%	At least 75-95%
Native Plant Species Diversity	No one species should be the dominant species in more than 20% of all the quadrants		
Non-native Invasive Plant Coverage	Non-native plants occupy more than 5% of any quadrat area
