Colorado River System

LAGUNA GRANDE RESTORATION CONCEPT

CHAUSSE PERSPECTIVES , VIEWS OF PROPOSED RESTORATION DESIGN*

CHAUSSE POST-RESTORATION WATER NEEDS

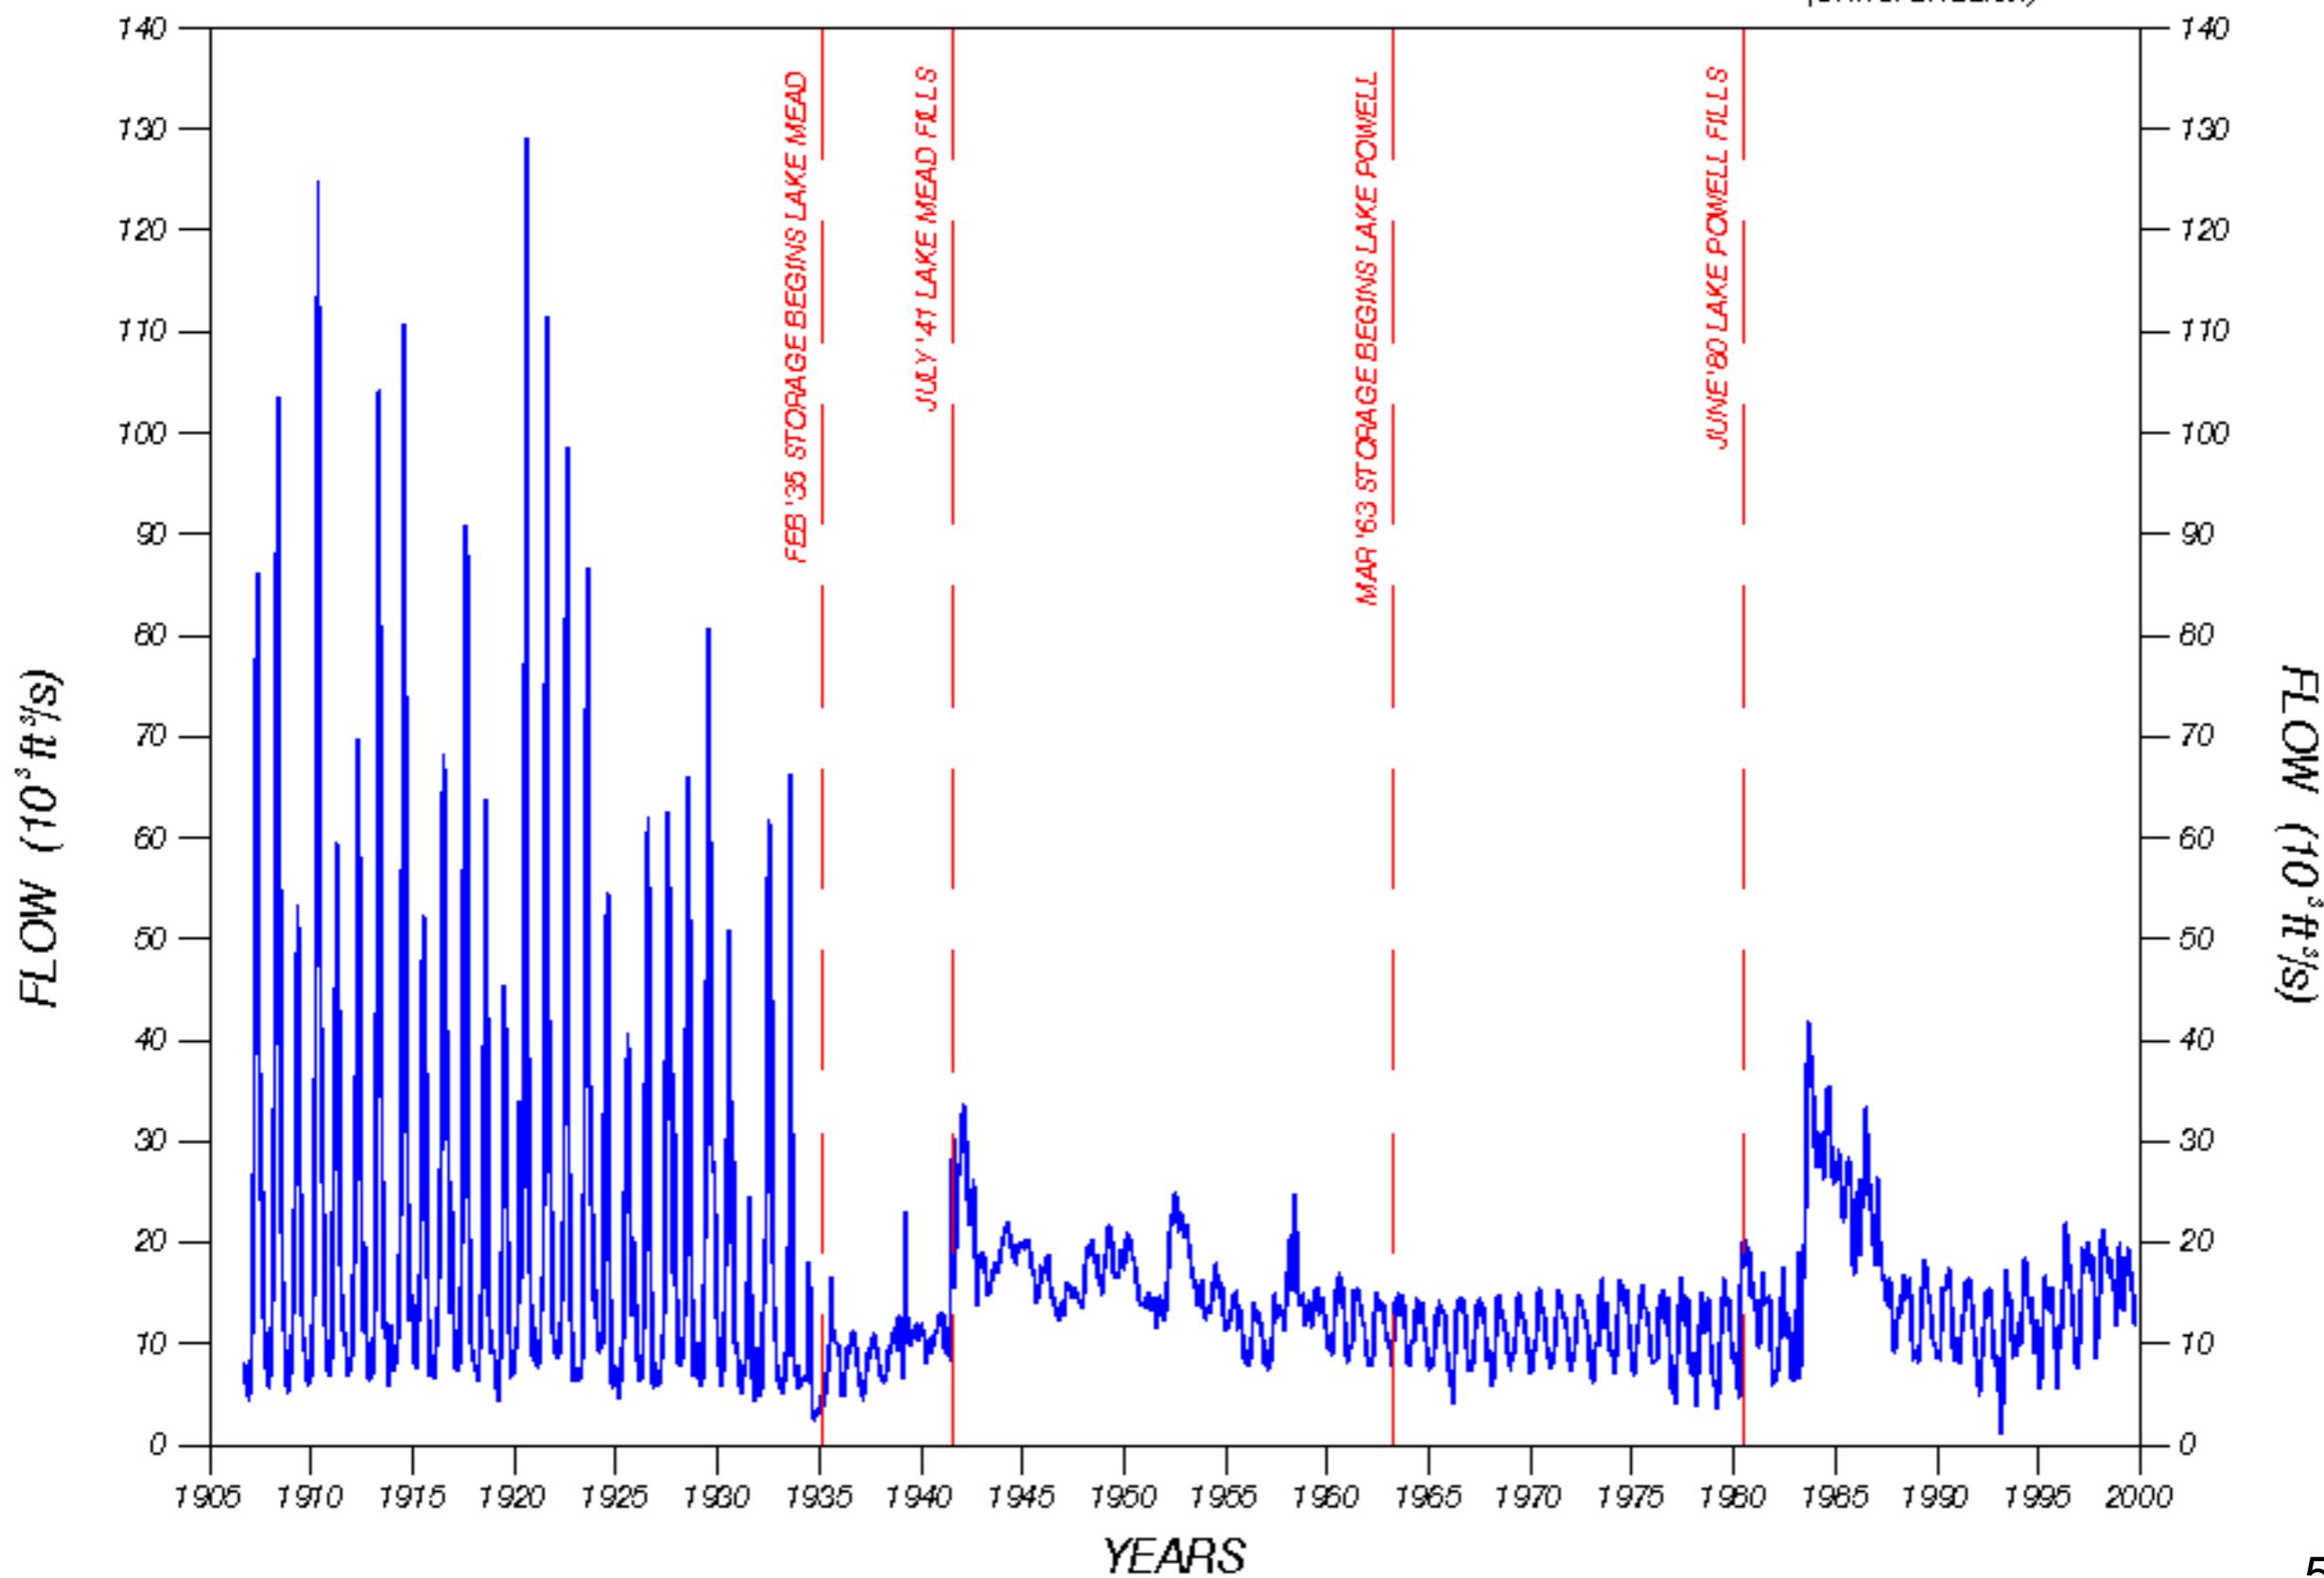
FLOW BELOW HOOVER DAM

1906 THROUGH SEPTEMBER 1999

(UNITS: ENGLISH)

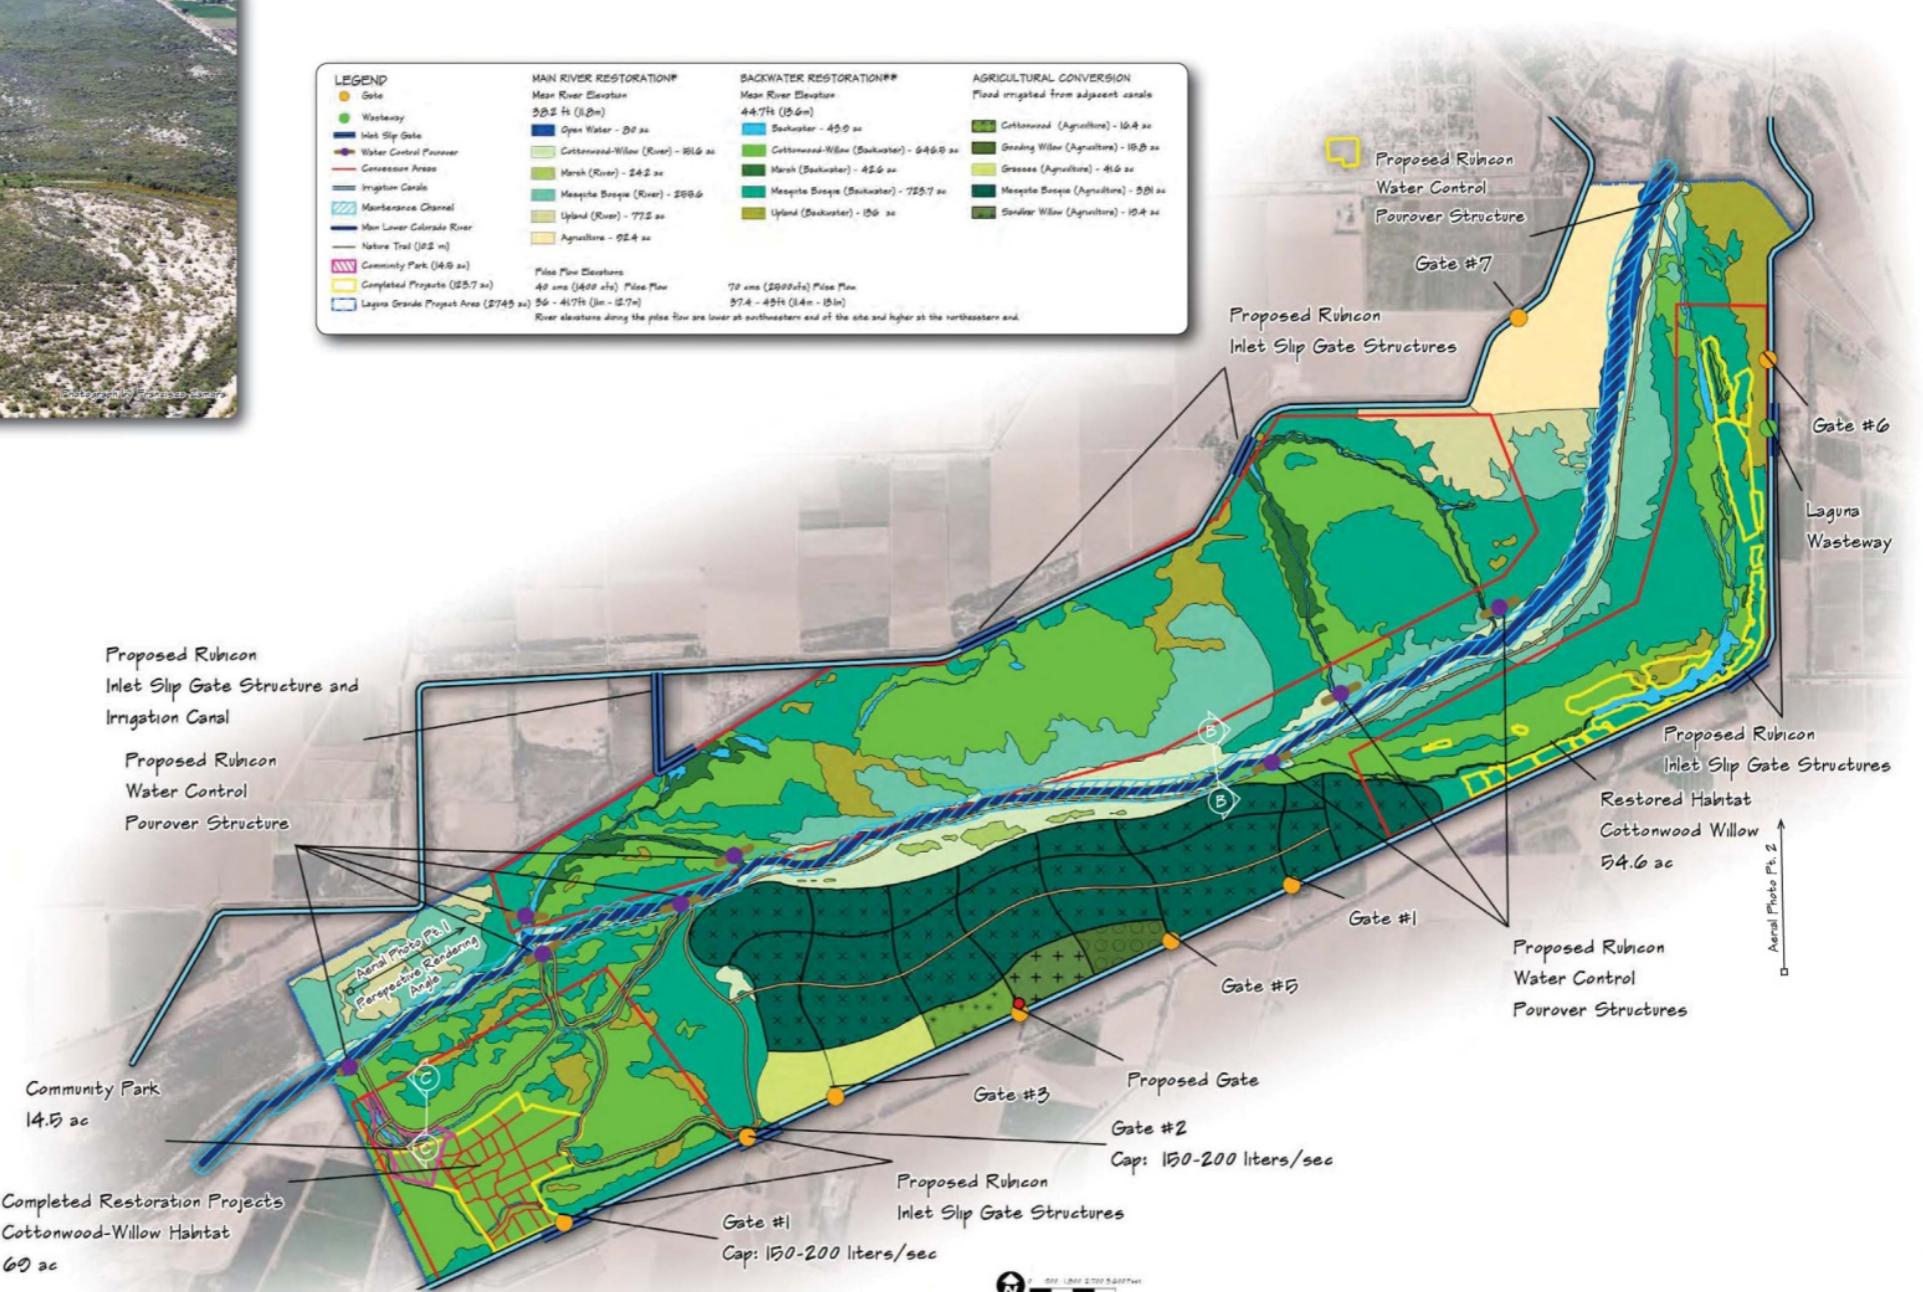
Sheet # 3

* Main River Restoration design is dependent on existing groundwater conditions and conditions enhanced by the proposed pulse flow

** Backwater Restoration design utilized historic channels, oxbows, and existing infrastructure to capture and hold water from pulse and base flow waters (delivered via the main river channel and adjacent irrigation canals) to improve groundwater conditions and allow for restoration of native riparian habitat.

*** Agricultural Conversion design creates a series of flood irrigated cells, using water from existing irrigation infrastructure. Irrigation cells immediately adjacent to irrigation canals will be used to cultivate nursery stock for native riparian, wetland, and upland species.
