Application of Coir Logs and Emergent Vegetation for Urban Lake Shoreline Stabilization:

**Results of a 5 year study and
discussion of a large scale implementation**

**City of Austin – Watershed Protection Department,
Environmental Resource Management**

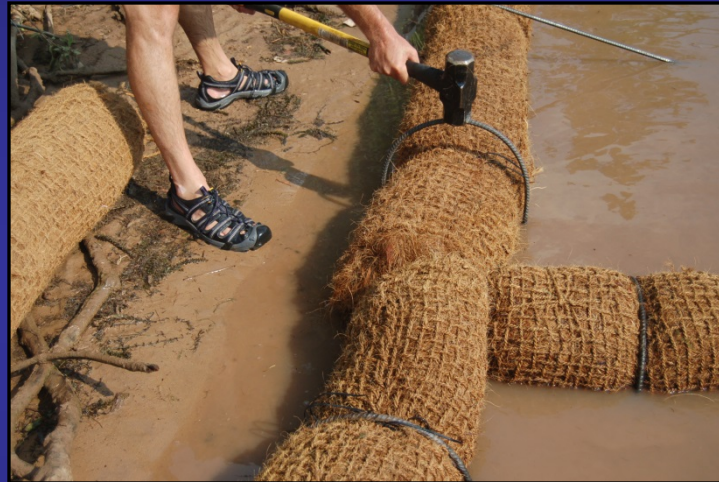
UV resistant zip ties

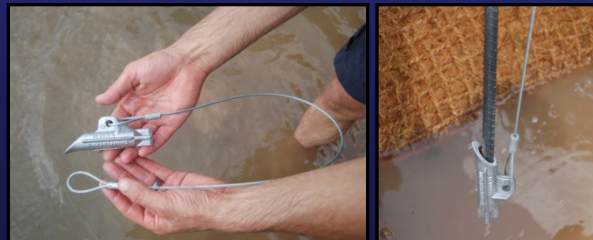
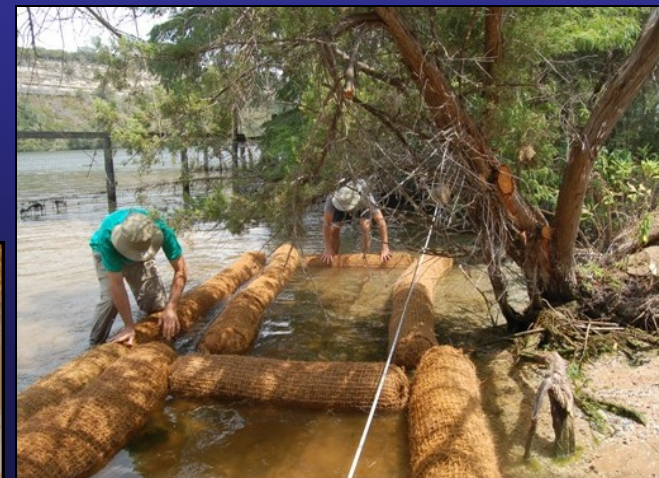
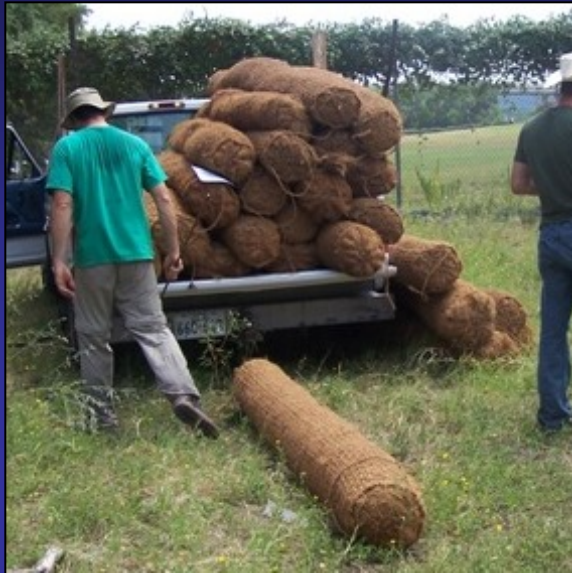
4ft rebar "staples"

duckbill anchors

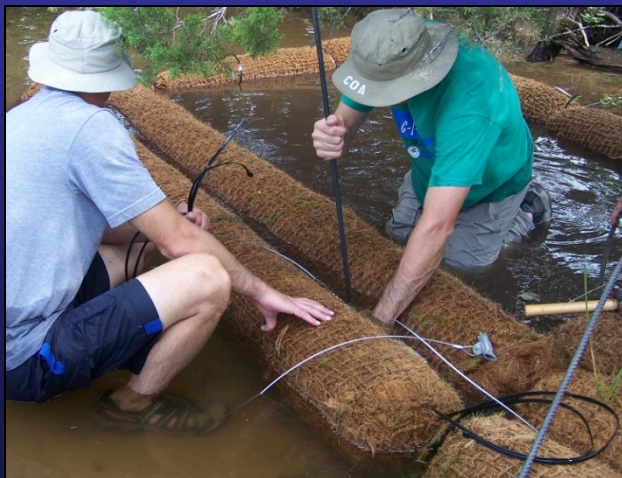
10ft long 12" Coir logs

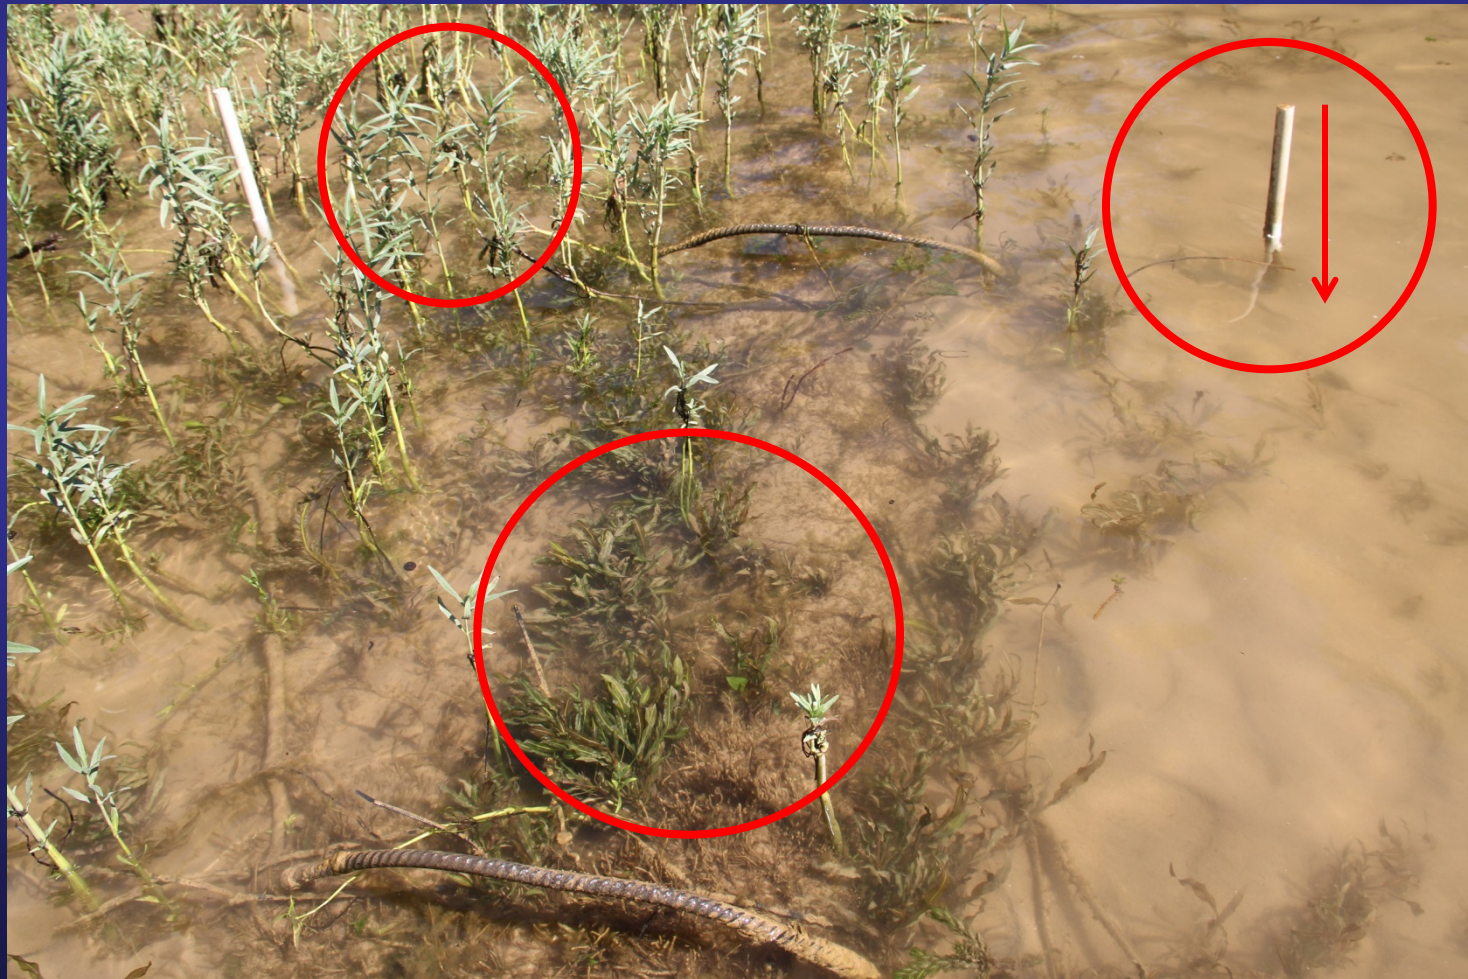
Parameters:

- Measure depth to substrate of exposed PVC gauges
- Plant Survival (presence/absence)
- Coir log integrity observations
- Photographs

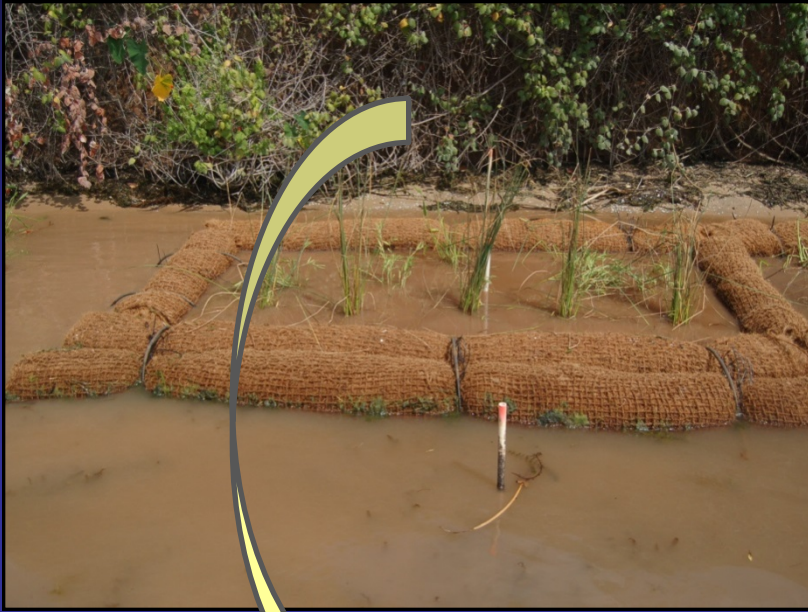
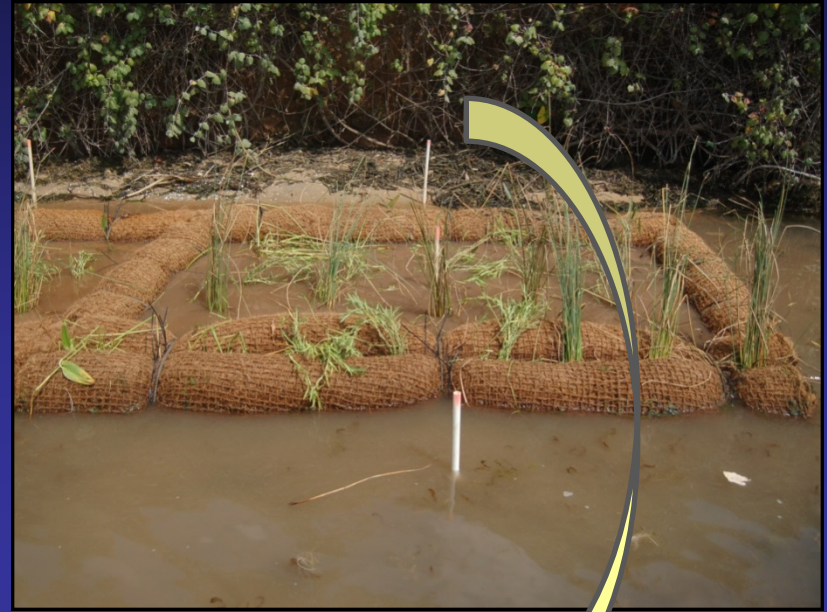
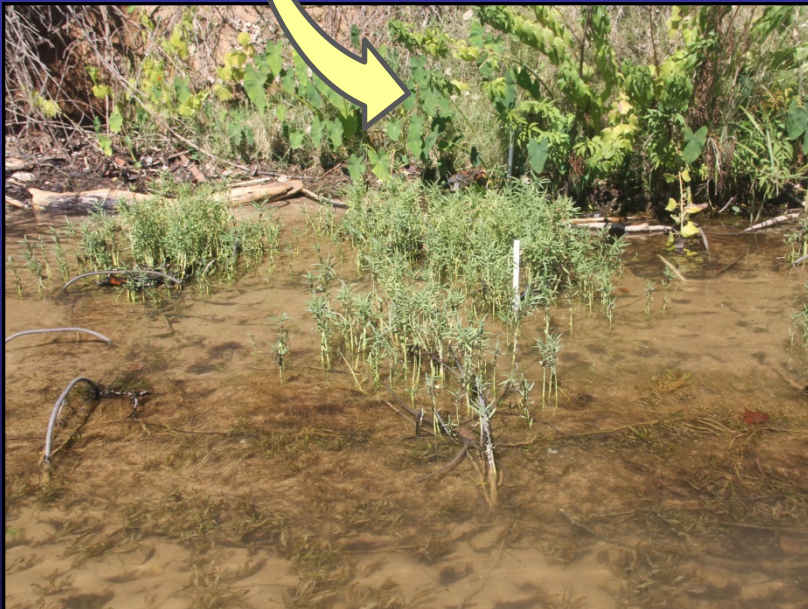
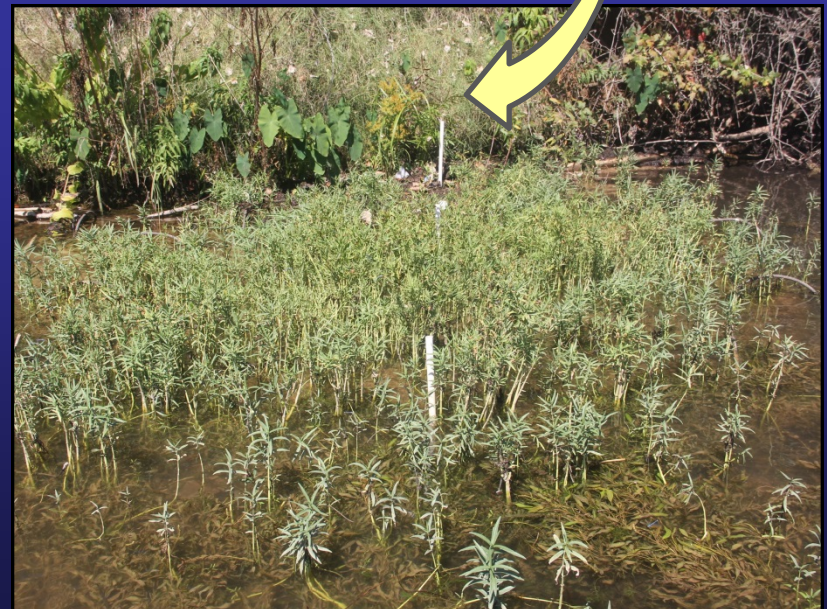
Coir bay with plantings

Sep
2009

4 yrs

Oct
2013

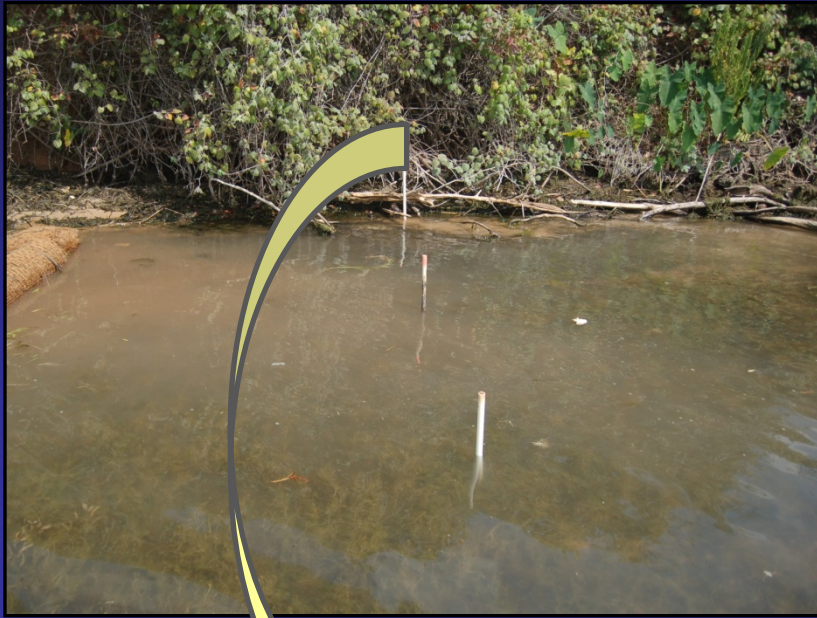
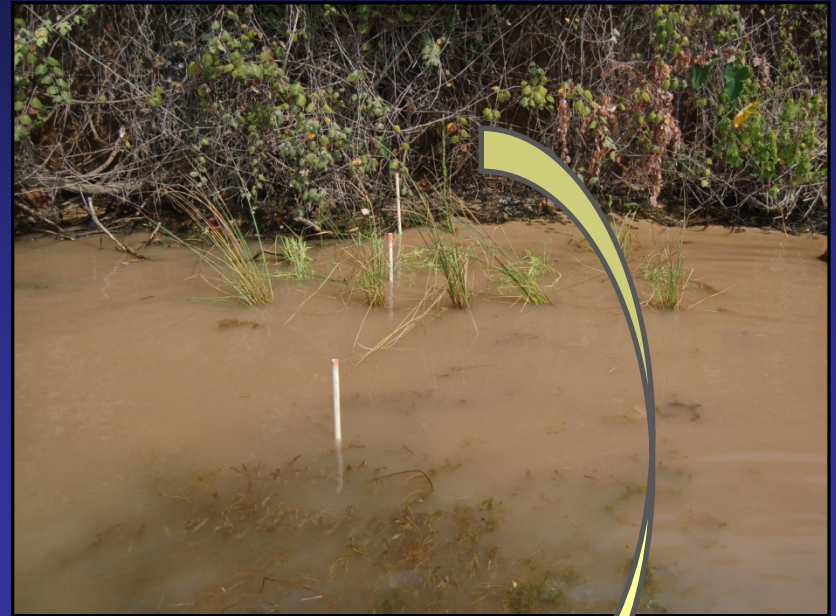
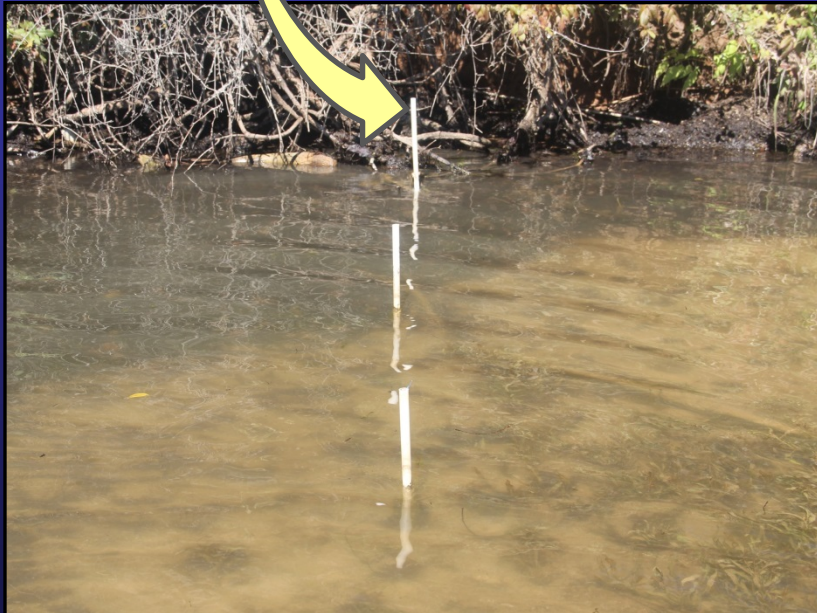
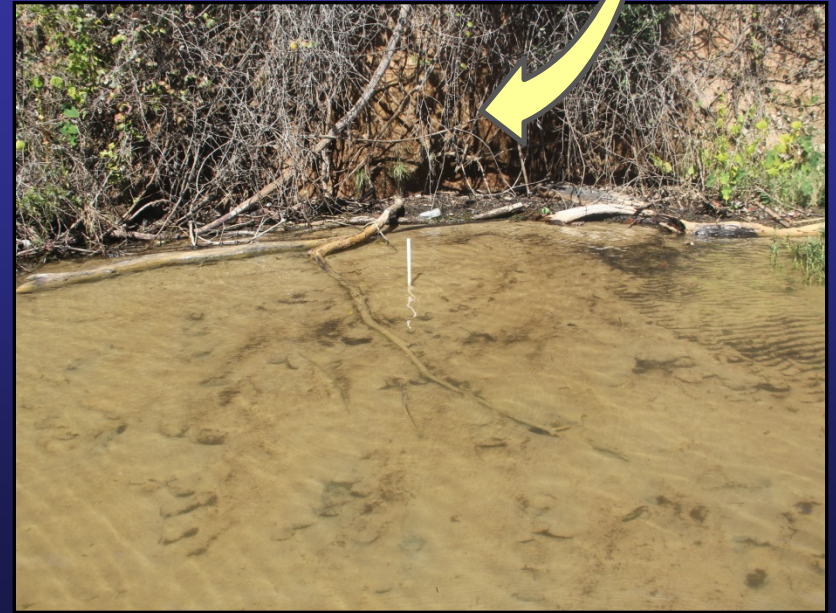
Controls

without plantings

with plantings

Sep
2009

4 yrs

Oct
2013

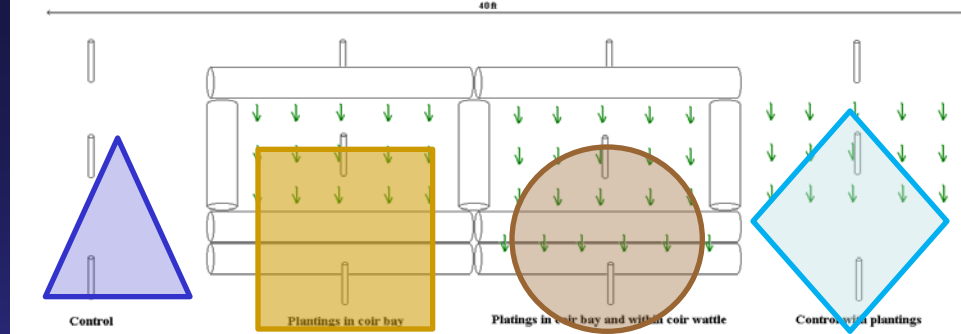
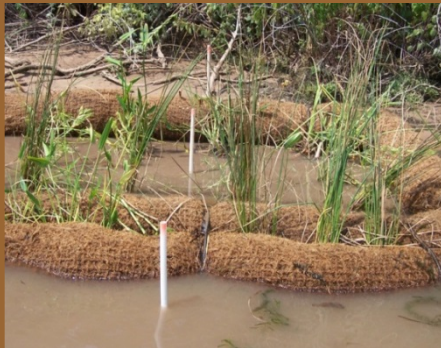
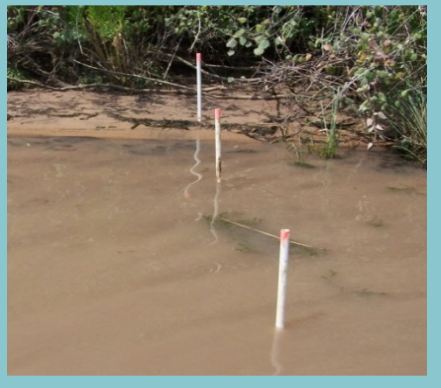
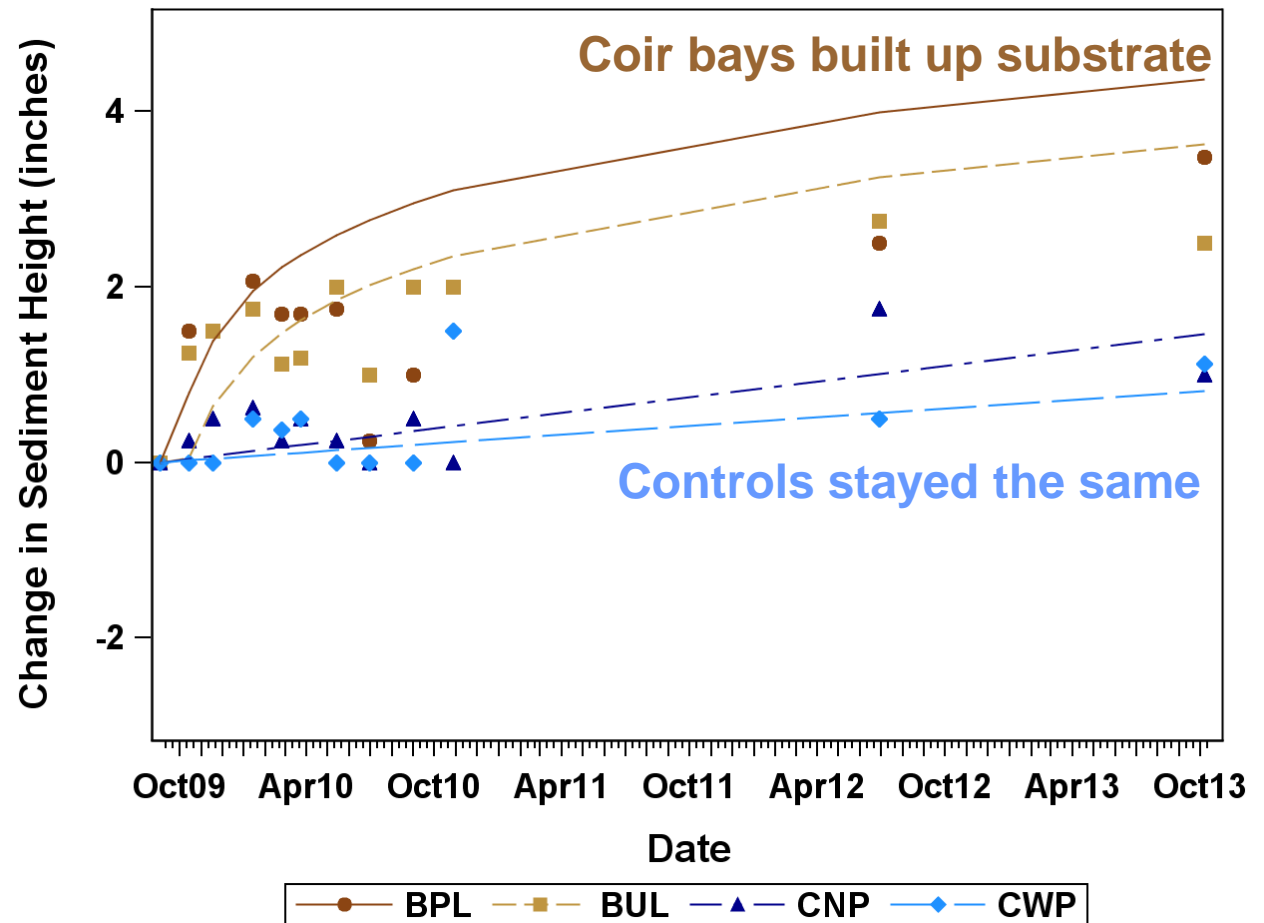
Regression analysis (by treatment)

Statistical Analysis*

- Repeated measures two-way ANOVA (treatment and transects as factors)
 - ✓ Difference between sediment levels between treatments and time and interaction between treatments and transects
- Tukey multiple comparisons test
 - ✓ No statistical difference between coir bay treatments
 - ✓ No statistical difference between controls
 - ✓ Statistical difference between coir bay treatments and controls
- Regression analysis

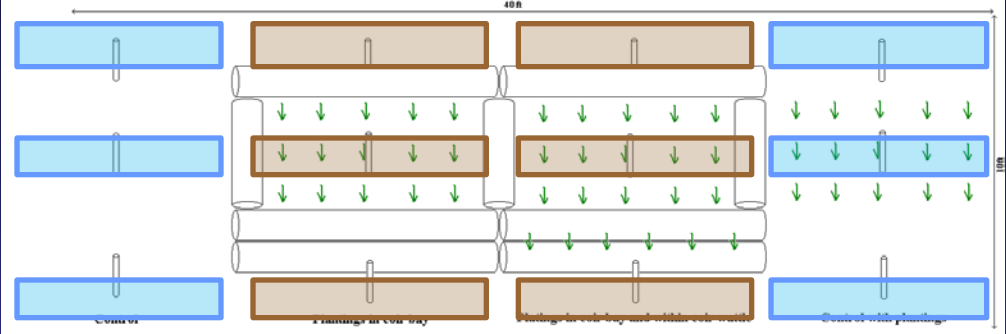
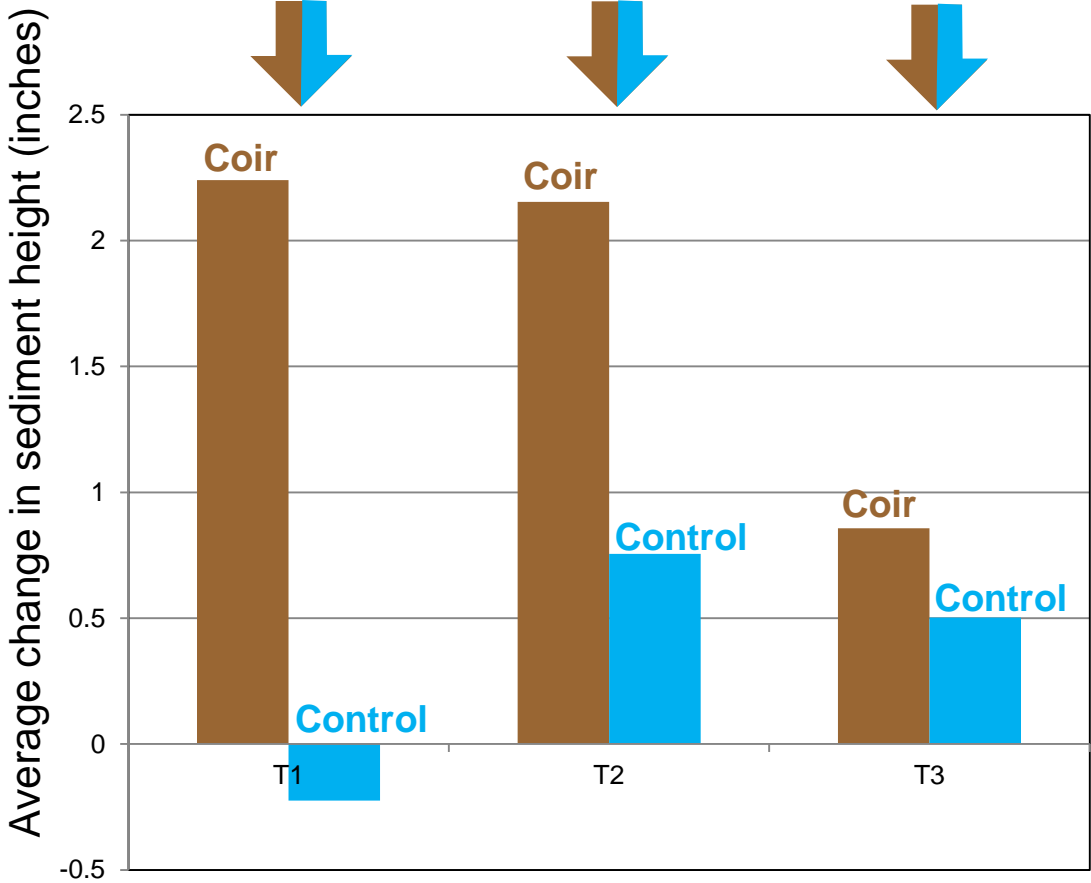
Results

by
transect
and
treatment

Transect 1
Transect 2
Transect 3

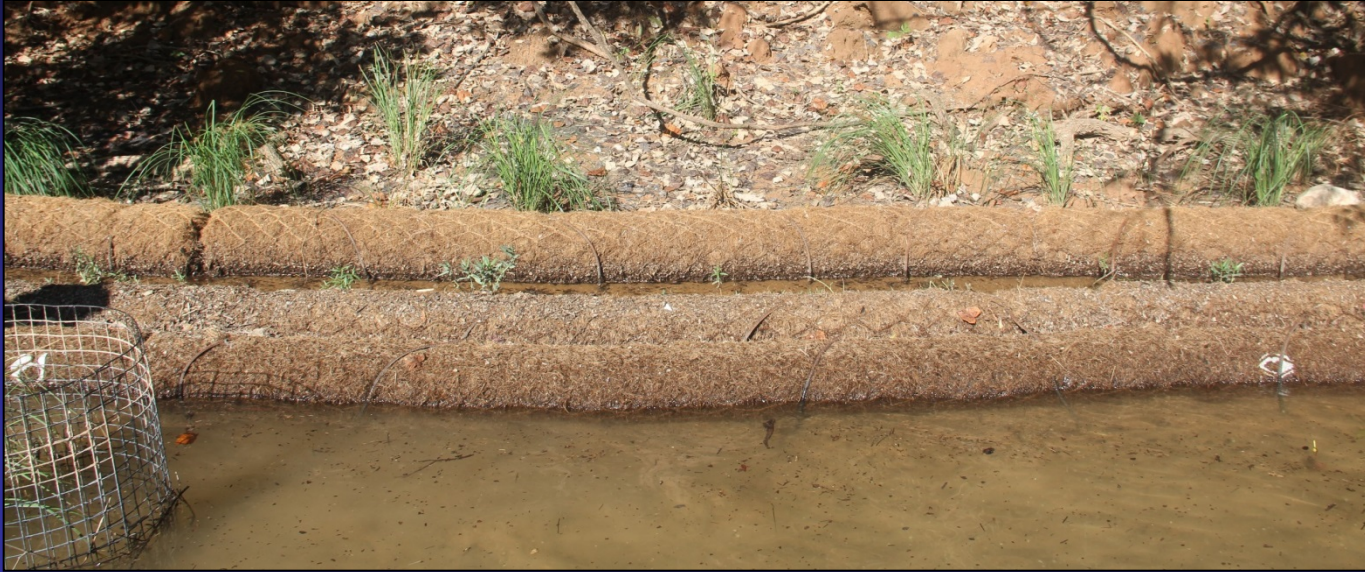
Tip 6: logs >6inches above normal pool

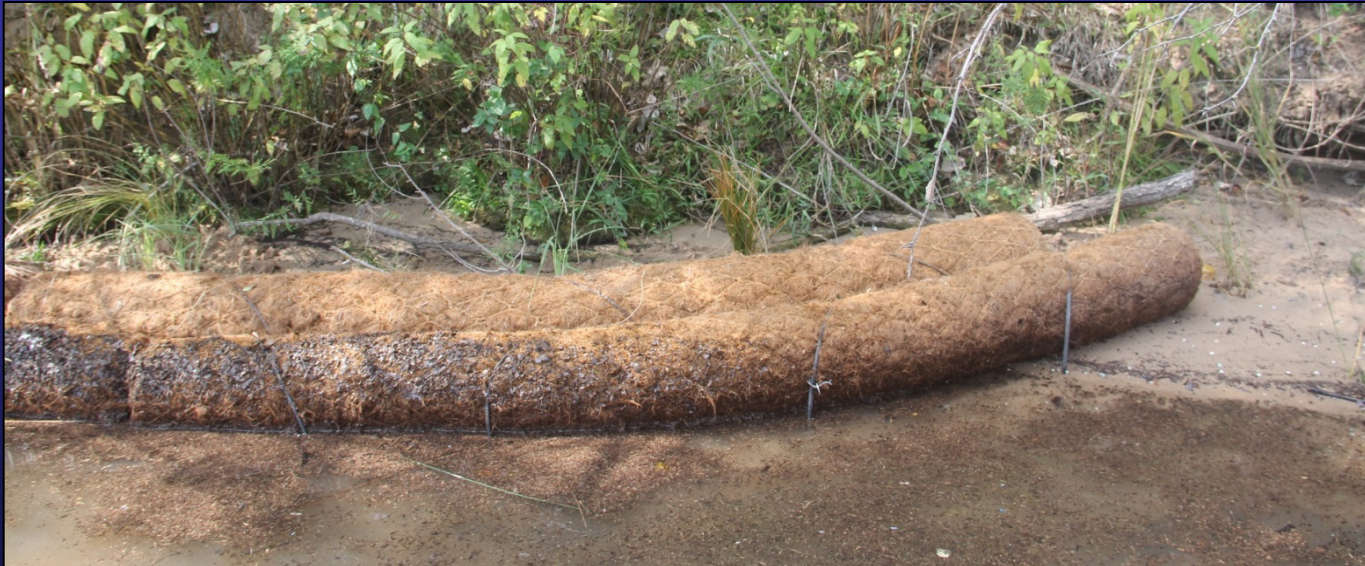
Tip 7: bend terminal ends to stop flanking

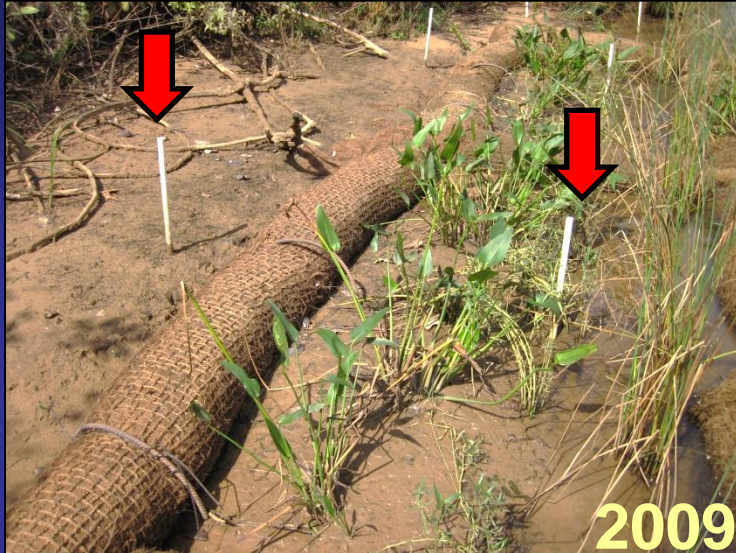
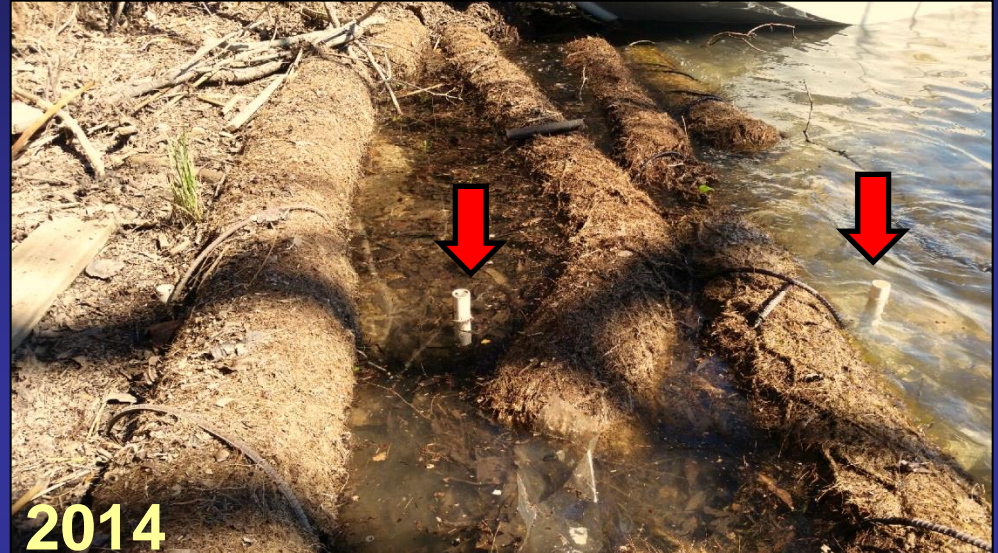
Tip 8: Ensure that your measuring gauges will stand the test of time

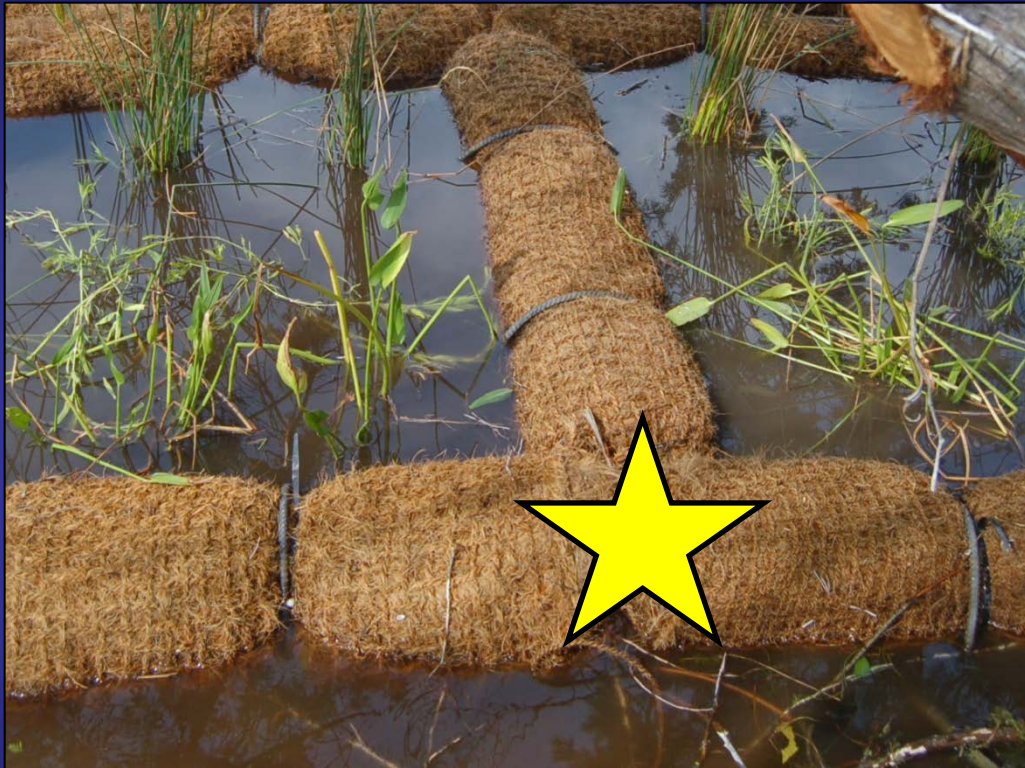
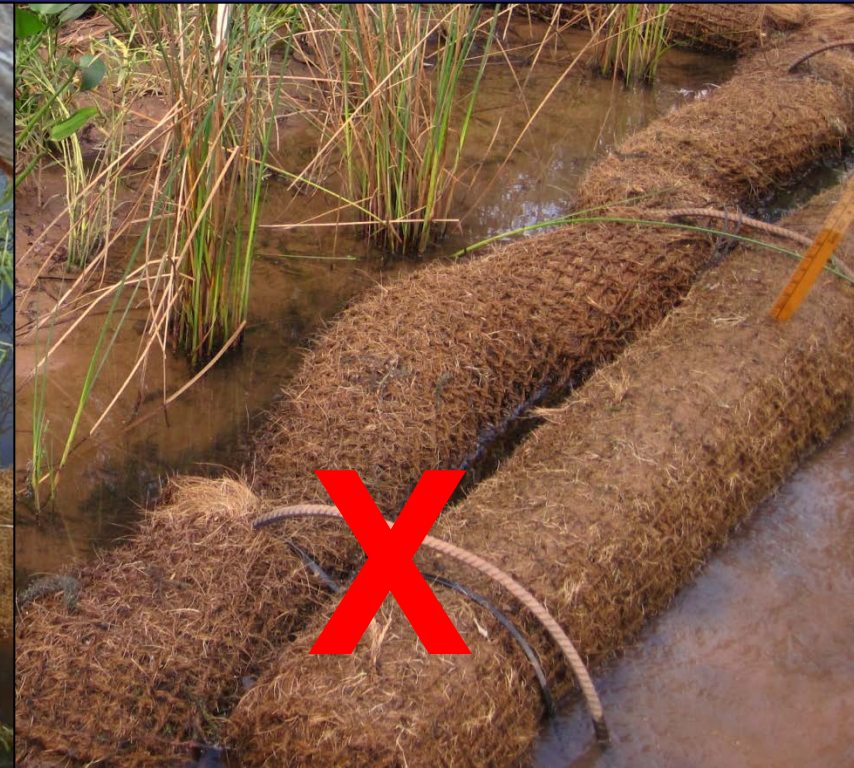
Tip 10: Rebar spanning single logs only (no doubles)
