The Functional Assessment of Floodplain Health: A Regulatory Tool to Protect the Natural and Traditional Character of Waterways

Appendix X: Functional Assessment of Floodplain Health

ECM Appendix X Functional Assessment of Floodplain Health

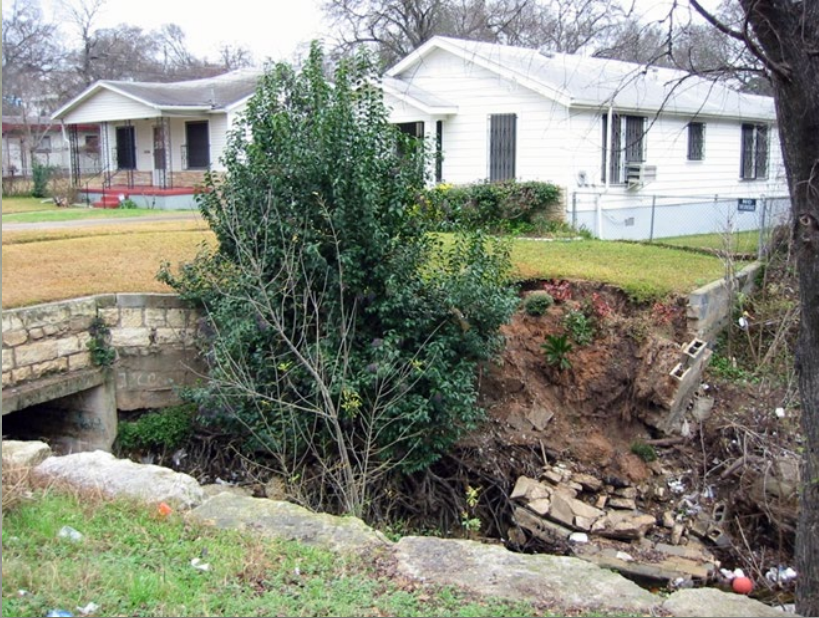
Unsafe

- 1) Necessary to protect public health and safety

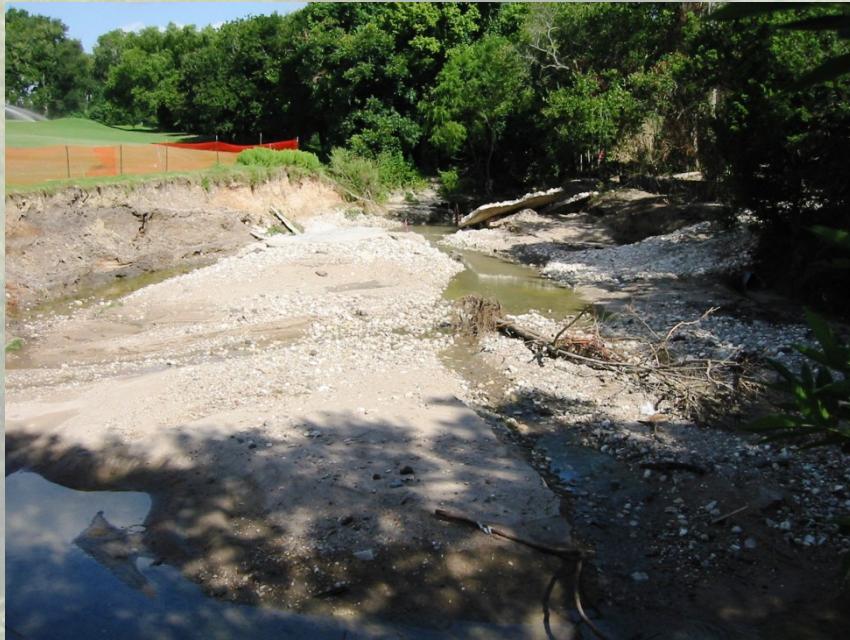
Poor Condition

- 3) Provides significant, demonstrable environmental benefit

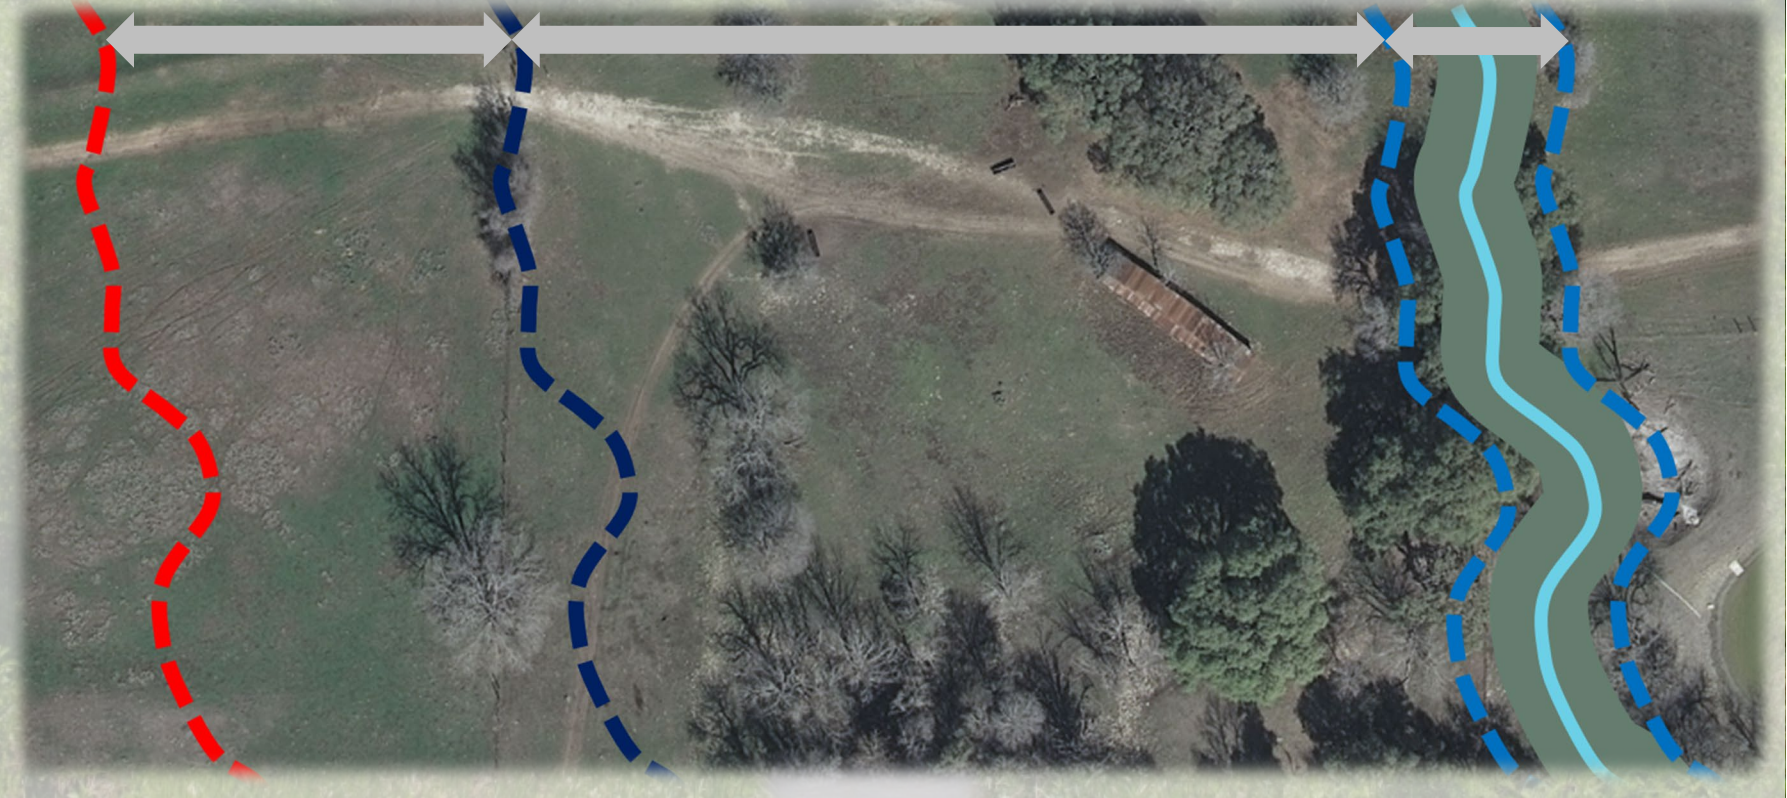
Functional Assessment of Floodplain Health

Zone 1
5 parameters

Zone 2
7 parameters
(Zone 1 + 2 more)

Zone 3
21 parameters
Riparian – 8 parameters (Zone 2 + 1 additional)
Geomorphology – 8 parameters
Aquatic Habitat – 5 parameters

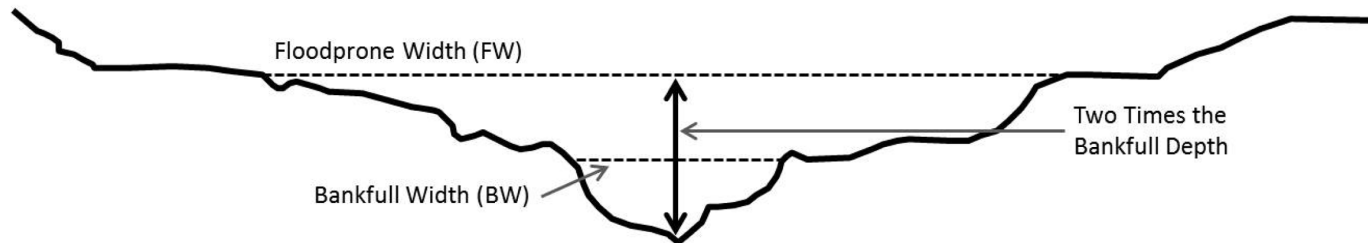
Measurement of Entrenchment Ratio (ER) at a Cross Section

Entrenchment Ratio: At a reference site along each 100 meter transect, measure the width of the floodprone area, bankfull channel width, and bankfull depth. Calculate the entrenchment ratio by dividing the floodprone width (channel width at 2 times the bankfull depth) by the width of the bankfull channel.

$$ER = \text{Floodprone Width (FW)} / \text{Bankfull Width (BW)}$$

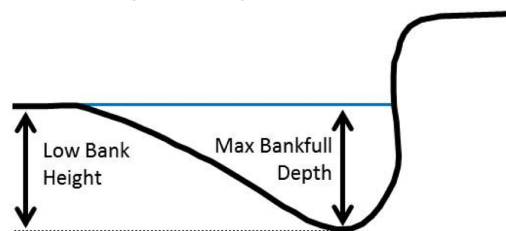
BHR = 1.0 (Excellent)

Floodplain Connectivity/Bank Height Ratio: Within each 100 meter transect, measure the bankfull depth and topographic low bank height. Estimate the bank height ratio by dividing the height of the low bank by the bankfull depth.

$$BHR = \frac{\text{Low Bank Height}}{\text{Max Bankfull Depth}}$$
