Accommodating Use and Enjoyment with Ecological Function: A Blanco River Restoration Demonstration Site

Ryan McGillicuddy
Texas Parks and Wildlife Department

Jackaroo Ranch Conservation Demonstration Area

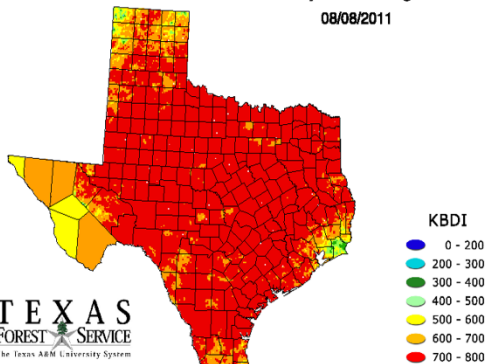
Keetch-Byram Drought Index
08/08/2011

- Guadalupe Bass extirpated from the system due to hybridization with non-native Smallmouth Bass
- 2011: Historic drought provided unique opportunity to remove Smallmouth Bass and hybrids from enduring pools above natural fish passage barrier

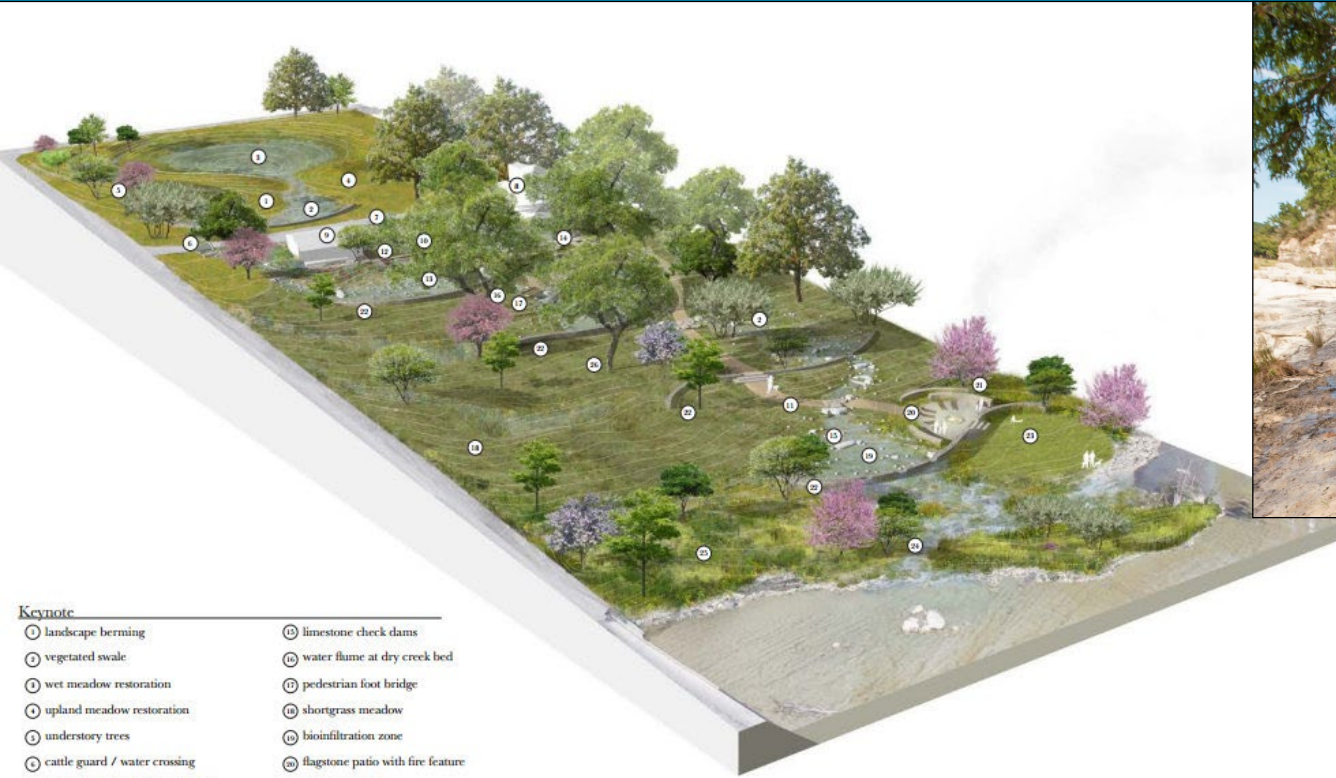
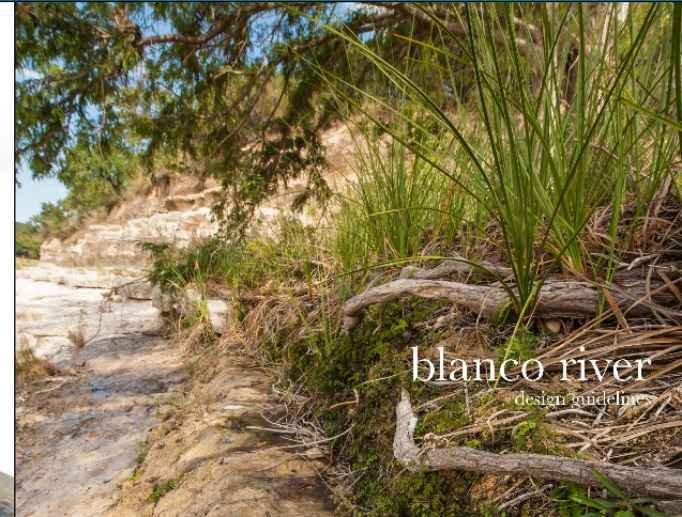
blanco river
design guidelines

- Developed in partnership with the Lady Bird Johnson Wildflower Center
- Encourage land management practices that accommodate recreational uses while also providing ecological functions

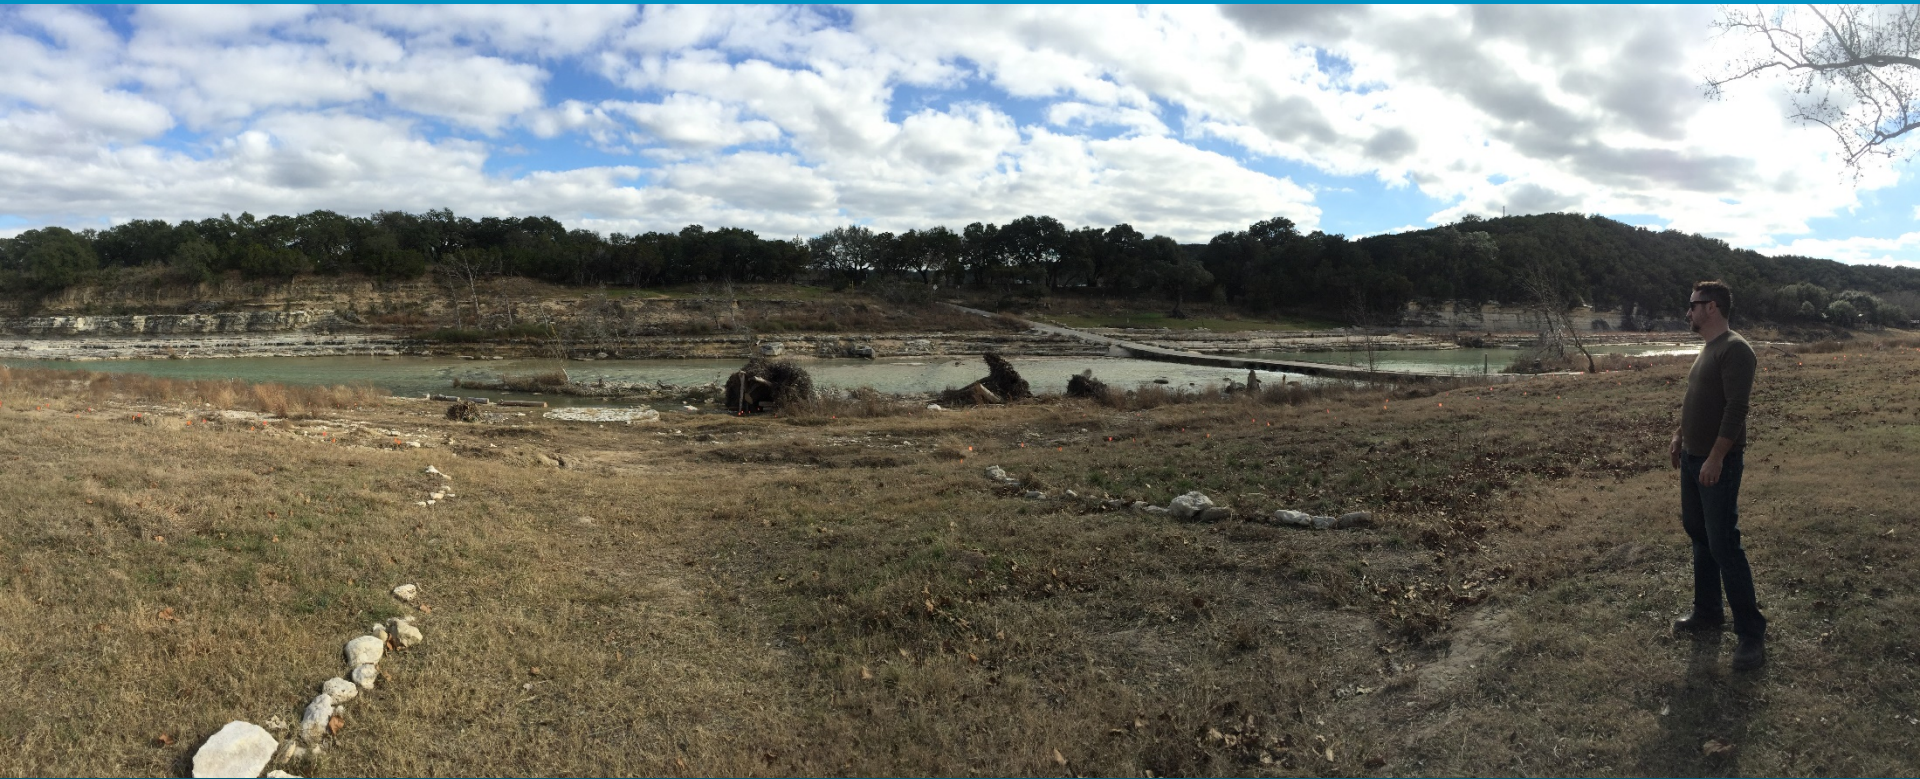
Establishment of “Grow Zone” and targeted access points

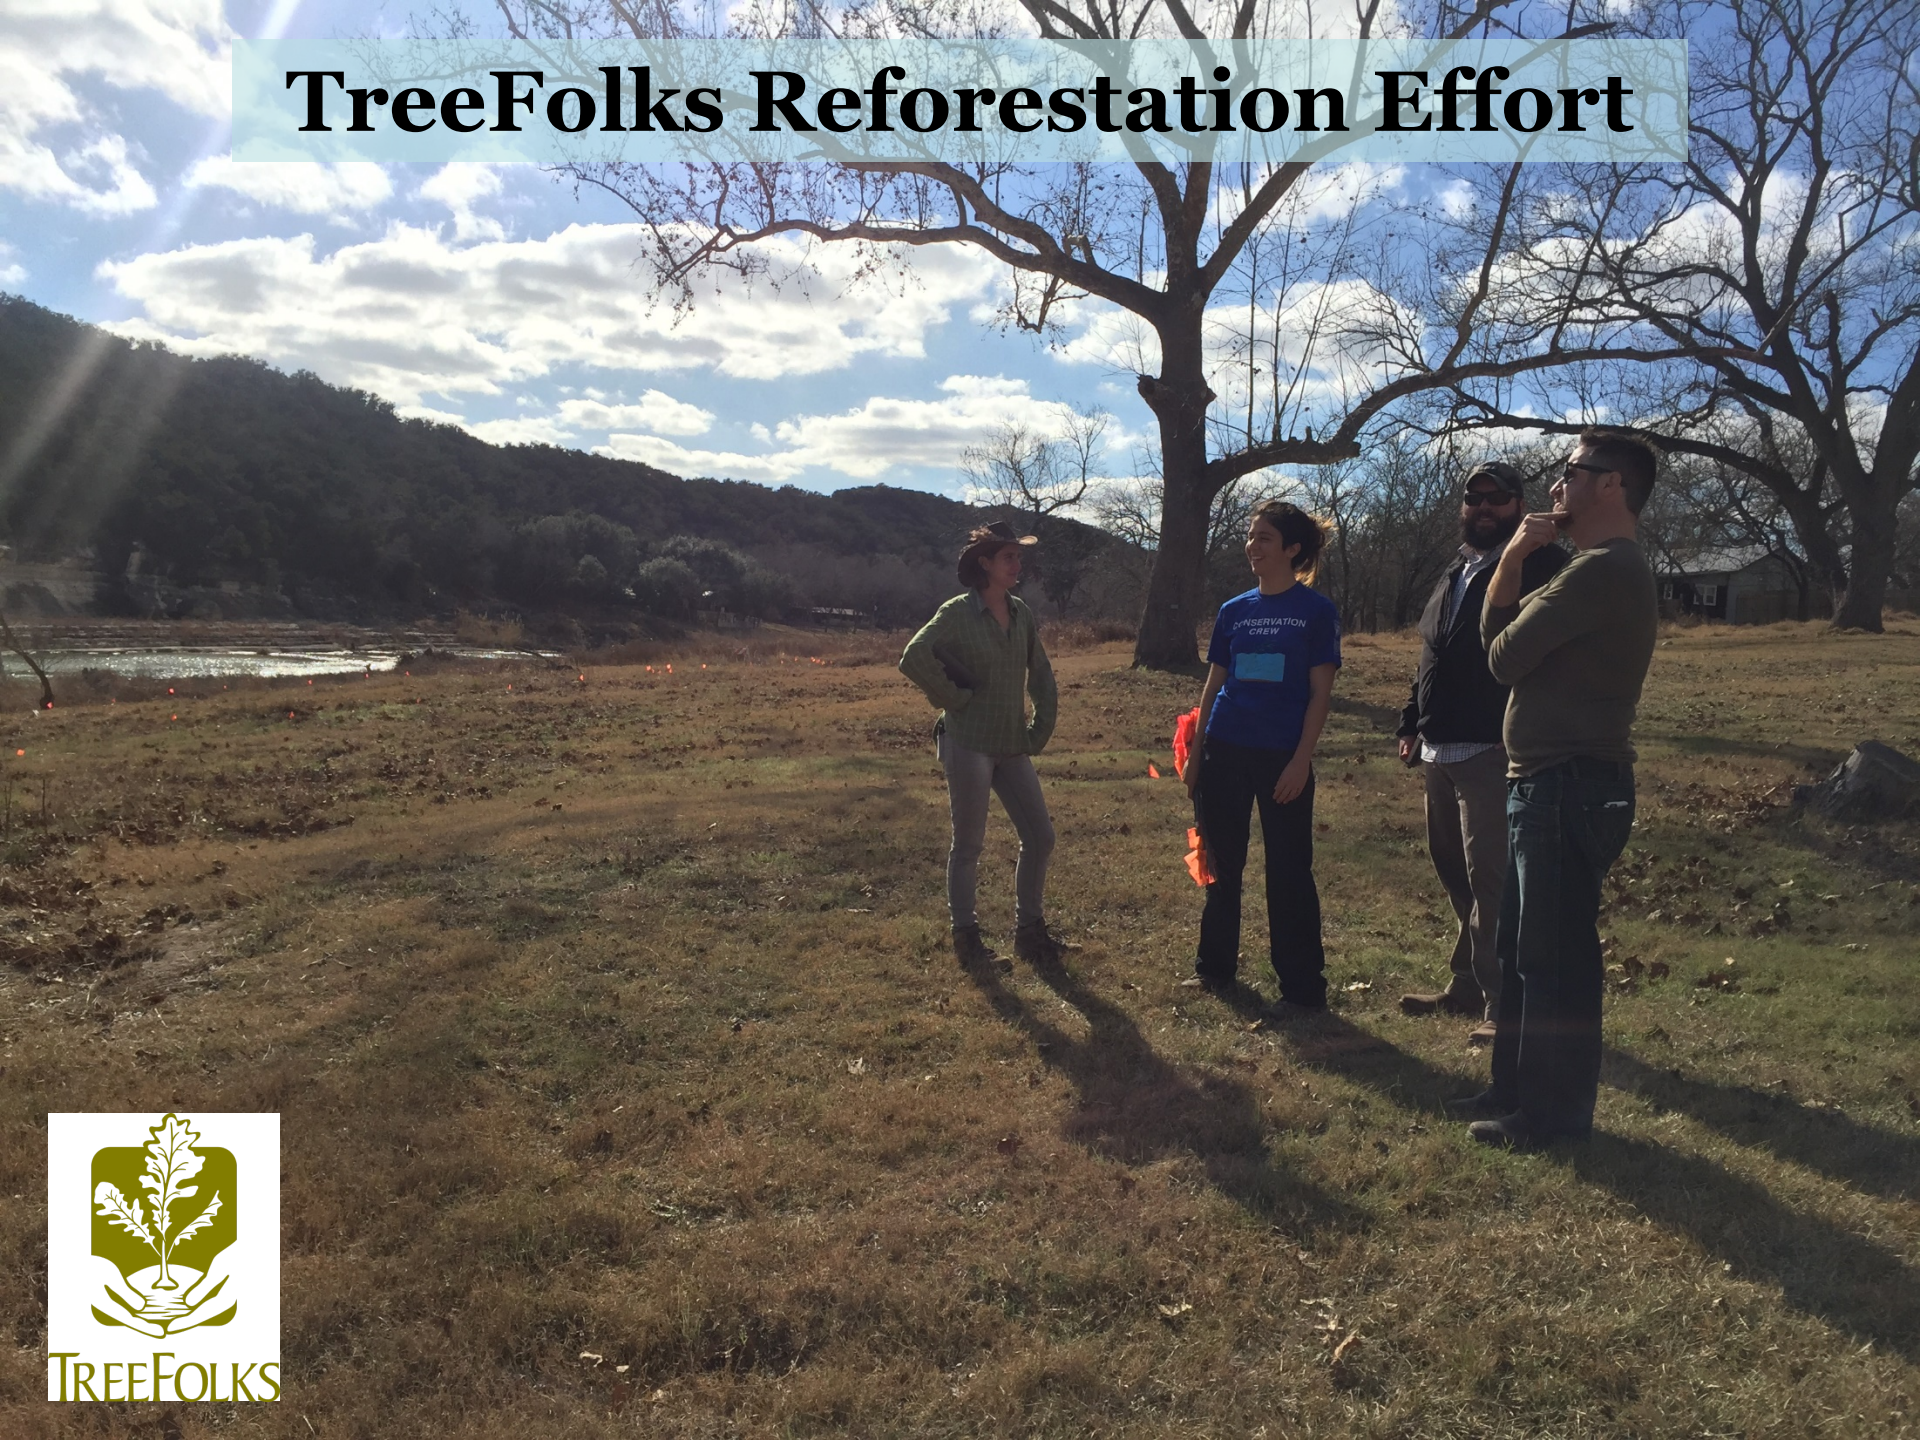
TreeFolks Reforestation Effort

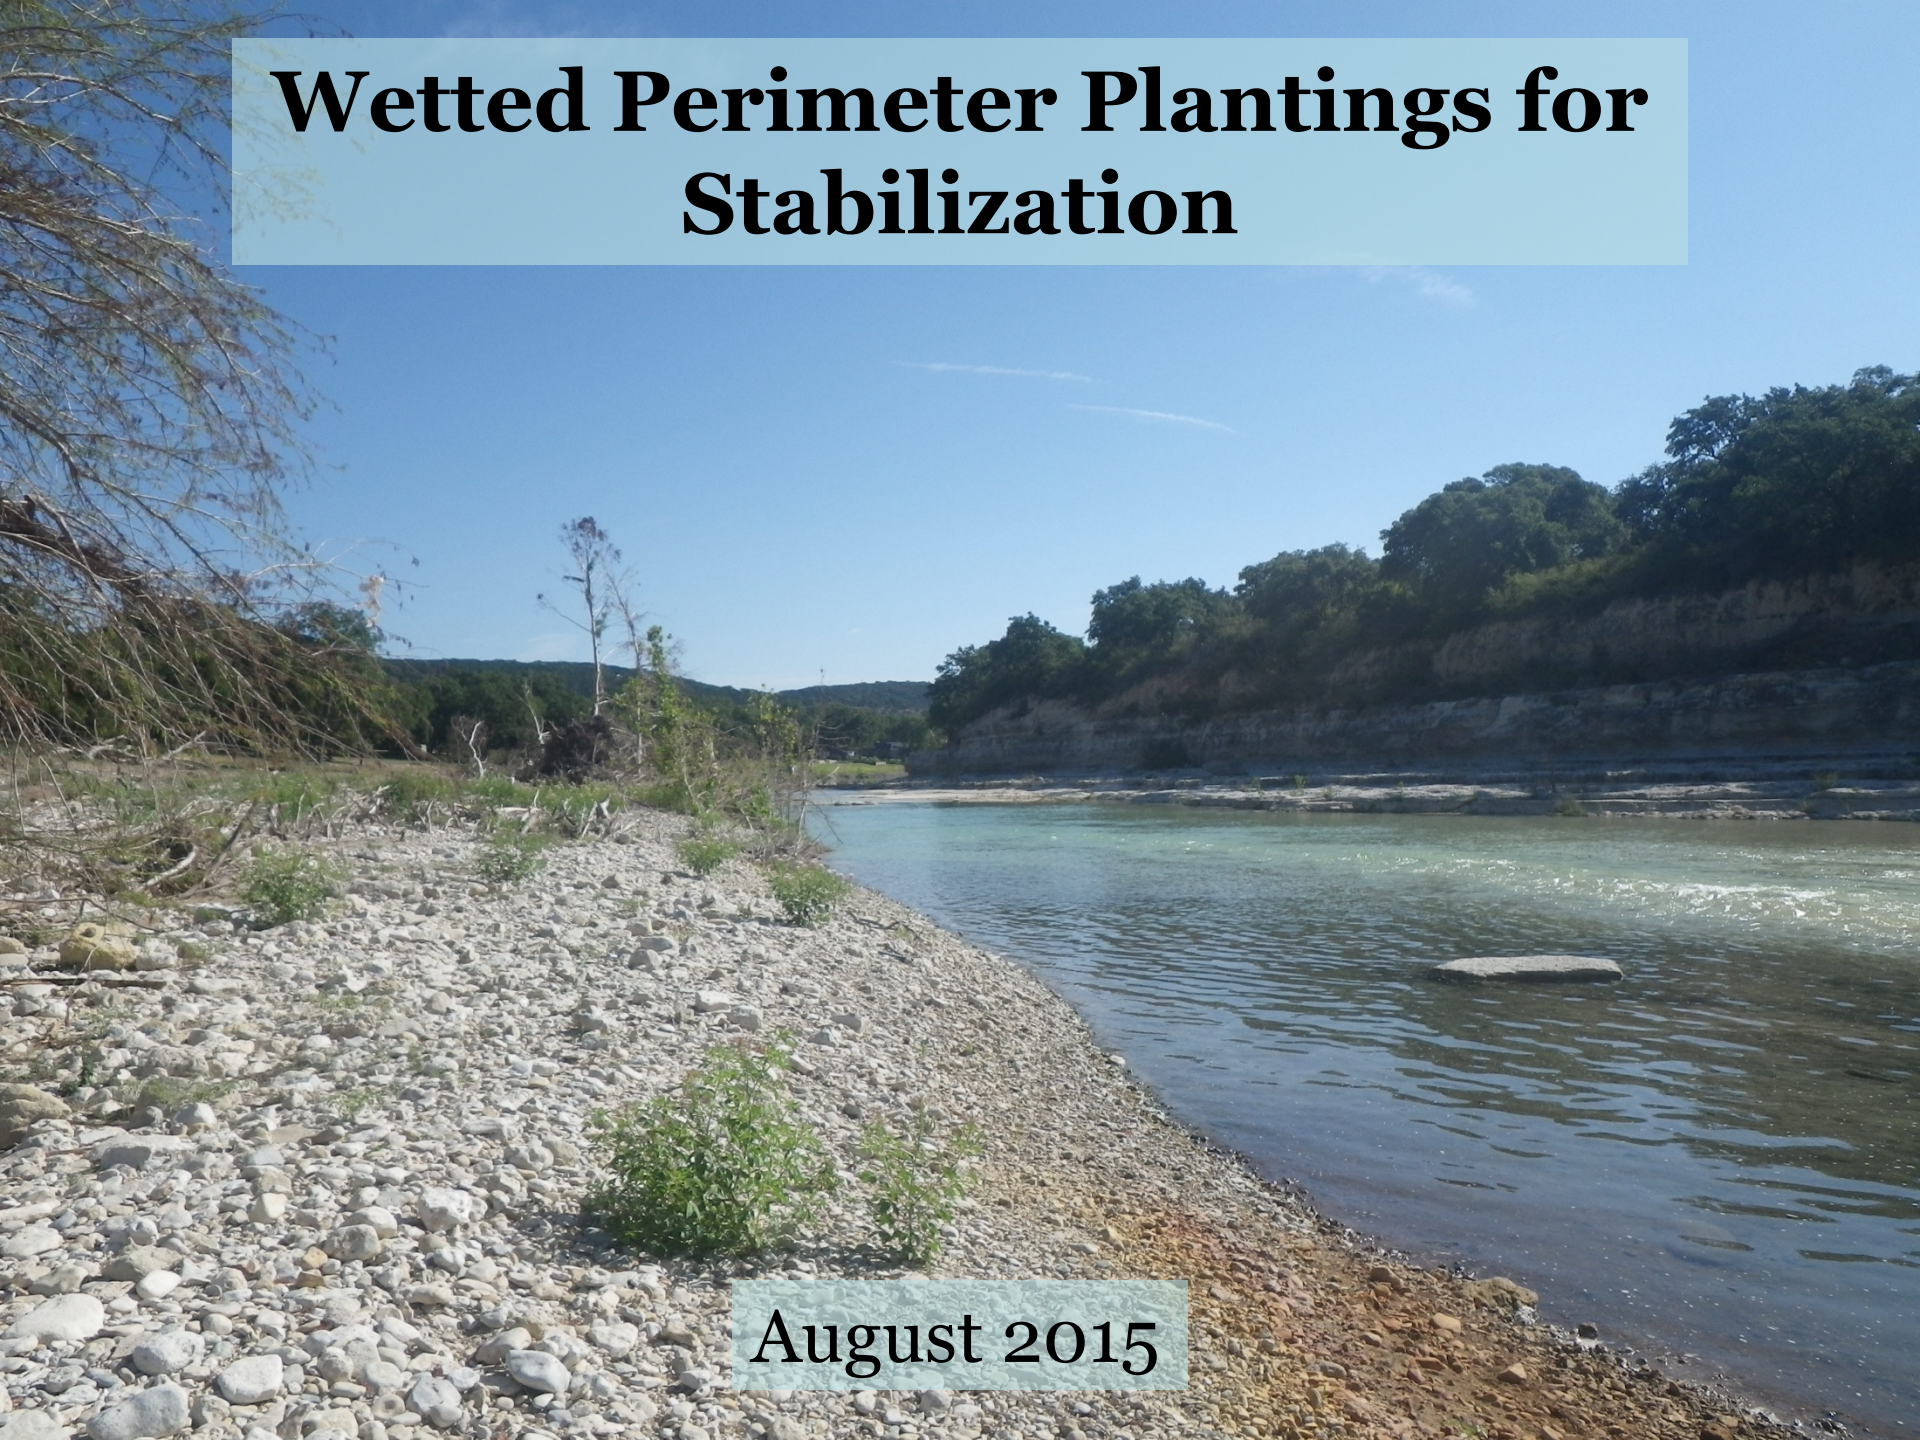
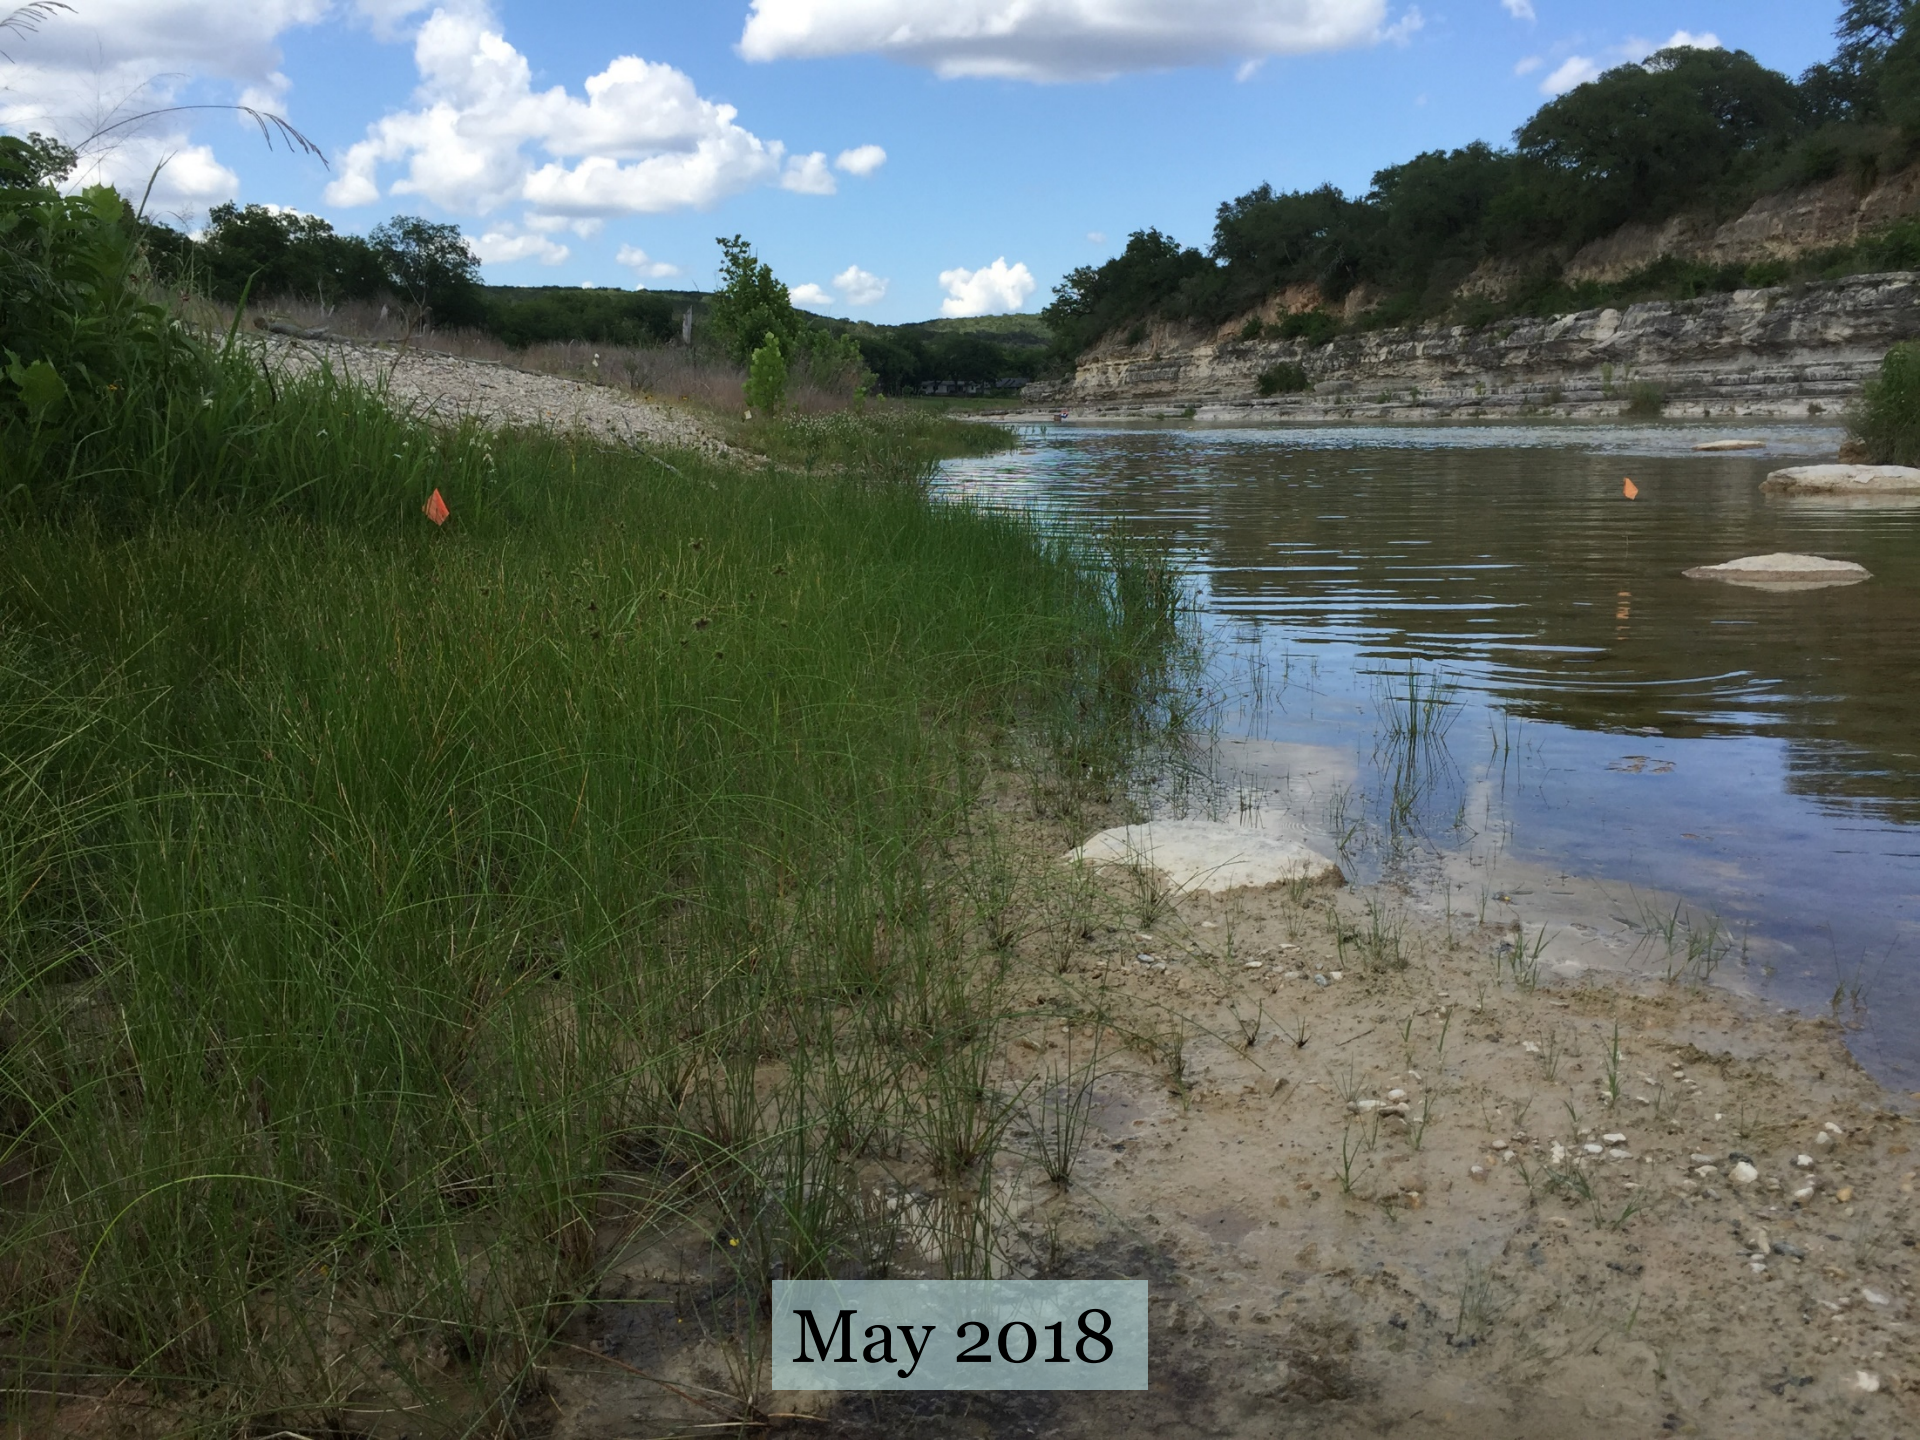
Wetted Perimeter Plantings for Stabilization

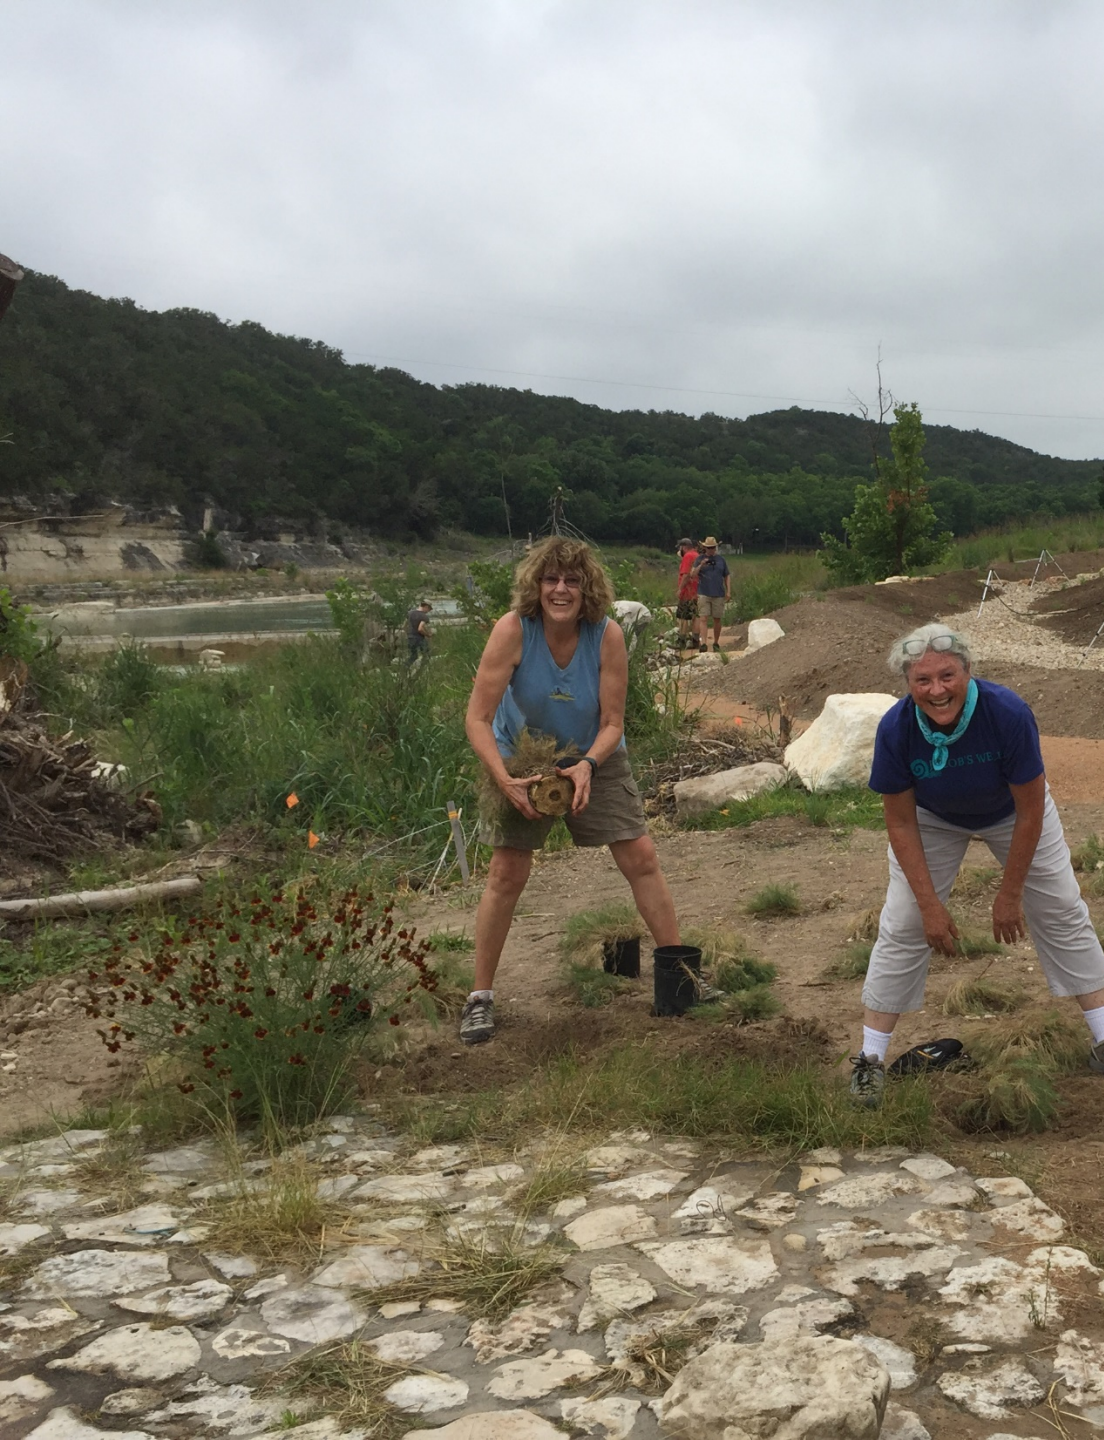
Plugged live roots:

- Lindheimer muhly (*Muhlenbergia lindheimeri*)
- Florida paspalum (*Paspalum floridanum*)
- Big bluestem (*Andropogon gerardii*)
- Nimblewill (*Muhlenbergia schreberi*)
- Switchgrass (*Panicum virgatum*)

Seed mixes (Native American Seed, Junction TX):

- Drainfield Mix
- Dam Slope mix
- Pollinator Essentials Mix
- Wetland Fringe Mix
- Thunder turf
- Sideoats grama

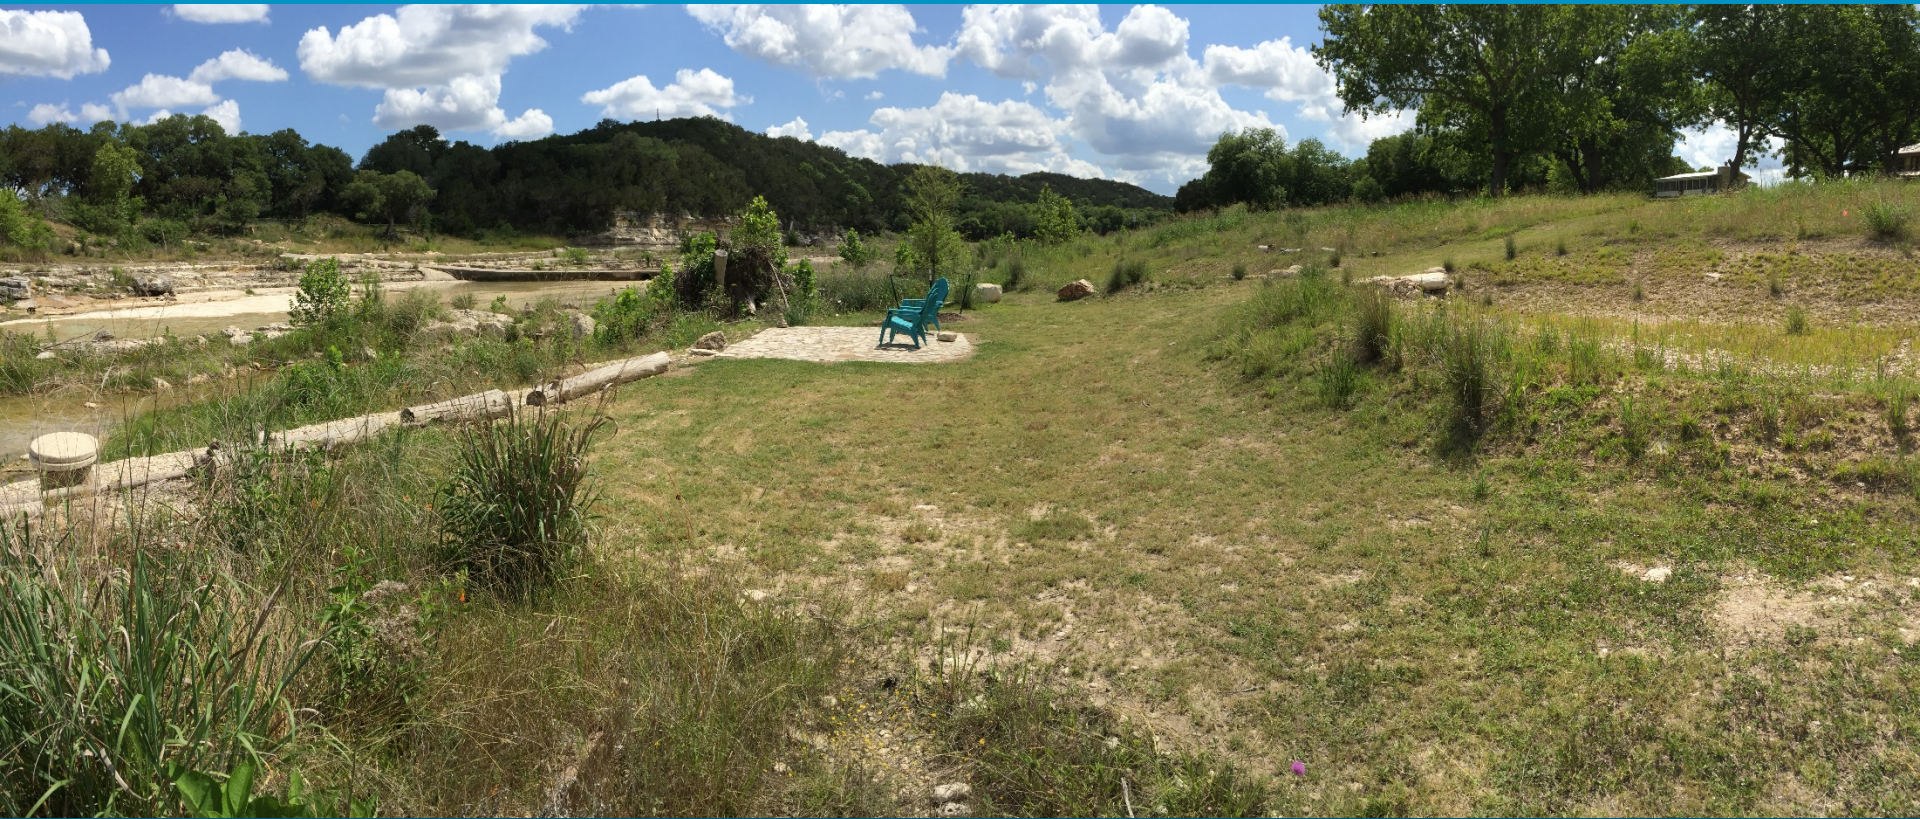
6" Rain Event
