# Flood Control Dams/Construction Runoff Impacts On Endangered Species Habitat in the San Marcos River

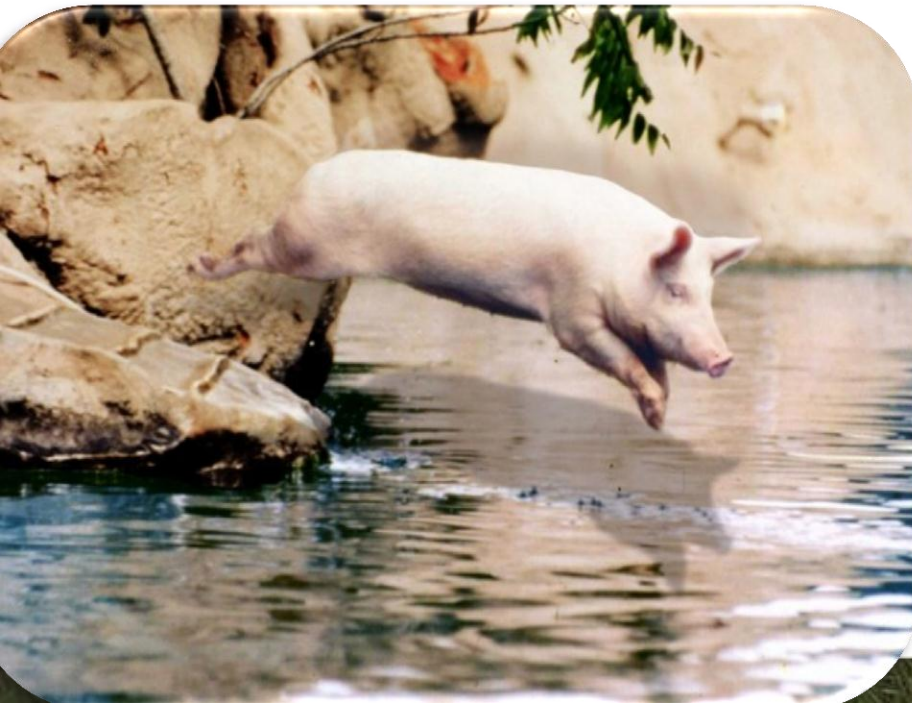
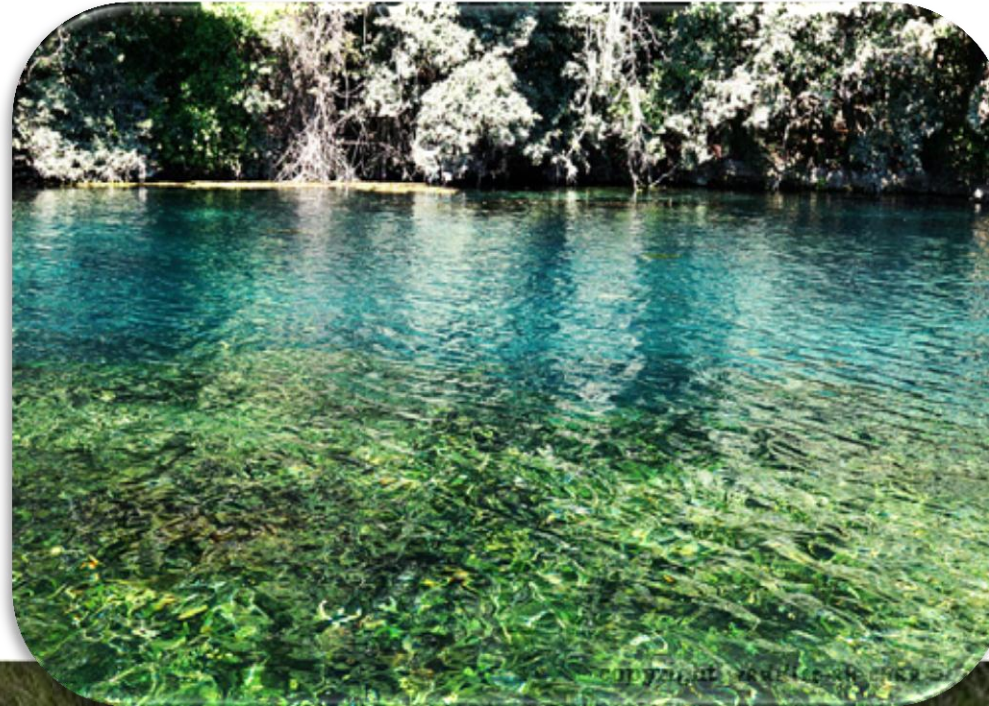
# San Marcos River Today

## Shallow river system

- < 2 feet deep
- Fine silts on bottom
- Impacts critical habitat
- Cloudy water on summer days
- Habitat Conservation Plan in effect

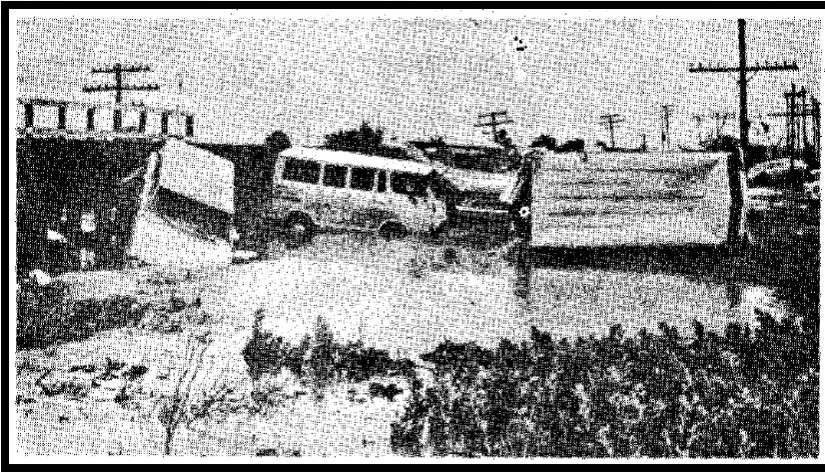
**1970 flood killed two, flooded 405 buildings and 15 miles of roadways. Spurred flood control project.**

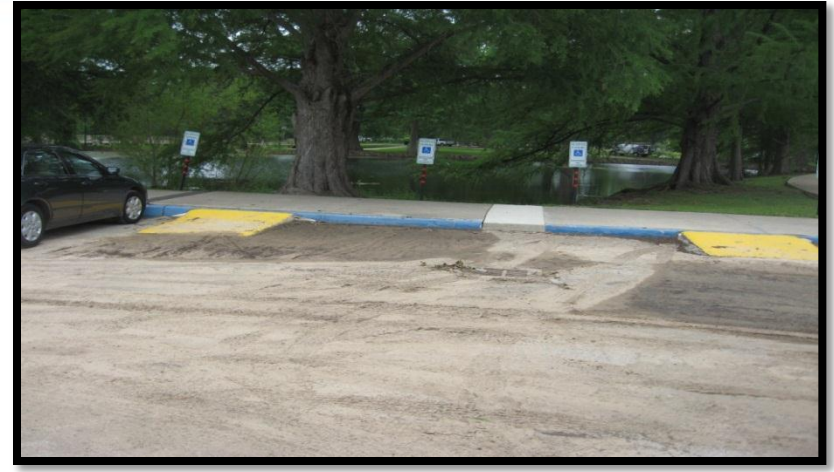
**Rapid Southwest Texas State and City growth, increased construction runoff**

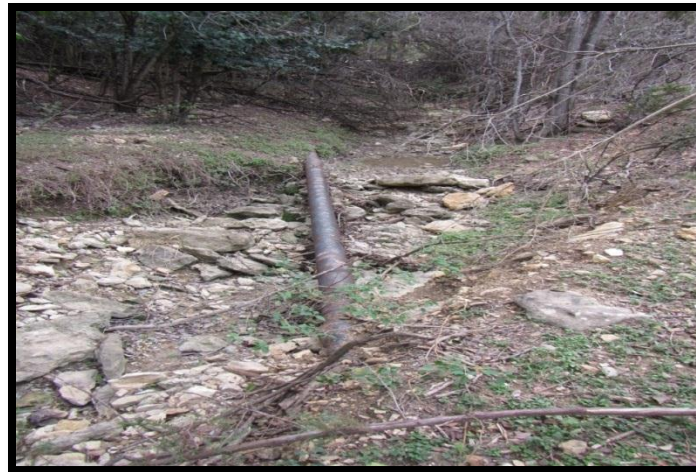
**Urbanization of Sessom Creek watershed before stormwater control measures, degrading creek**

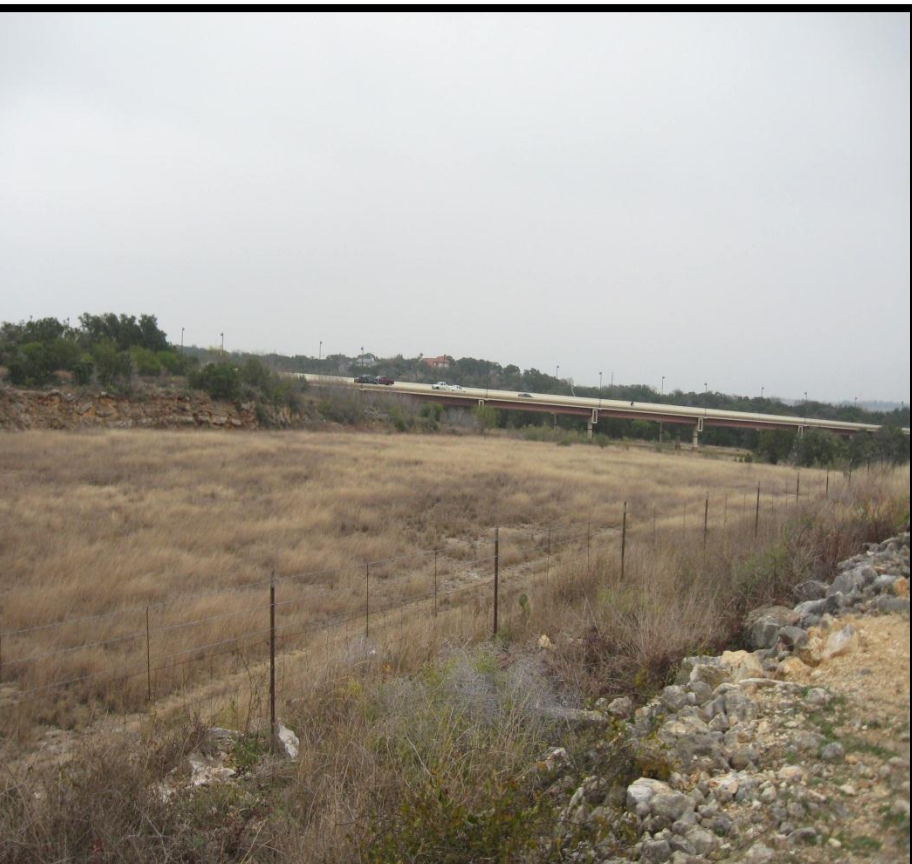
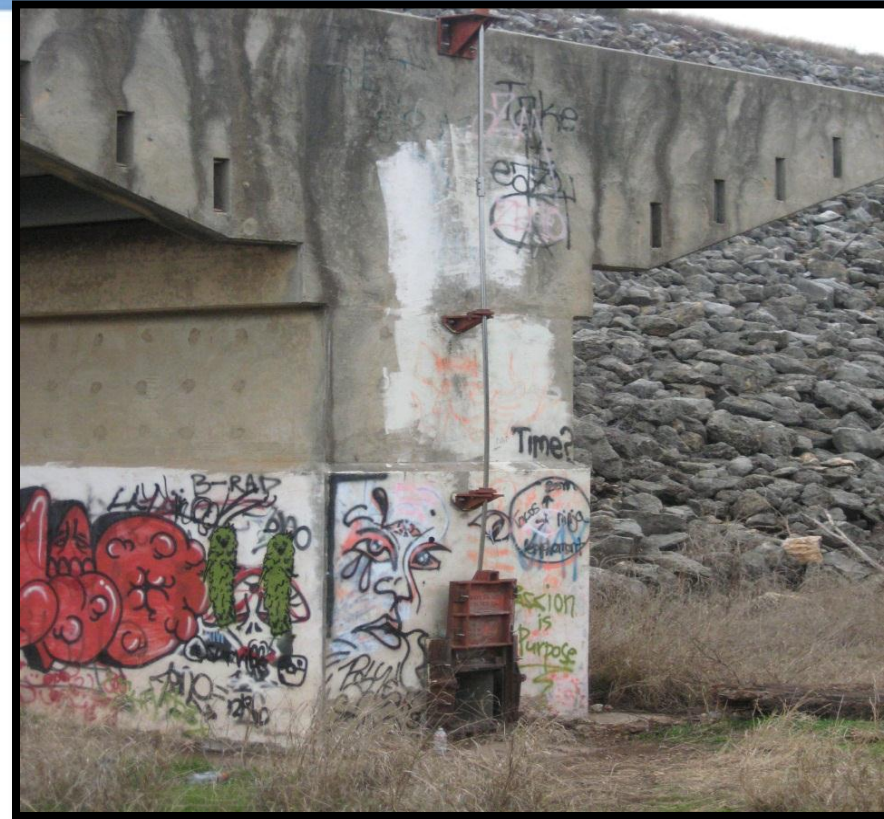
# Soil Conservation Service Dams

- Low flow outlets
- 4' to 5' culverts in dams
- 50' to 100' in height
- Emergency spillways – 300 feet

- 2013 Halloween Flood protection
- Reduced City 1998 flood damages
- Slight emergency spillway damage

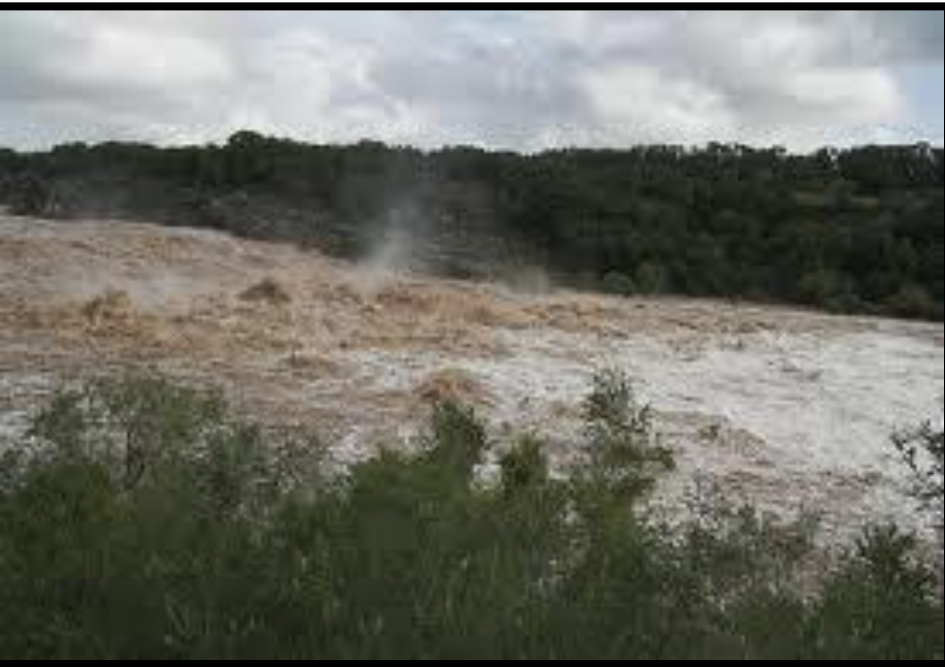
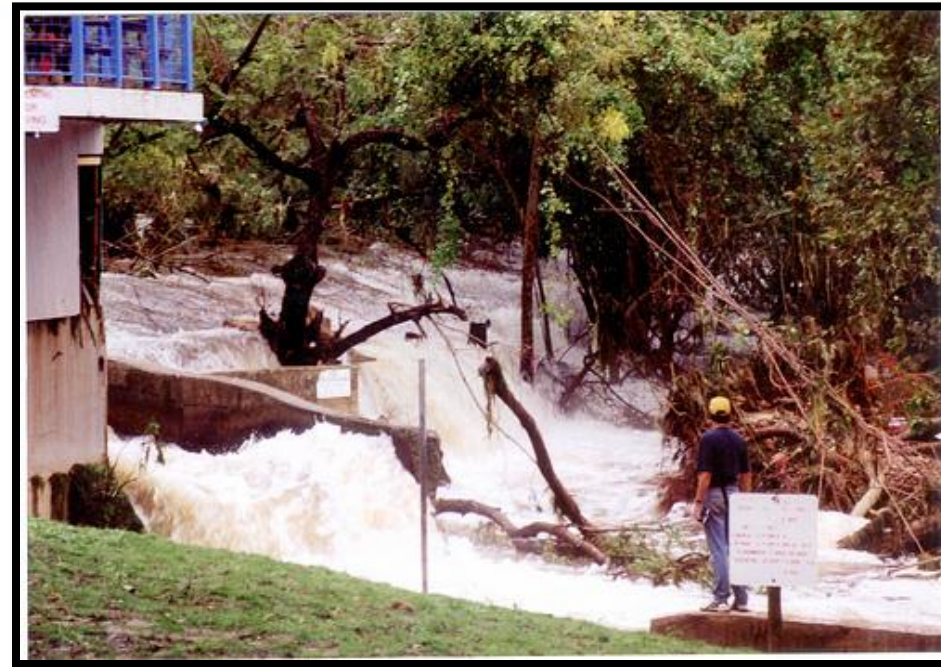
# 1998 Flood

- Emergency spillway flows about 6 feet deep
- Significant river flooding
- River was not scoured
- Why? 12+ years limited flow, river deposition, deep rooted plants??
